ANALYSIS OF COMPOSITE REPAIR METHODS FOR PIPELINE MECHANICAL DAMAGES SUBJECTED TO CYCLIC LOADING

Christopher R. Alexander
Stress Engineering Services, Inc.
13800 Westfair East Drive
Houston, Texas 77041-1101

Keith Leewis
Gas Research Institute
8600 West Bryn Mawr
Chicago, Illinois 60631

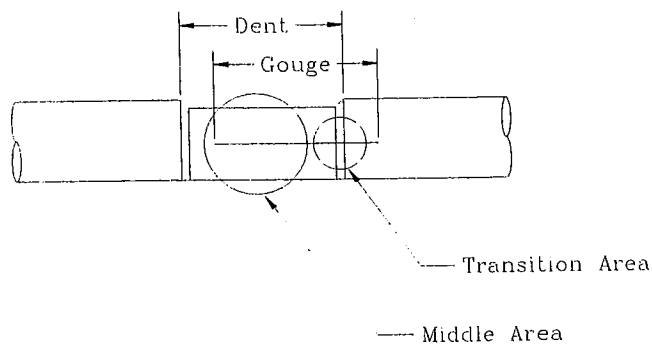
Fig. 5 Failure Location Guide

In order to determine where the failures were occurring in the samples beneath the Clock Spring, the wrap was removed from several of the failures and examinations using dye penetrant techniques were used. **Table 10** shows where the location of the failure occurred for the selected specimens and **Fig. 5** indicates graphically where the failures occurred. A ground region of a dent/gouge region for one of the samples is shown in **Fig. 6** prior to the installation of Clock Spring. **Figure 7** is a photograph taken of Specimen A2-3 after the removal of the Clock Spring. The surface was cleaned and dye penetrant was used for crack detection.

Specimen Number	Residual Dent Depth (d/D) ⁽²⁾	Gouge Depth (d/t, percent)	Failure Location (refer to Fig. 5)
B-1	5.5	15	Middle
B-2	5.9	15	Middle
B-3	5.9	15	Middle
A2-3	5.4	15	Middle/Transition
B2-1	5.5	15	Transition
B2-2	5.4	15	Transition
B2-3	5.8	15	Middle/Transition

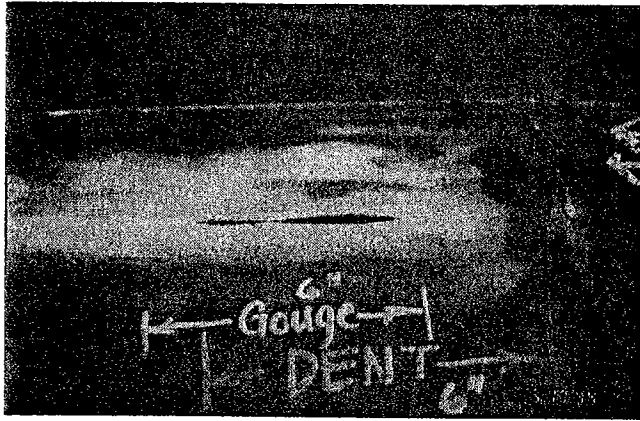
Fig. 7 Inspection of Specimen A2-3 After Removal of Clock Spring

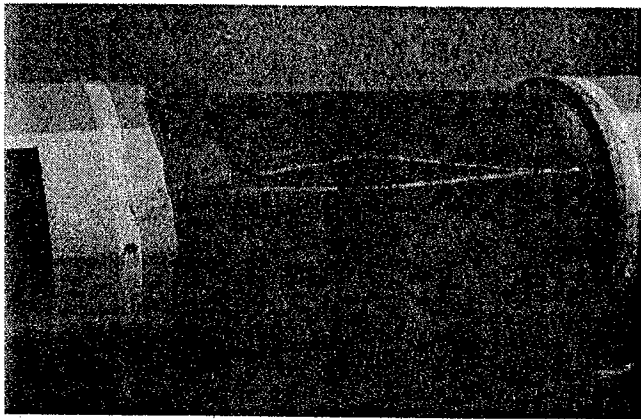
The fatigue strength of the pipe itself also became an issue in the process of testing. A longitudinal weld failure which occurred in Sample B-2 between specimens B2-5 and B2-6 is shown in Fig. 8. Although these samples did not fail, their removal was required because there was no way to repair this section or weld these specimens to adjacent pipe regions. Most of the failures in the Clock Spring samples were not catastrophic and typically appeared like the leak shown in Fig. 9. The failure of the Clock Spring seemed to be caused by the detachment of the wrapping from the surface of the pipe which prevented the Clock Spring from combating the opening and closing of the gouge region (thus inducing crack propagation). This bending is what causes the fatigue failures in the damaged sections.

Fig. 8 Longitudinal Weld Seam Failure in Sample B2

Considering that 5 cycles per two months (with a pressure differential of 200 psi) is typical for a gas pipeline (Fowler et al.), the 54,000 cycles experienced by the failed longitudinal weld in Specimens B-2 (see Fig. 8) corresponds to an infinite life. Even the life for this weld in a liquid line would be over 70 years (600 psi at 730 cycles per year).

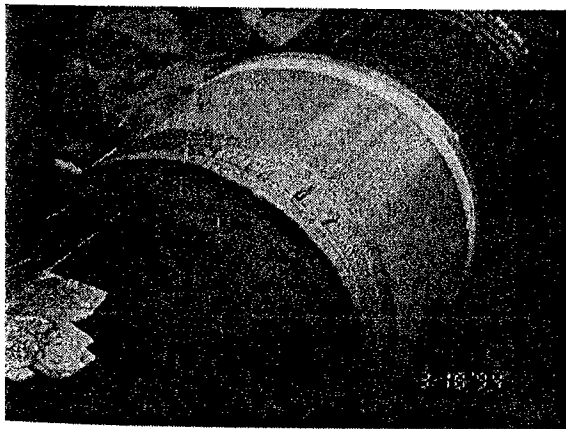
Fig. 9 Typical Failure in a Clock Spring Sample

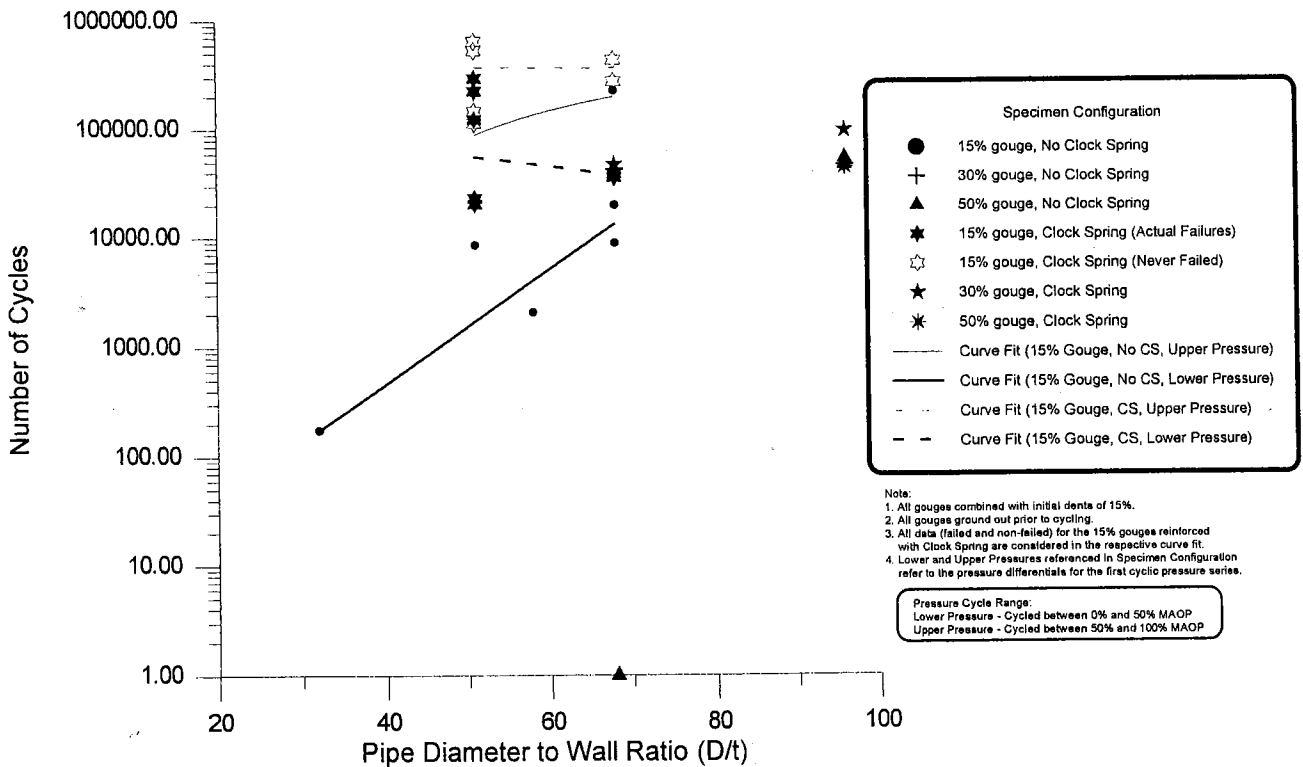
The results plotted in Fig. 10 compare the Clock Spring data to previous fatigue data obtained for pipes with various dent and gouge defects. Before discussing the data found in this figure, the method by which the *equivalent* number of cycles was obtained must be presented. Because most of the samples were tested with different pressure ratios, direct comparison of the fatigue data requires modification in order to present meaningful results. This was accomplished using an equation based on a combination of Miner's Rule and the DOE-B curve. This method calculates an equivalent number of cycles at a specified pressure for a pipe which was pressure cycled at other pressure ratios. This equation is presented in addition to an example problem where:

When samples covered with Clock Spring are compared with uncovered defective regions, the covered samples exhibit fatigue lives approximately 2 to 5 times as long as their uncovered counterparts for pipes with D/t ratios less than 68. Based on this information, Clock Spring serves to increase the fatigue life of pipes with dent/gouge defects for these pipes. However, the results for the 24" sample ($D/t=96$) indicate that Clock Spring does not have as significant a contribution as with the lower D/t pipes. The likely basis for this observation is the unusually high cycle numbers that existed even with the unrepaired defects.

Fig. 10 Fatigue Life Results
