OTC 23454

Application of a Grouted Sleeve to Remediate Damaged Subsea Pipeline

Alessandro Vagata and Bill Bath, Saipem America; Chris Alexander, Stress Engineering; Alexander Aalders, Williams Midstream; Danny Seal, GL Nobel Denton

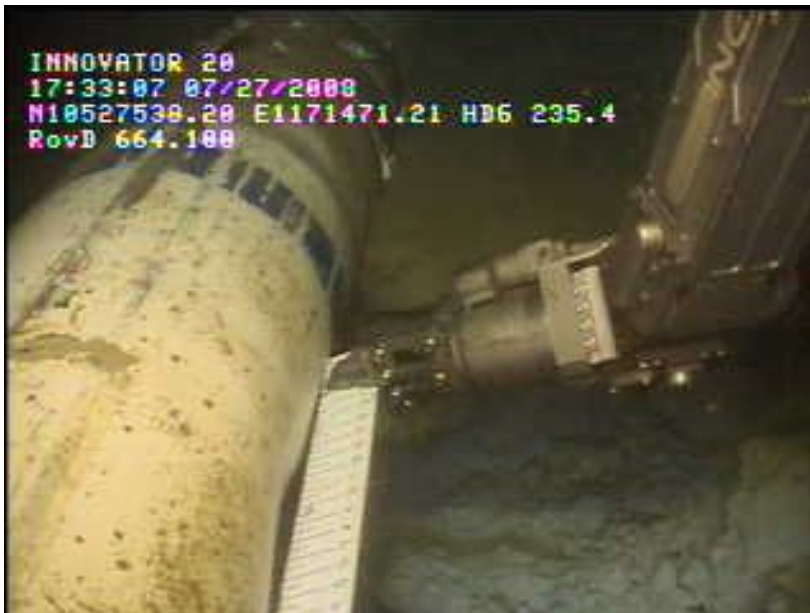
In 2005 the Canyon Chief pipeline was hooked by an anchor. At a depth of 2,300 feet, the anchor dented the 18”- 7/8” wall pipe and pulled it 1500 ft away from its original path. ROV inspection at the time of the accident indicated that the pipeline was not leaking. However, in the interest of safety, the pipeline pressure was lowered to about 800 psi and allowed to continue in operation while a remediation method was developed. It was hoped that after remediation, the pipeline could be returned to the full 3,200 psi safe operating pressure.

This remediation project was started with minimum information. Available information included data from a measuring pig run that showed the actual dimensions of the dent, an ROV picture of the dent (Figure 1) that showed that the pipe was clean and the coating was mostly intact, and a sonar image of the bend in the pipeline. This image (Figure 2) was overlaid with scale circles that provided an estimate that the radius of the bend was between 35 and 80 feet.

Figure 1 - Estimating the dent with a straightedge

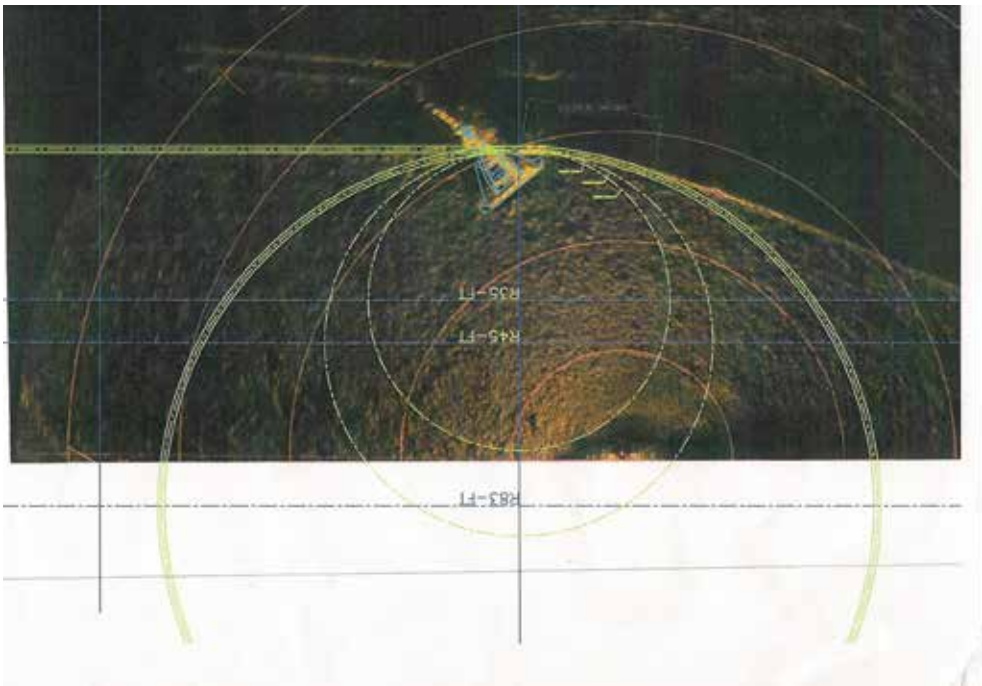
Figure 2 - Estimating the radius of curvature of the pipeline

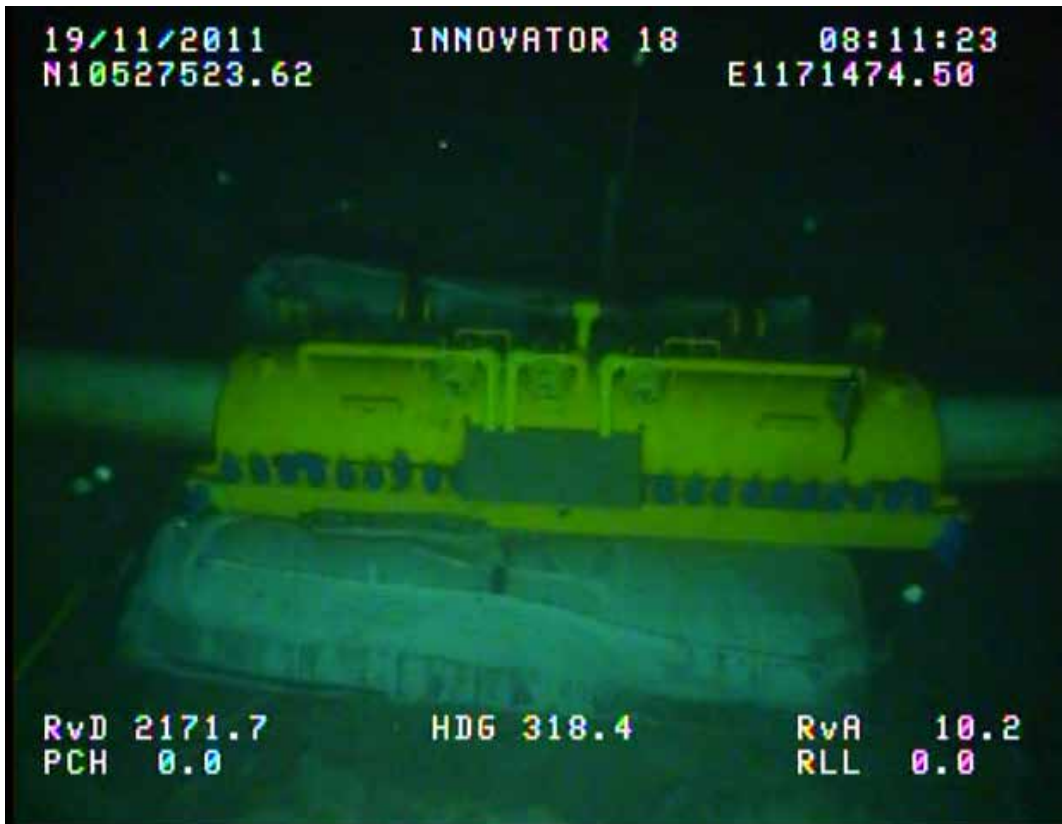
Figure 10 – Grout Sleeve and Grout Bag installed on the pipeline

Installation of the grout sleeve required that an access hole be dredged under the pipeline. This hole needed to be about 20 ft long and 4 feet deep to provide clearance for the bottom half of the sleeve to swing closed under the pipeline. It was recognized that the weight of the sleeve plus the cement grout would be around 12,000 lbs, when the buoyancy module was released. Therefore, to prevent the pipe from sagging into the hole we installed an ROV-operated pipe support frames about 30 ft. back from either side of the hole (Figure 9). Each frame consisted of two mudmats and a single, motor-operated grab. These frames did not lift the pipeline but simply added mudmat support. After the grout sleeve was installed, the ROV pulled a fabric grout bag into the hole under the sleeve. This bag was then filled with cement grout to fill the vacant space below the grout sleeve. After the grout was allowed to cure for a few hours, the ROV disconnected the spreader bar from the sleeve and it, along with the buoyancy module and suppressor weight, were recovered to the surface. The pipeline support frames were also released and recovered. The only things left on the sea floor were the grout sleeve and the grout bag supporting it (Figure 10). This remediation action cleared the pipeline for full operating pressure operation.
