## **EVALUATING ANCHOR IMPACT DAMAGE TO THE SUBSEA CANYON CHIEF PIPELINE USING ANALYSIS AND FULL-SCALE TESTING METHODS**

### **ABSTRACT**

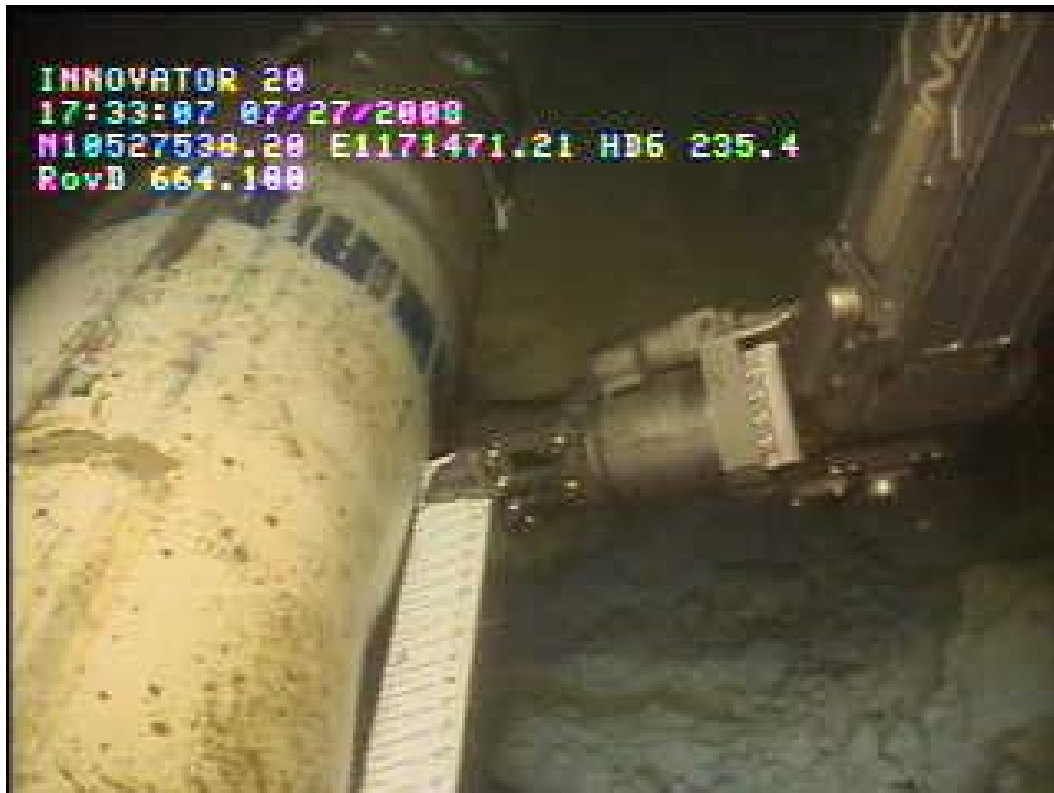
information included ROV video footage, in-field measurements using ROV-assisted tools, and in-line inspection data that provided the three-dimensional geometry of the dent. A photograph is provided in Figure 1 was taken using an ROV showing the geometry of the dent. As observed in this figure the coating was relatively intact, although the in-line inspection tool did detect metal loss in the vicinity of the dent. Figure 2 includes a sonar image of the bend in the pipeline, which was overlaid with scale circles used to provide an estimate of the radius of bend. As shown, the radius of the bend was between 35 and 80 feet.

Figure 1 – ROV-assisted measurement of dent using a straightedge

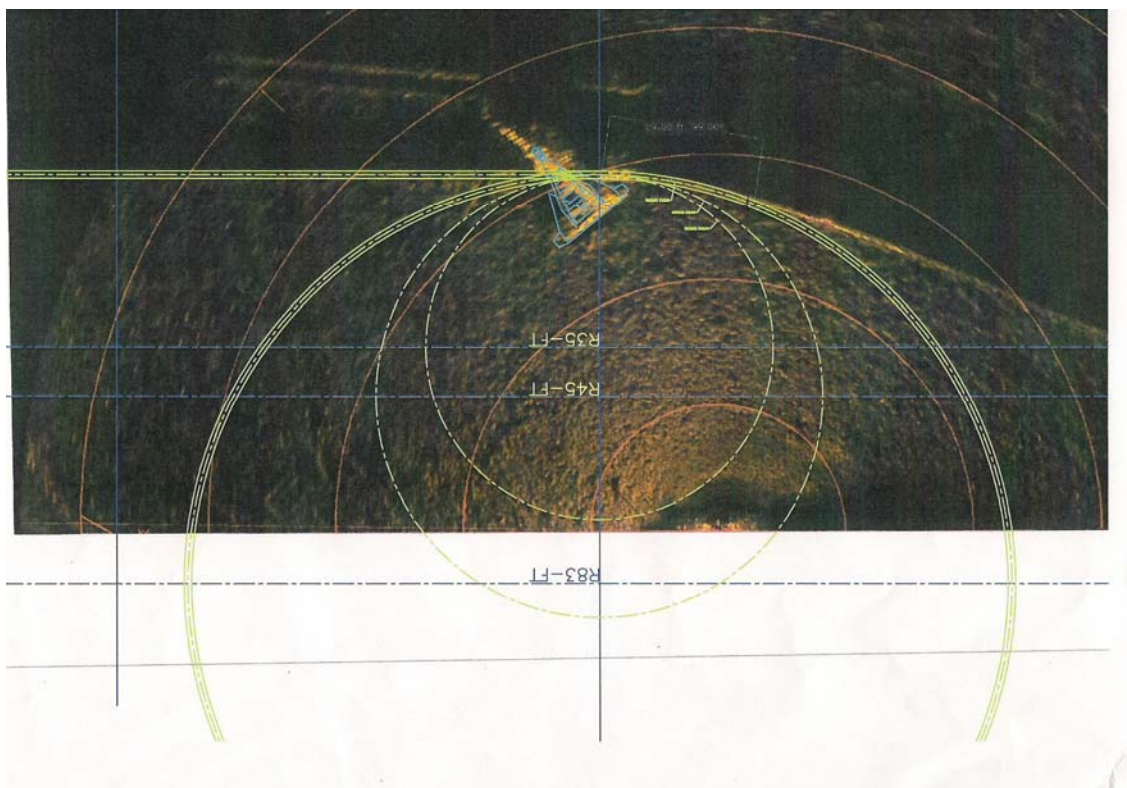
Figure 2 - Sonar image with radius of curvature estimation of the pipeline

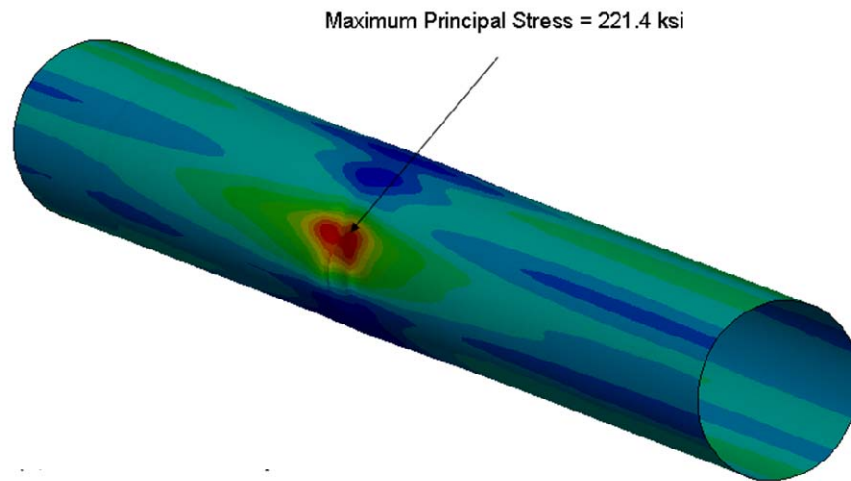
An in-line inspection conducted by Rosen detected the presence of multiple dents, including one having a depth of 7.4 percent of the outside diameter of the pipe. Additionally, this dent damage included a localized metal loss having a depth of 11 percent of the pipe's nominal wall thickness. A total of 16 dents were evaluated using finite element analysis (FEA), although the primary focus was a 7.4 percent deep dent, identified by Rosen as Dent ID 339968. Figure 3 provides a stress contour plot from the finite element analysis for the dented region at a pressure of 100% SMYS (hoop stress of 60,000 psi). As noted in Figure 3, the maximum principal stress is 221.4 ksi, corresponding to a stress concentration factor of approximately 3.7. FEA was also used to calculate stresses in the sleeve and also estimate the level of strain reduction in the dented region due to the presence of the sleeve. Figure 4 is a schematic diagram showing the layout for this particular FEA model, while Figure 5 plots strains in the dented region with and without reinforcement. As observed in this latter figure, the sleeve acted to reduce strain in the dent by a factor of approximately 5 at a pressure of 1,450 psi (25% SMYS).

Maximum principal stresses in Dent ID 339968

Figure 3 - Stress contour plot for dented region 100% SMYS (hoop stress of 60,000 psi)

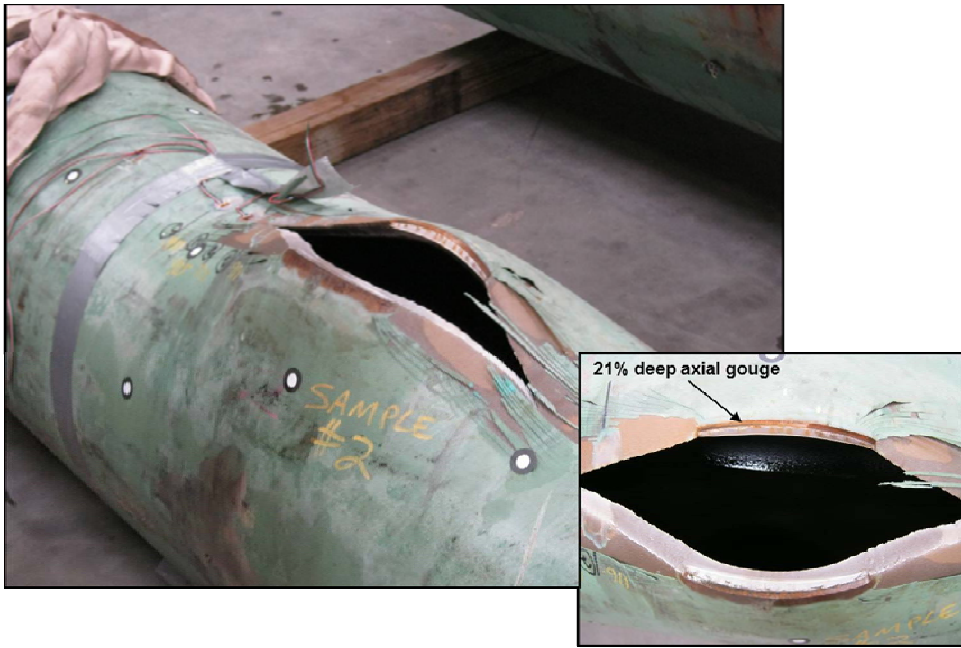
- Sample #2 failed at 9,739 psi (167% SMYS), only failure to occur in the dent defect
  - Dent with 21% deep axial gouge
  - Failed in dent/gouge area
- Sample #3 failed at 9,986 psi (171% SMYS)
  - Dent with 11% deep axial gouge
  - Failed in seam weld (away from dent)
- Sample #4 failed at 9,530 psi (163% SMYS)
  - Dent with 11% deep circumferential groove
  - Failed in seam weld (away from dent)
- Repaired sample failed at 9,486 psi (163% SMYS)
  - Dent with 21% deep axial gouge
  - Failed in base pipe outside of repair

Figure 10 - Photograph showing burst test for Sample #2 (21% deep axial gouge)

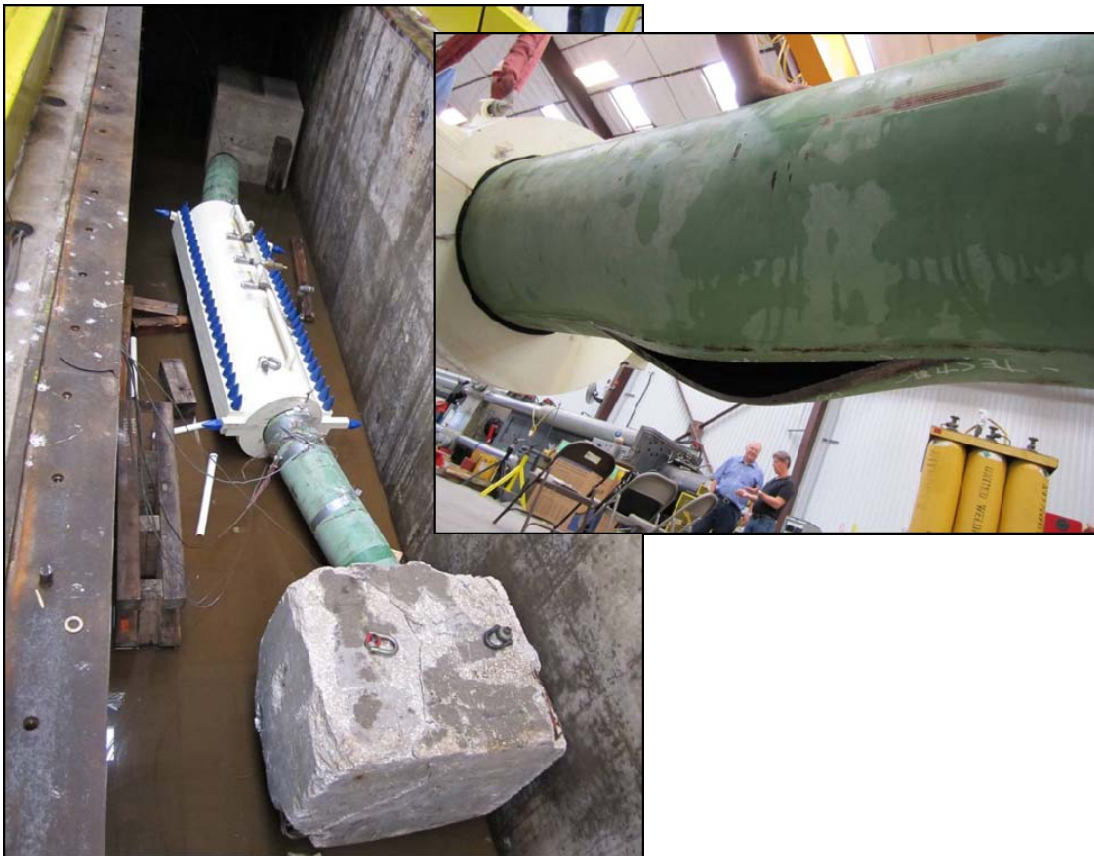
In contrast to the unreinforced samples where the maximum hoop strain was measured to be 11,166  $\mu\epsilon$ , the maximum hoop strain in the reinforced dent was measured to be 1,060  $\mu\epsilon$  (located 6 inches axially from the center of the dent). The significance of this comparison is that the Saipem sleeve was effective in reducing strain in the dented region to levels equivalent to those associated with hoop strains measured in the undamaged base pipe. Figure 11 is a photograph showing the burst test for the repaired sample. Note that the failure occurred on the base pipe outside of the reinforcing sleeve.

Figure 11 - Photograph showing burst test for repaired sample with failure outside of sleeve

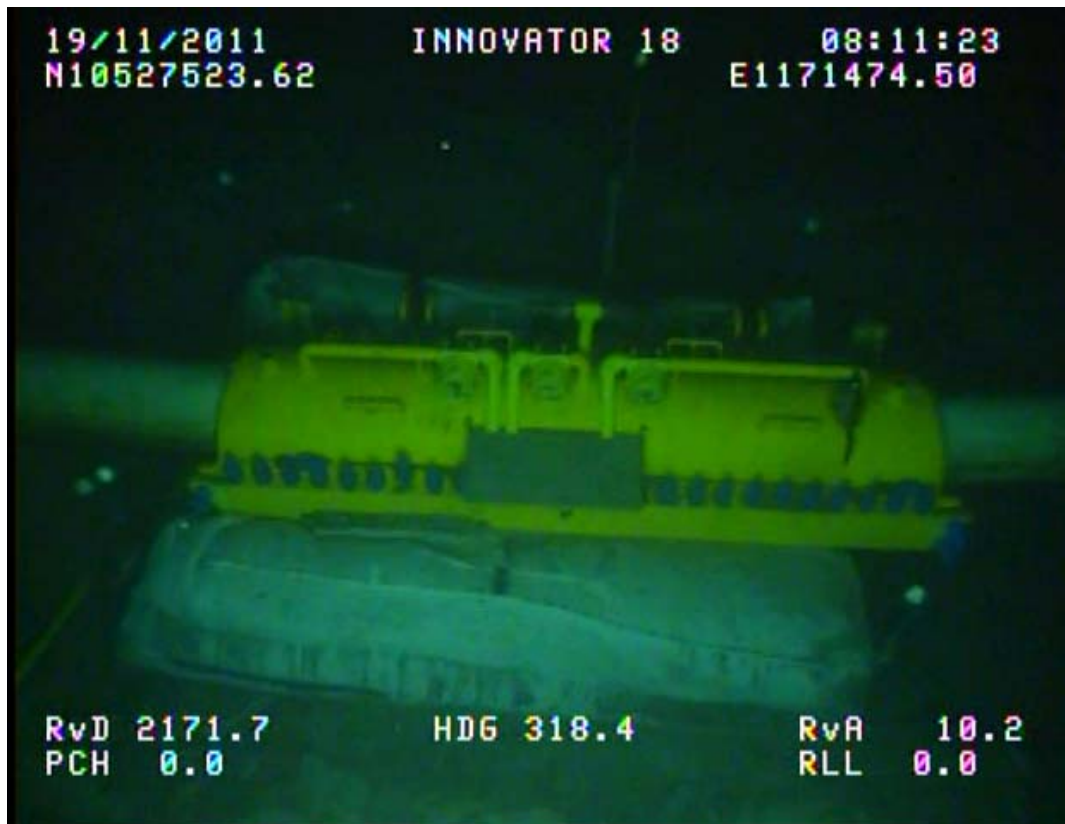
Figure 14 – Grout sleeve and Grout Bag installed on pipeline

spreader bar from the sleeve and it, along with the buoyancy module and suppressor weight, was recovered to the surface. The pipeline support frames were also released and recovered. The only components that remained on the sea floor were the grout sleeve and the grout bag supporting it. The final configuration is shown in Figure 14 in a photograph taken by an ROV. This remediation action cleared the pipeline for full operating pressure operation.
