## **GIRTH WELD FAILURE IN A LARGE DIAMETER GAS TRANSMISSION PIPELINE**

### **ABSTRACT**

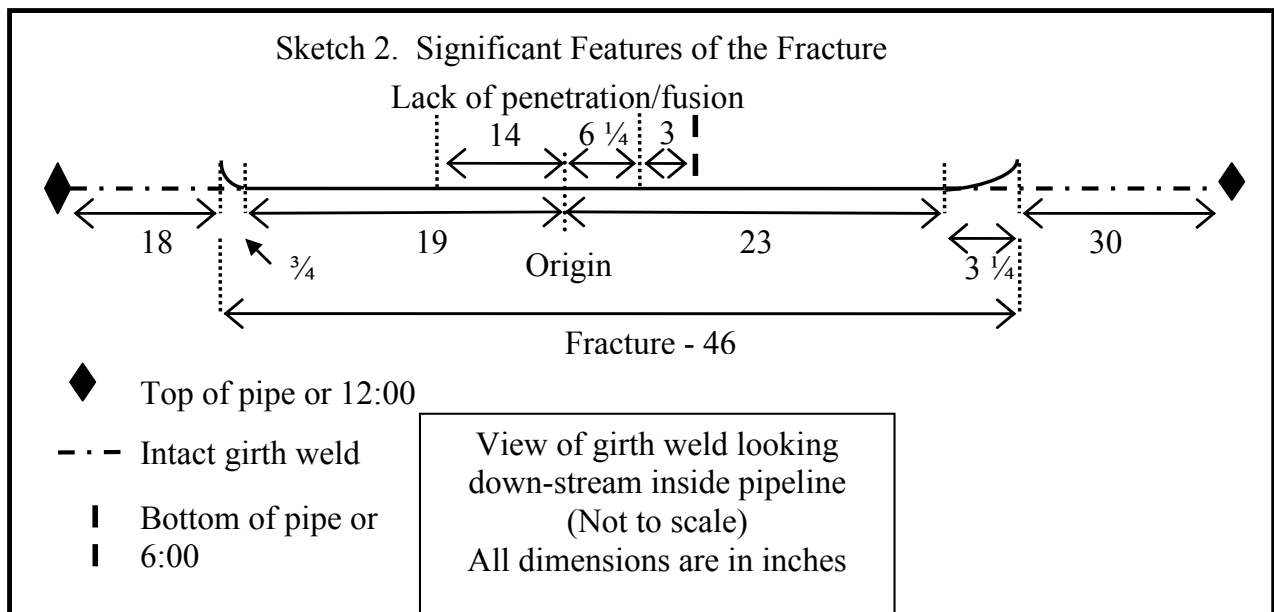
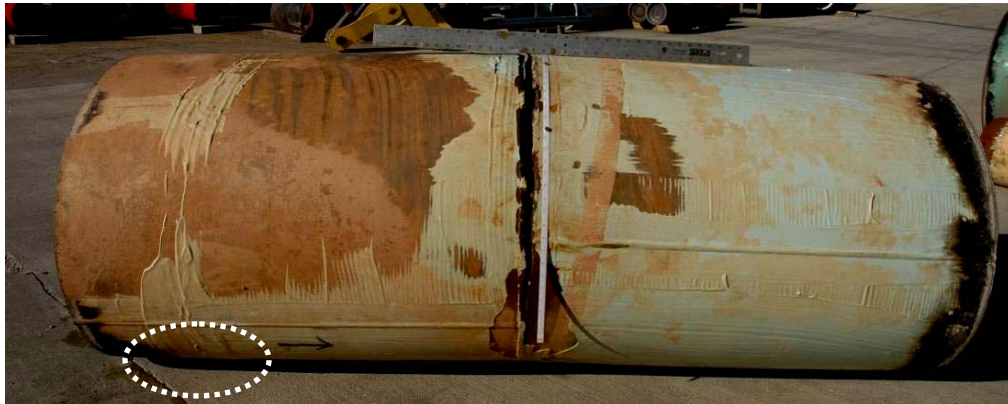
The bend in the pipeline at the failed girth weld (i.e., deviation from a straight line) was measured. A maximum deviation of 1.5 in. was measured at 155 deg (at about 5:00 o'clock and with 12:00 o'clock being the top of the pipe), as depicted in Sketch 1. The pipe had split circumferentially for about 46 in., most of which was in the girth weld or heat affected zone (HAZ). The fracture stopped at both ends shortly after entering the base material of the pipe. Examination revealed a lack of penetration/fusion (LP) in the root pass of the weld.

Sketch 2 shows the relative locations of the significant features including the origin, the area of LP and the ends of the fracture.

**Figure 2 – Photograph and two sketches showing ruptured pipe section as received**  
(Arrow (circled) indicates direction of flow)

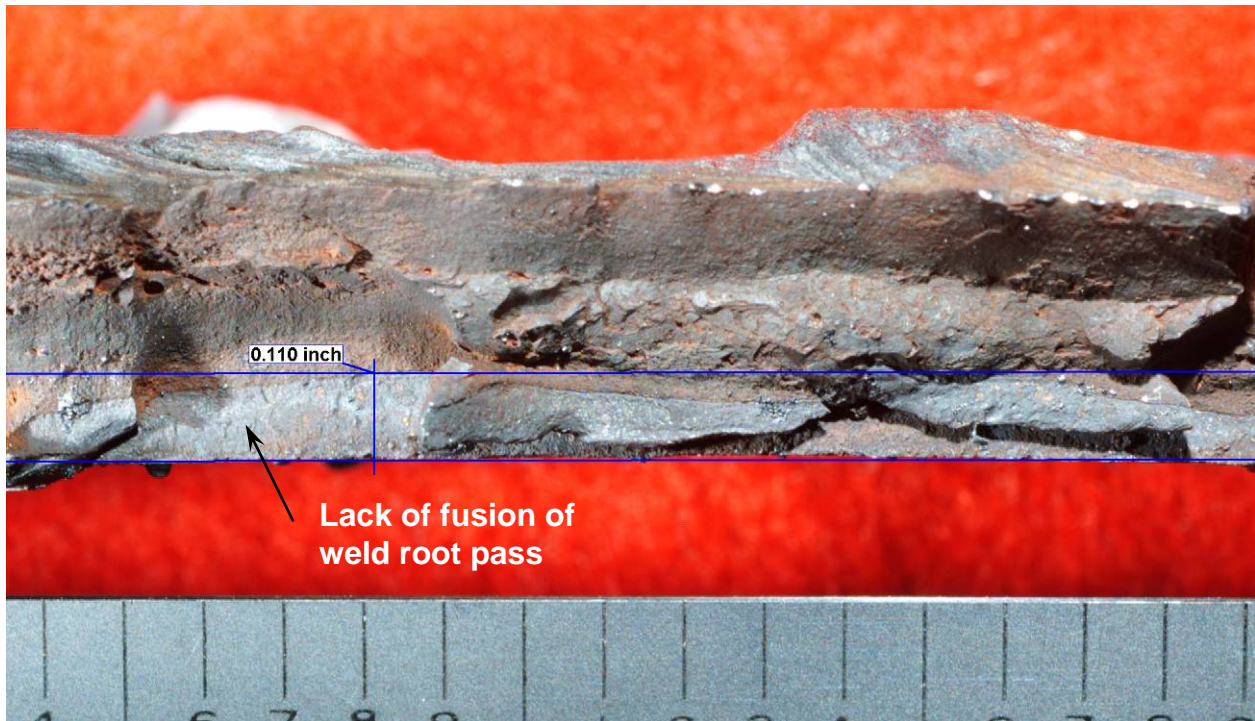
The fracture was first viewed with low-power magnification (less than 35X) using a stereoscope. This examination identified a 20¼-in. long welding imperfection, specifically a LP. The LP was 0.110 in. at its deepest location as shown in Figure 3. Shown in Figure 4 is a cross-section of the weld, again revealing the LP both on the fracture side of the weld root bead and the opposite side.

**Figure 3 - Photomicrograph of fracture origin and depth of LP**  
(Scale divisions are in inches)

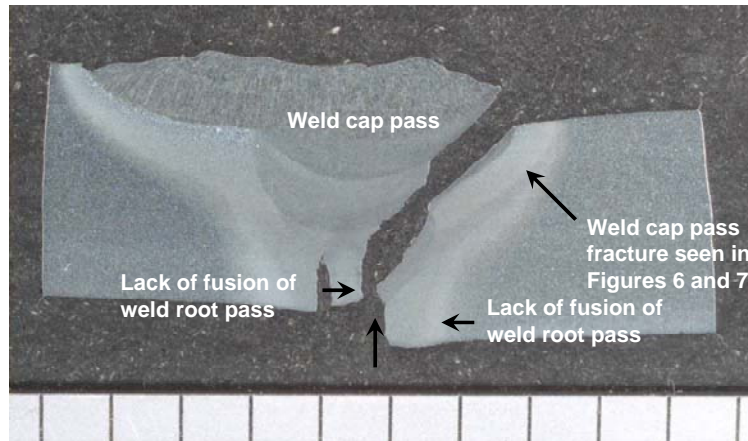
Metallurgical examination of the failed pipeline joint revealed a welding imperfection in the root pass which was a maximum of 0.110 in. deep and 20¼-in. long. This imperfection was located near the 8:00 o'clock position when looking down-stream. The joint failure was initiated at this imperfection, followed the girth weld and its HAZ for most of its length, and then terminated in the pipe material. The fracture exhibited some ductility for its entire length. When the

**Figure 4 - Photomacrograph girth weld cross-section at fracture origin showing lack of fusion between the root and bevel land.**

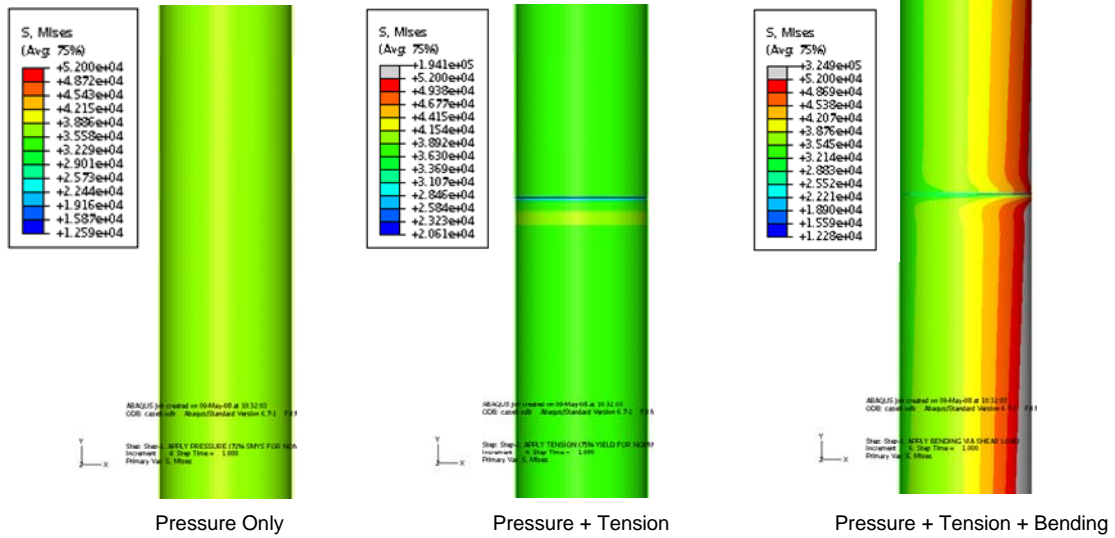
**Figure 7 – von Mises stresses for Case 9**  
(units for plotted stress contours are in psi)

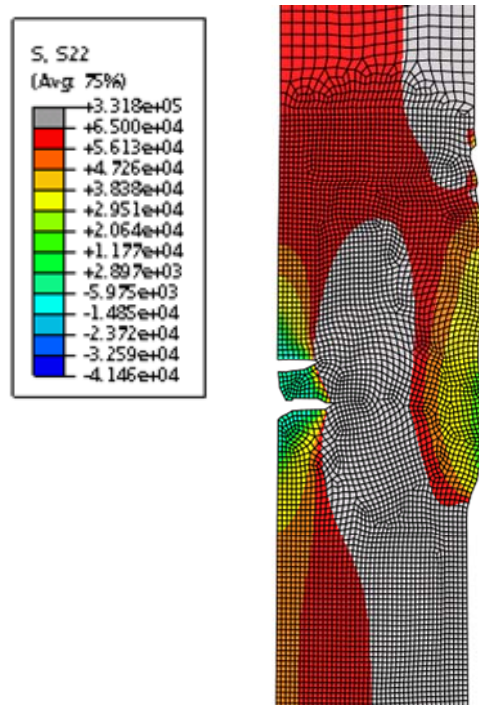
**Figure 8 – Axial stresses for Case 9 considering pressure, tension, and bending**  
(units for plotted stress contours are in psi)

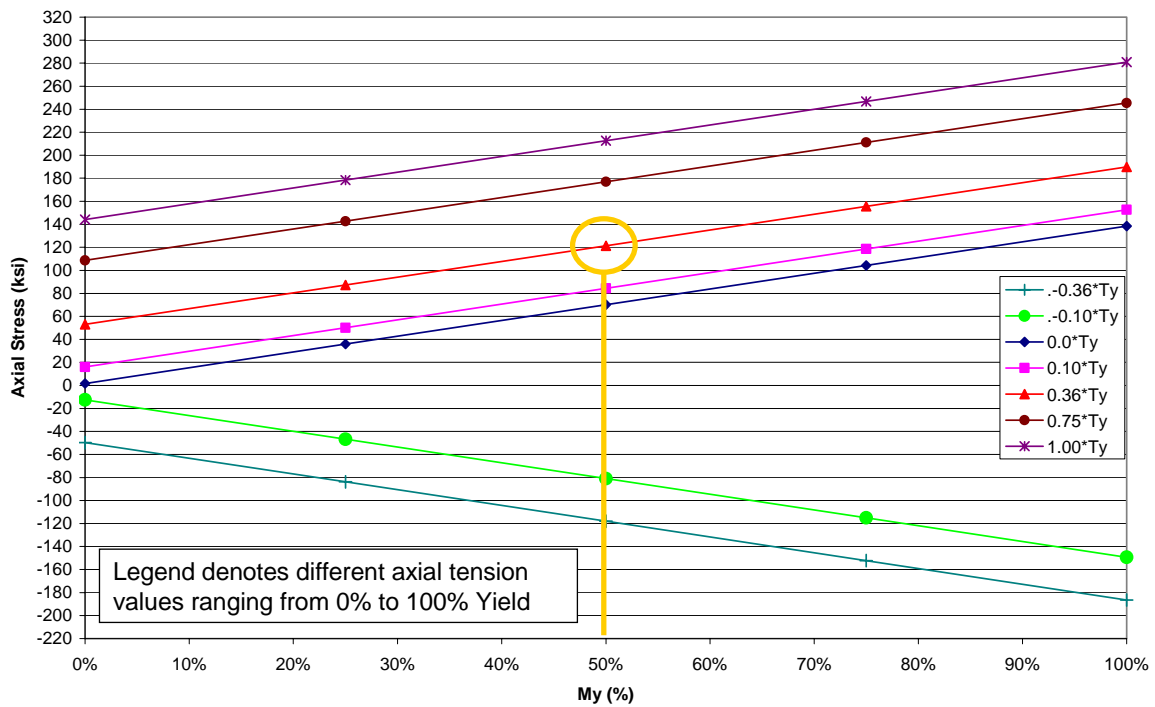
Figure 10 – Plot showing resulting axial stress of 120 ksi for 50% $M_{yield}$  and 36% $T_{yield}$

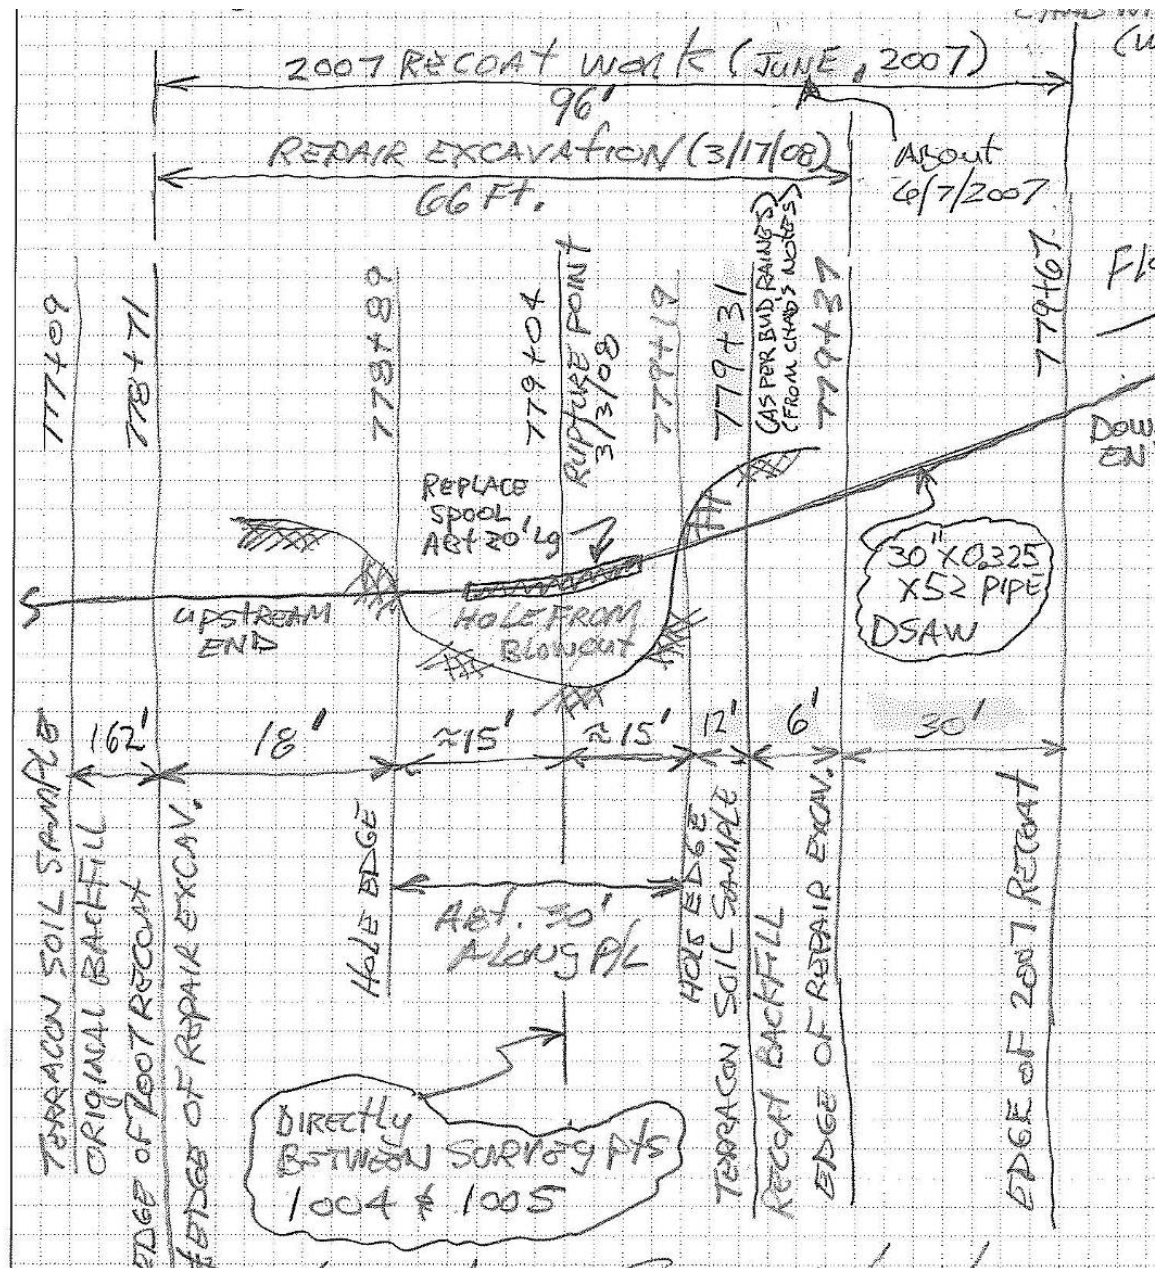
Once the local finite element model work was complete, the next phase of work focused on calculating section forces and moments in the vicinity of the weld considering global pipe loading. Of particular interest in performing the global finite element model was the terrain of the pipeline and the soil properties. During the recoating work in 2007, soil was excavated along the pipeline including the area around the girth weld in question. In the process of backfilling the soil, it appears that proper compaction was not achieved and the resulting soil did not have the same properties as the undisturbed soil. Figure 11 is a sketch provided showing the overall layout for the pipeline. Of particular importance is the 66 feet of soil that was excavated in early 2008. It is this region of soil that was modeled using degenerated soil properties that are reflective of what would happen if the soil were not properly back-filled and compacted following excavation.

Figure 11 – Sketch showing layout of excavation activities near girth weld

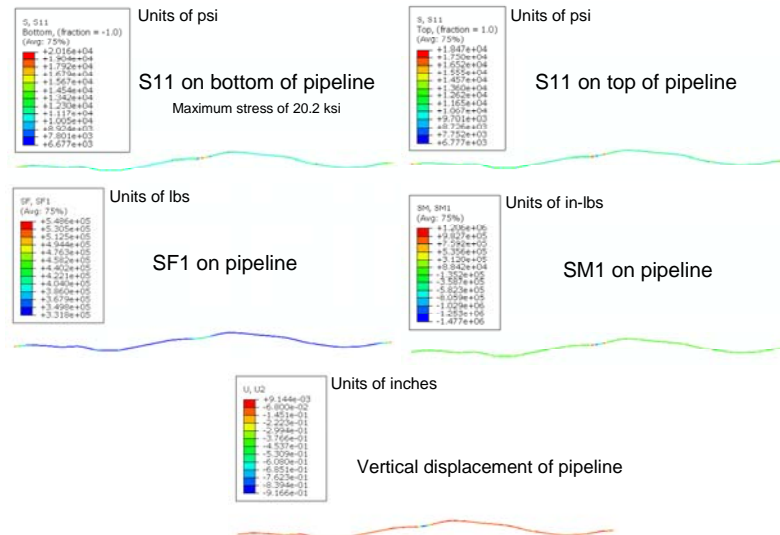
**Figure 14 – Stresses, forces, moments, and displacements for the dry soil case**

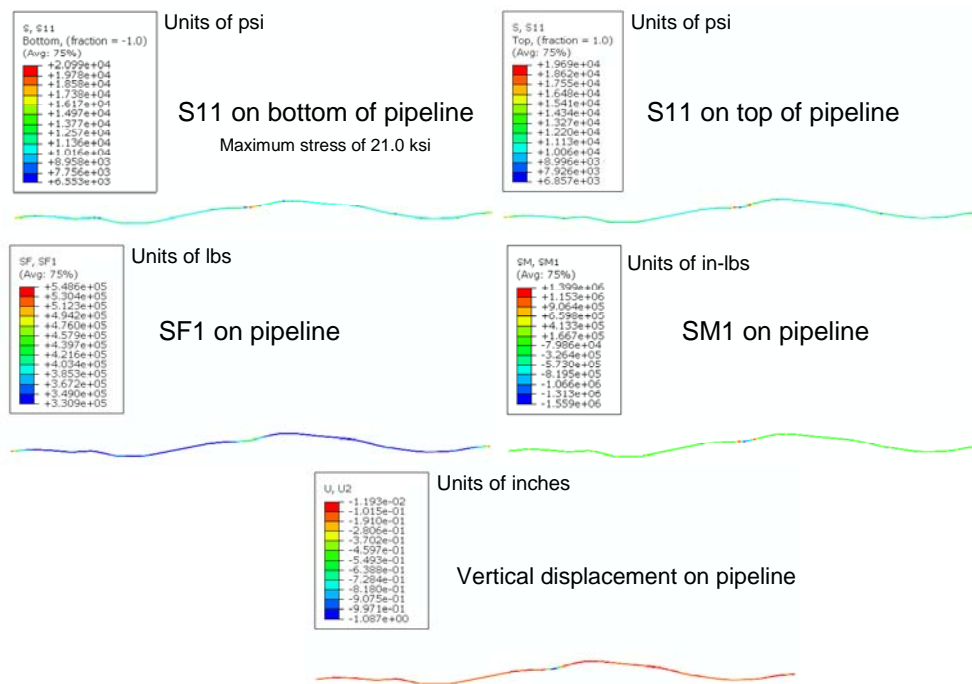
What is important to note in all of these contour plots is that the maximum values occur in the vicinity of the girth weld. With the reduced soil properties in this region of the models, based on actual conditions, as expected the resulting pipe deflection generated elevated stress conditions in the girth weld. A point of emphasis is that the resulting section forces and bending moments associated with the calculated displacement correspond almost exactly to the pre-analysis estimated vertical displacement of 1 inch.

Figure 15 – Stresses, forces, moments, and displacements for the wet soil case

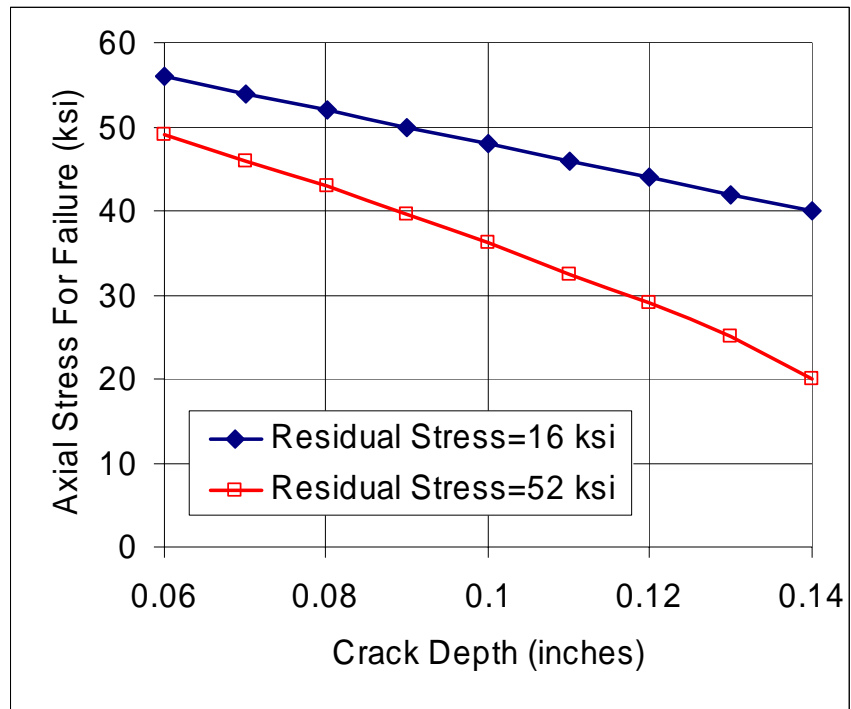
The results of the analysis are summarized in Table 8. The table gives the axial stress that is predicted to cause failure of the specified cracks. Two crack lengths were examined, a 20 inch long crack similar to what was observed from the metallurgical evaluation and a 2-inch long crack. In comparison to stresses associated with the 20-inch crack, the 2-inch long crack increases the axial stress required for failure from 4 ksi (53 – 49 ksi) to 14 ksi (34 – 20 ksi) for crack depths of 0.06 and 0.14 inches, respectively. A graph showing the variation in axial stress as a function of crack depth is given in Figure 17 for the 20-inch cracks.

Figure 17 - Axial Stress Required to Cause Failure of a 20-inch Long, ID Surface Crack.

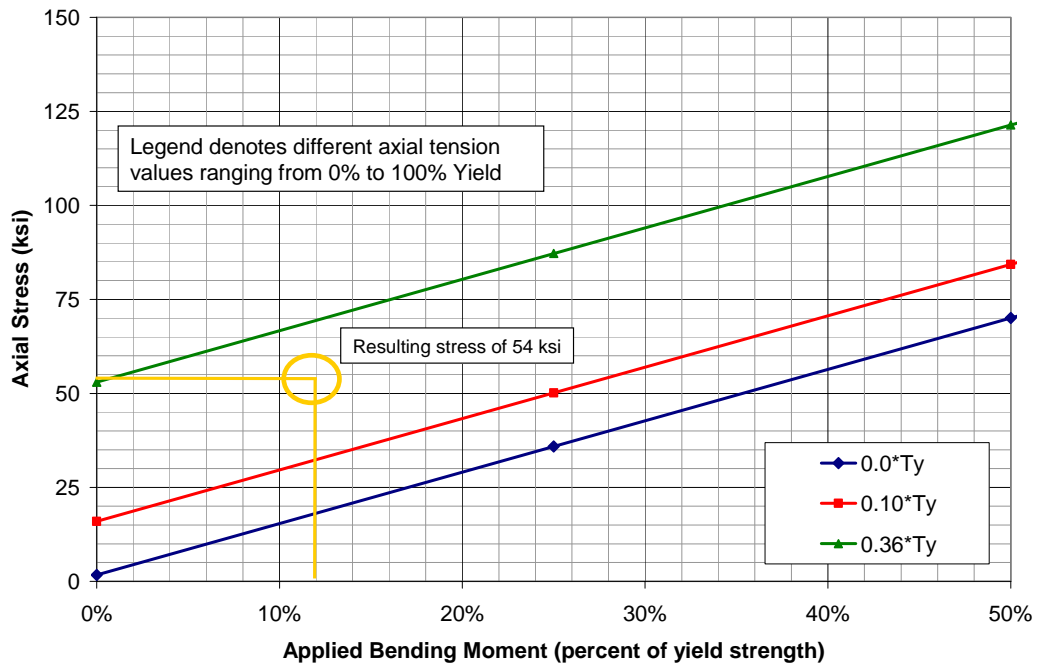
From the global finite element model, the section forces and moments for the wet case were calculated to be 420,000 lbs (26.4% yield) and 1.4 million in-lbs (11.7% yield), respectively. Figure 18 plots the maximum axial stress from the local axisymmetric finite element model where results are plotted as functions of applied axial tension values and bending moments. As noted, using the loading conditions for the wet case the resulting maximum axial stress in the weld is approximately 54 ksi.

Figure 18 – Maximum axial stress as function of tensile force and bending moment (data acquired from local finite element model at girth weld location)
