Title: ASSESSING MECHANICAL DAMAGE IN OFFSHORE PIPELINES - TWO CASE STUDIES

ASSESSING MECHANICAL DAMAGE IN OFFSHORE PIPELINES – TWO CASE STUDIES

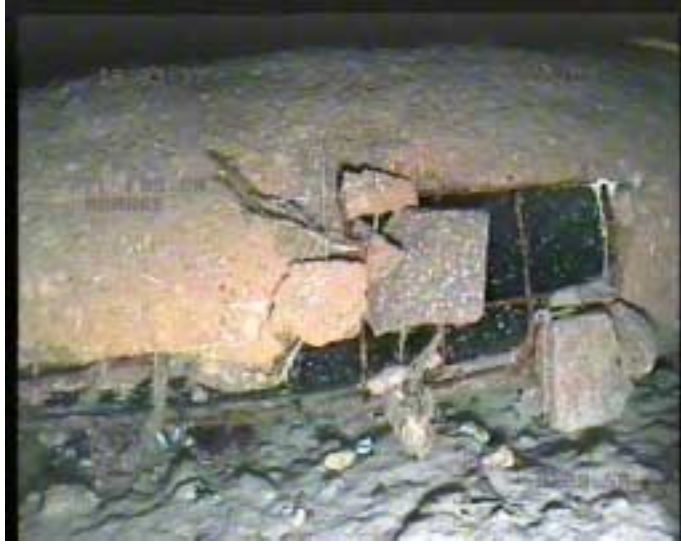
A general visual inspection (GVI) of the EOS20 pipeline, using a remotely operated vehicle (ROV), was conducted for BP by Stolt Offshore in May 2003. The GVI was part of BP’s planned inspection and maintenance programme for this pipeline, and it was the first GVI since commissioning the pipeline. Damage to the concrete weight coating, extending over approximately 1.5 m, was discovered by ROV, Figure 2. No damage had been reported during the as-laid survey in 2001. Visual inspection of the area of damage, by ROV, located an area of scrape marks in the bare metal, over a total length of approximately 400 mm within the area of damaged concrete, Figure 3. The nearest field joint to the damaged area was approximately 4 m away.

Figure 2 Damage to the concrete weight-coat

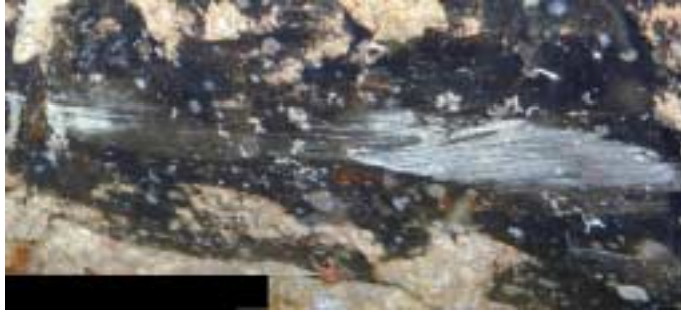
Figure 3 Area of bare metal within the damaged area

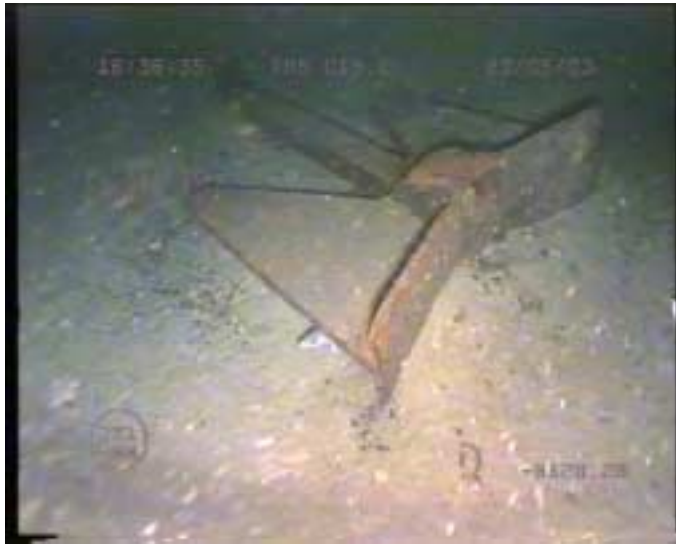
A large anchor (measuring about 1.5 m between the flukes, 2 m along the stalk) was found lying 2 m from the pipeline, Figure 4. Attached to the anchor was approximately 150 m of anchor chain. The pipeline was found to have been displaced by up

Figure 4 The anchor

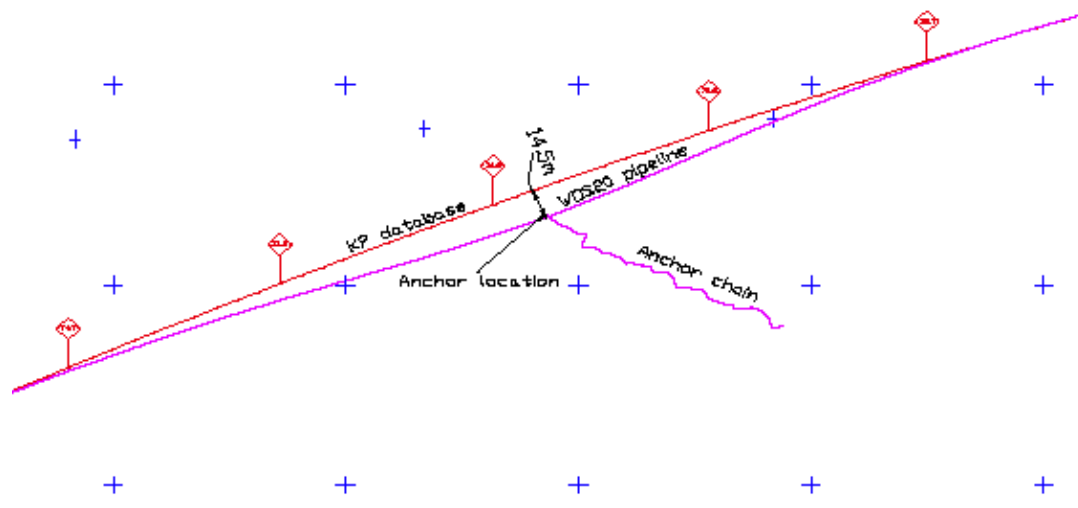
to 14.5 m from the as-laid position over a length of about 370 m, with the apex of the displacement located at the site of concrete damage, Figure 5. The evidence is consistent with an anchor snagging the pipeline and subsequently being abandoned by the vessel.

Figure 5 Displacement of the pipeline

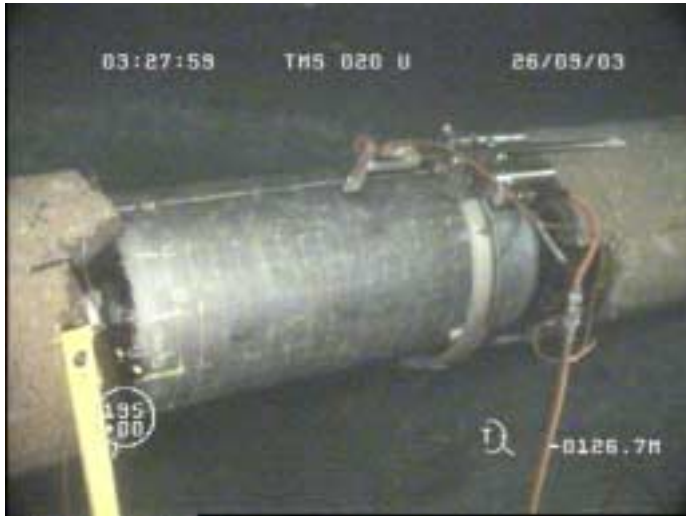
In September 2003, the damage to the EOS20 pipeline was subject to a detailed visual inspection by divers. Then, the seabed below the pipeline was excavated to allow unrestricted access to the damaged area. Approximately 1 m of the concrete coating was removed around the full circumference, the asphalt enamel coating was removed, and the surface was blast cleaned to a bare metal finish, Figure 6.

The detailed visual inspection identified a shallow dent and two areas of abrasion, between 6 o'clock and 9 o'clock (where 12 o'clock is the top of the pipe). No other areas of damage were identified. No crack-like indications were identified by the MPI or the ultrasonic inspections. A small number of inclusions were identified near the inside surface of the pipe wall. The abraded areas were lightly dressed with a hand file to remove some of the surface roughness.

The two areas of abrasion were described as parent metal surface abrasion with minor tramlines. Both were approximately 55 mm wide; one was 102 mm long and the other was 180 mm. Subsequent measurements taken from the microset of the damage area indicated that the maximum depth of metal loss was less than 1 mm.

Figure 6 The damaged area after the removal of the coating

On completion of the inspection activities, the excavated area was filled with grout bags to reinstate the original seabed level and a concrete mattress was installed over the damaged section of the pipeline. A detailed assessment of the damage indicated that no further repair was required. The restriction on the operating pressure of the pipeline was removed.

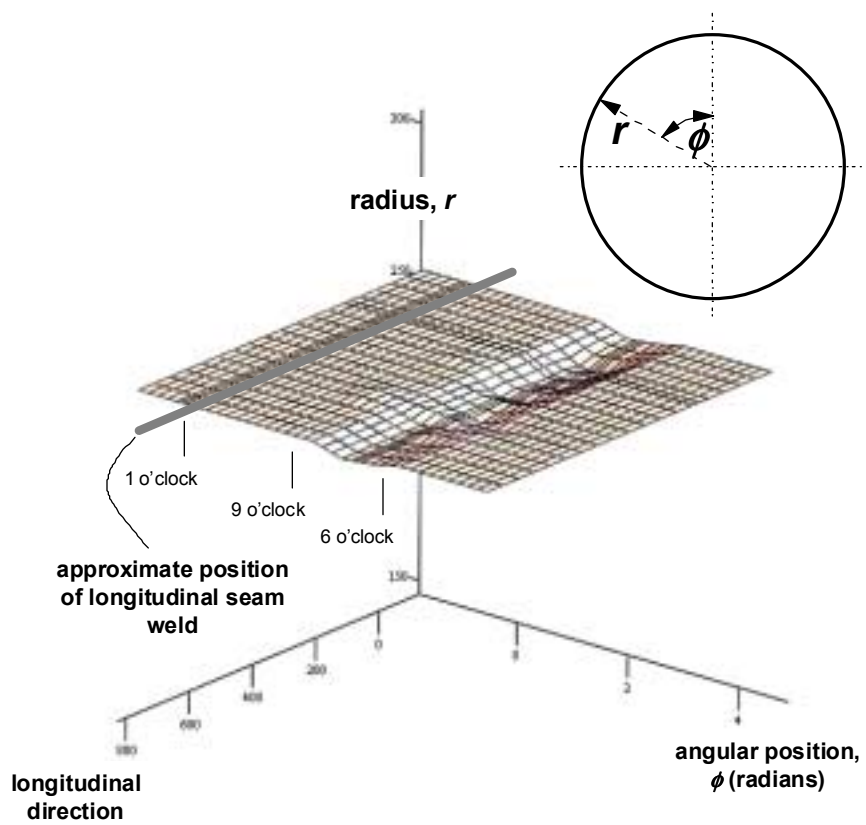
Figure 7 is a radial representation of the dented area, based on the outside calliper measurements. The dent is coincident with a longitudinally flattened area of the pipe. It was concluded that this flattened area was a manufacturing feature, not related to the anchor impact; flattening of this sort, and in this location, is a credible manufacturing defect in UOE line pipe (and the size of the feature was within API 5L tolerances), and the extent and location of the flattening was not consistent with the concrete damage. The maximum depth of the dent was measured as 6 mm (1.2 percent of the pipe diameter). The dent depth is based on the

maximum reduction in the diameter of the pipe, and therefore includes the flattened area. It was determined that the dent was smooth (the minimum radius of curvature of the dent was greater than five times the wall thickness). The dent did not affect the curvature of any welds.

Figure 7 Radial representation of the dent in the pipeline

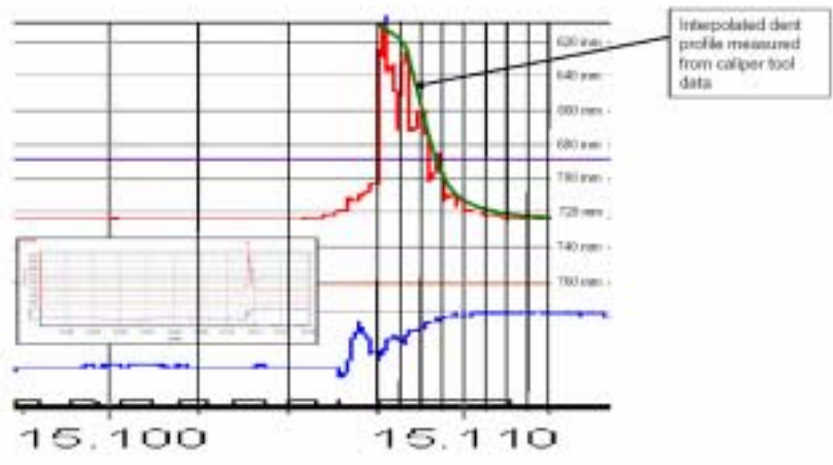
pig. The damage was subsequently localised using a calliper pig. This latter tool also indicated that the diameter was reduced at this location by some 109 mm (4.3 in.), Figure 8, equivalent to 14% of the outside diameter of the pipe. Anecdotal accounts suggested that an anchor drag from a large vessel during a storm early in 2005 might have been the cause of the damage. At this point in time the pipeline had been trenched, but natural backfill had not yet taken place, so the pipeline was therefore partially exposed.

Figure 8 Calliper pig data in vicinity of feature

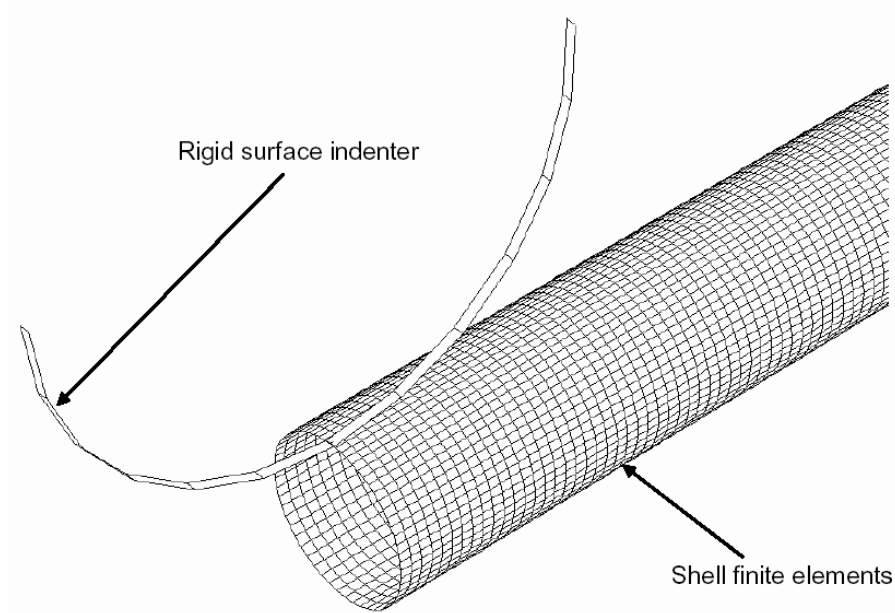
The preliminary study made use of elastic-plastic, non-linear geometry FEA using a rigid indenter (Figure 9) to produce an equivalent residual dent depth (after re-rounding) to that recorded by the calliper pig, e.g. Figure 10. From this analysis a strain level on the order of 3% was calculated. This was initially not of particular concern as recently introduced ASME guidance allows strain in dents up to 6%. In addition, calculations using the design *S-N* curve with an appropriate stress concentration factor (SCF) for the dent (accounting for the increased strain) indicated very long fatigue lives under the expected fluctuations in internal pressure, giving further confidence. The cyclic hoop stress range was approximately 174 N.mm^{-2} for a pressure range of 80 bar. Using this stress range, the fatigue life was found to be 188,980 cycles. This fatigue life corresponded to conditions that exceeded the service requirements many times over. Further supporting test data from the literature and confidential project data confirmed the conclusion that fatigue was not a limiting factor should the dent be as assumed, i.e. a plain dent, not on a weld.

Figure 9 Finite element model

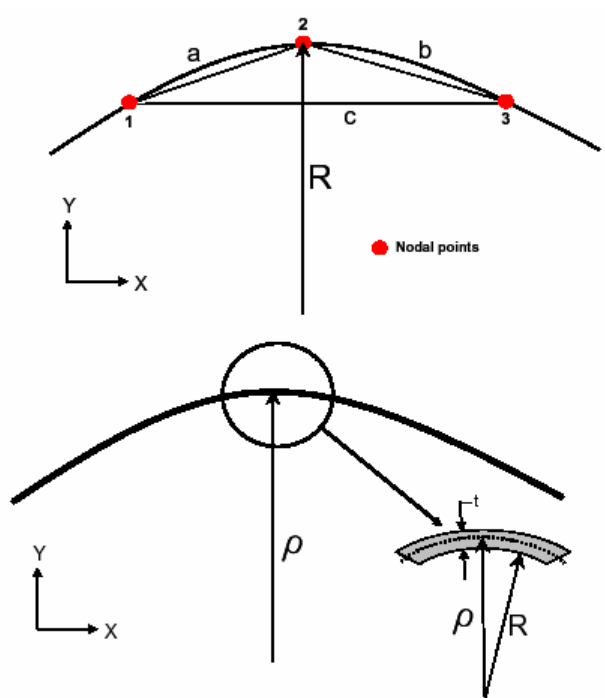
The most severe of the three dents involved a 90 mm deep (3.5 in) by 160 mm long (6.3 in) feature. By ascribing a relatively smooth profile to this region, bending strains based on curvature were calculated that ranged from 2.9 % to 15.4 %, Figure 11. The

estimated fatigue lives considering these strain values as elastic stress ranges were calculated to be only 792 cycles and 5 cycles, respectively. This is supported by unpublished test data for wrinkles (a similar defect) where a short fatigue life of 1,086 cycles was obtained. In conclusion, the simple strain calculations supported by test data demonstrated that the dents posed a significant threat to the integrity and future operation of the pipeline system. The defect(s) were therefore unable to be accepted to remain in the pipeline and were sentenced for repair. No further investigation for the presence of metal loss or gouges was necessary given the severity of the dents.

Figure 11 Calculation of bending strain from curvature

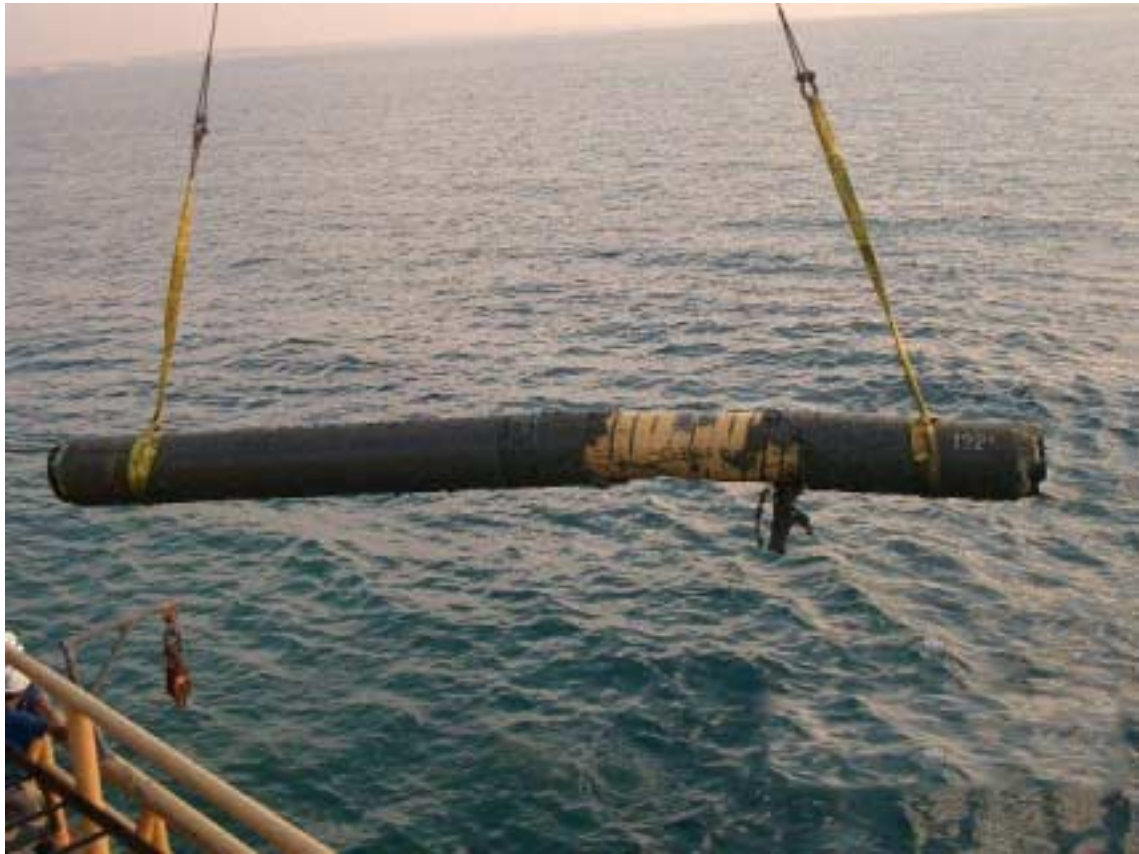
On recovery of the pipe section to the surface, Figure 12, the true extent of the damage became readily apparent. The pipeline had been permanently deformed by the impact and the combination of this global deformation and the local dent damage, Figure 13, was even more severe than apparent from the diver survey.

Figure 12 Damaged section showing dents and global deformation of the pipe

The repair was made subsea using a replacement spoolpiece and mechanical pipeline connectors – a procedure where justification was made based on type approval and industry recommended practices [12,13].

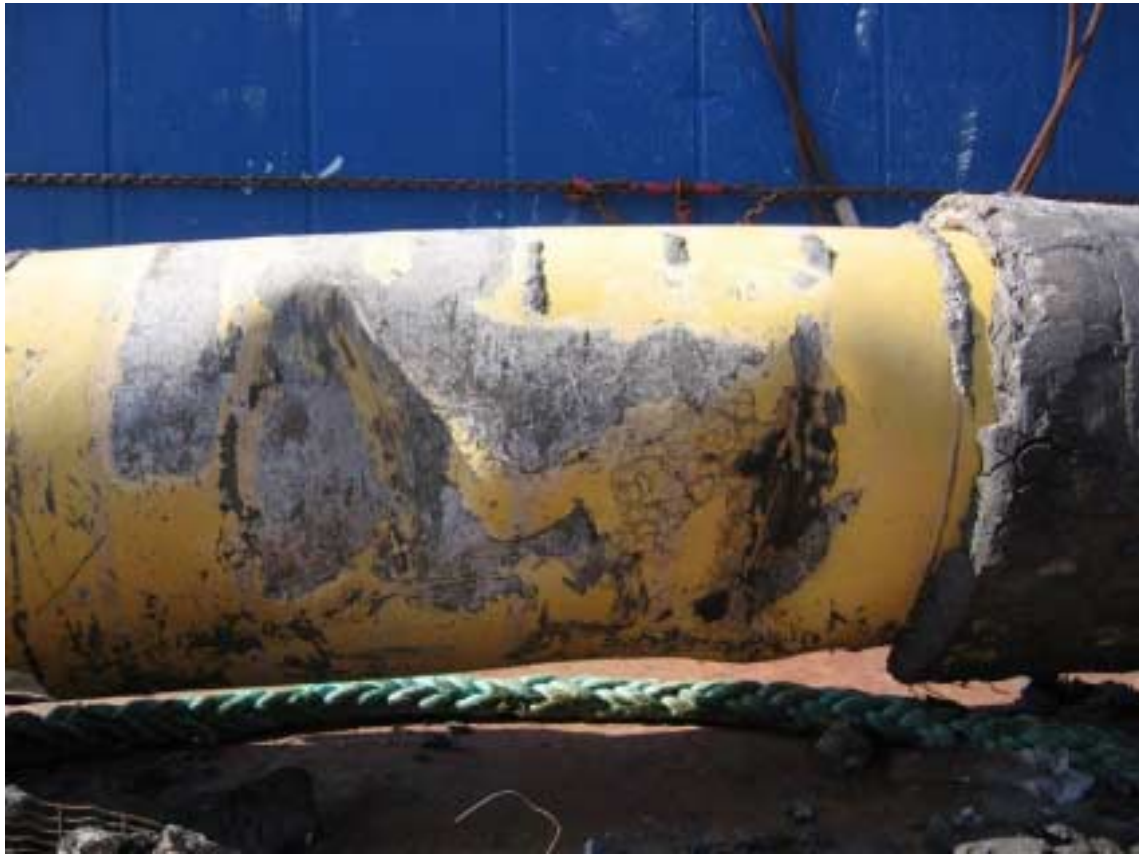
In any case, by simple inspection it would be impossible to categorise this collection of closely spaced, kinked dents as being plain dents, invalidating the analyses.

Figure 13 Clustered and kinked dents
