# **EVALUATING THE ABILITY OF COMPOSITE MATERIALS TO RESTORE MECHANICAL INTEGRITY TO PIPELINES HAVING WRINKLE BENDS**

Dr. Chris Alexander  
Stress Engineering Services, Inc.

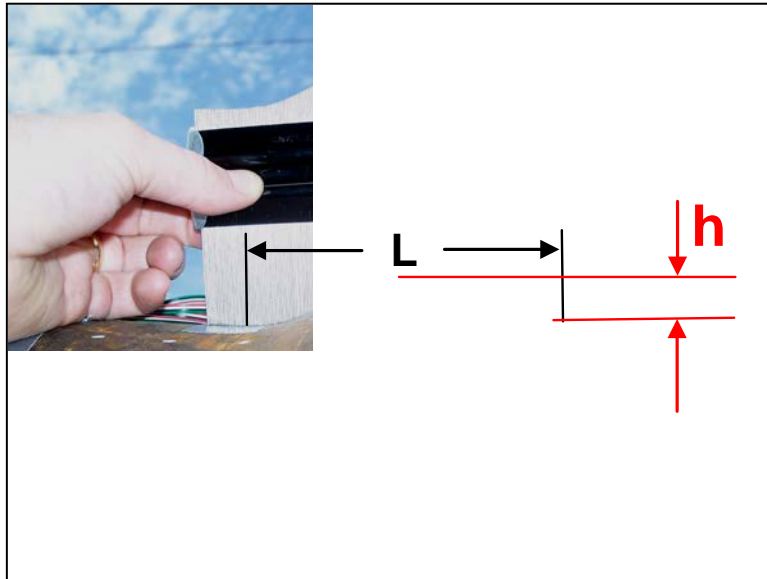
**Figure 1 – Measurement made using steel profile comb with “h” and “L” values**

- Sample EP22-1A  $h/L = 0.093$
- Sample EP22-1B  $h/L = 0.121$
- Sample EP22-2A  $h/L = 0.095$
- Sample EP22-2B  $h/L = 0.119$
- Sample EP30-1A  $h/L = 0.132$  (0.108 if adjusted for 40 percent corrosion)
- Sample EP30-1B  $h/L = 0.123$  (0.103 if adjusted for 40 percent corrosion)

A useful tool for measuring the wrinkle profiles is the steel profile comb. A photograph showing the use of this comb on Sample EP22-1B is shown in Figure 1. Using this tool provides a quick check on the  $h/L$  ratio as the profile can be traced onto a sheet of paper thus permitting  $h$  and  $L$  to be measured. Also shown in this figure are the geometric wrinkle bend variables associated with the length,  $L$ , and height,  $h$ , values. The length,  $L$ , is represented as the distance over which the curvature of the wrinkle decays back to the original profile of the pipe. For the pipes used in this study, the length was relatively well defined as the pipe was generally straight outside of the wrinkle. This might not be possible for all wrinkle profiles.

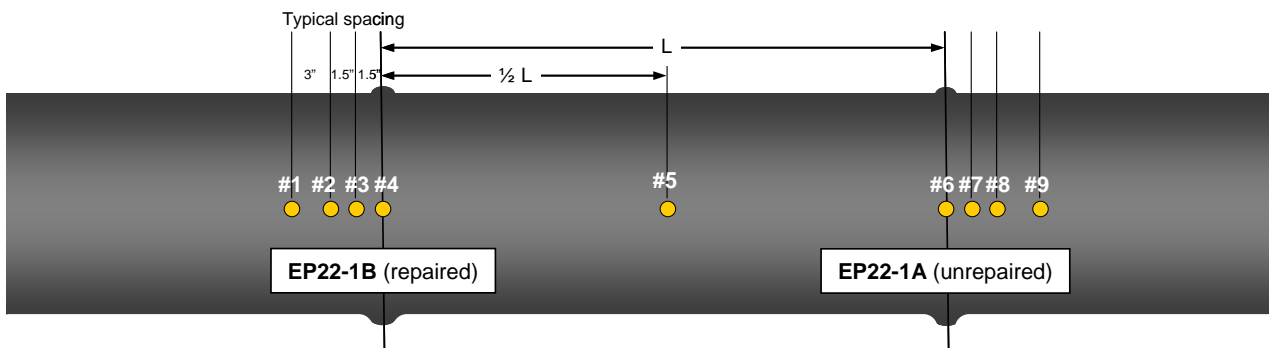
**Figure 2 – Schematic showing strain gage locations**  
(markings specifically for the gage configuration on Sample EP22-1)

Figure 2 is a schematic diagram showing where strain gages were installed on each wrinkle. As noted, there are two wrinkles on each test sample and a middle gage at location #5 was installed on the bare pipe between the wrinkles to capture nominal hoop and axial strain values. As noted in this figure, a total of

nine strain gages were installed on each test sample. For the pressure cycle testing, data were recorded at 1 scan per second. After testing the results were output to an EXCEL spreadsheet for post-processing.

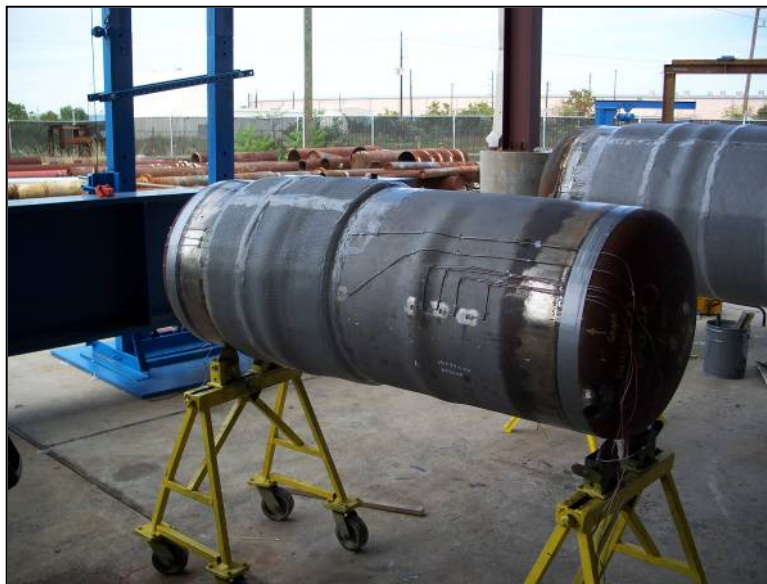
**Figure 3 – Photo showing completed installation of composite material**

Strain gages were installed prior to installation of the composite material. Epoxy putty was used to create a smooth profile around the strain gage lead wires. Additionally, a layer of epoxy was painted to seal the exposed pipe prior to installation of the reinforcing material. Figure 3 shows a completed repair on the pipe sample using the composite reinforcement.

One of the primary objectives of this program was to assess the ability of composite materials to reinforce the wrinkles and reduce strain during pressure cycling. Armor Plate, Inc. provided materials and staff to install the Armor Plate Pipe Wrap (APPW) system on four of the six eight wrinkles. Prior to testing, all pipe samples were sandblasted to near white metal. It was decided that because of the large axial stresses present in a wrinkle, the repair should orient fibers in the axial direction. This differs from conventional composite repairs used to reinforce corrosion where the predominant fiber orientation is circumferential. The following composite reinforcement configuration was used, resulting in a total thickness of 0.564 inches. The length of each repair was approximately two feet, with one foot being on each side of the center of the wrinkle.

- Three layers hoop-oriented cloth totaling 0.188 inches (one-third composite thickness)
- Three layers axially-oriented cloth totaling 0.188 inches (one-third composite thickness)
- Three layers hoop-oriented cloth totaling 0.188 inches (one-third composite thickness)

The total thickness of the composite material equaled a value approximately 1.5 times the nominal pipe wall thickness. As noted, the inner and outer layer sets each equal 0.5 times the wall thickness and are oriented in the hoop direction, while the middle set of layers are oriented axially and have a thickness equal to 0.5 times the pipe wall thickness.

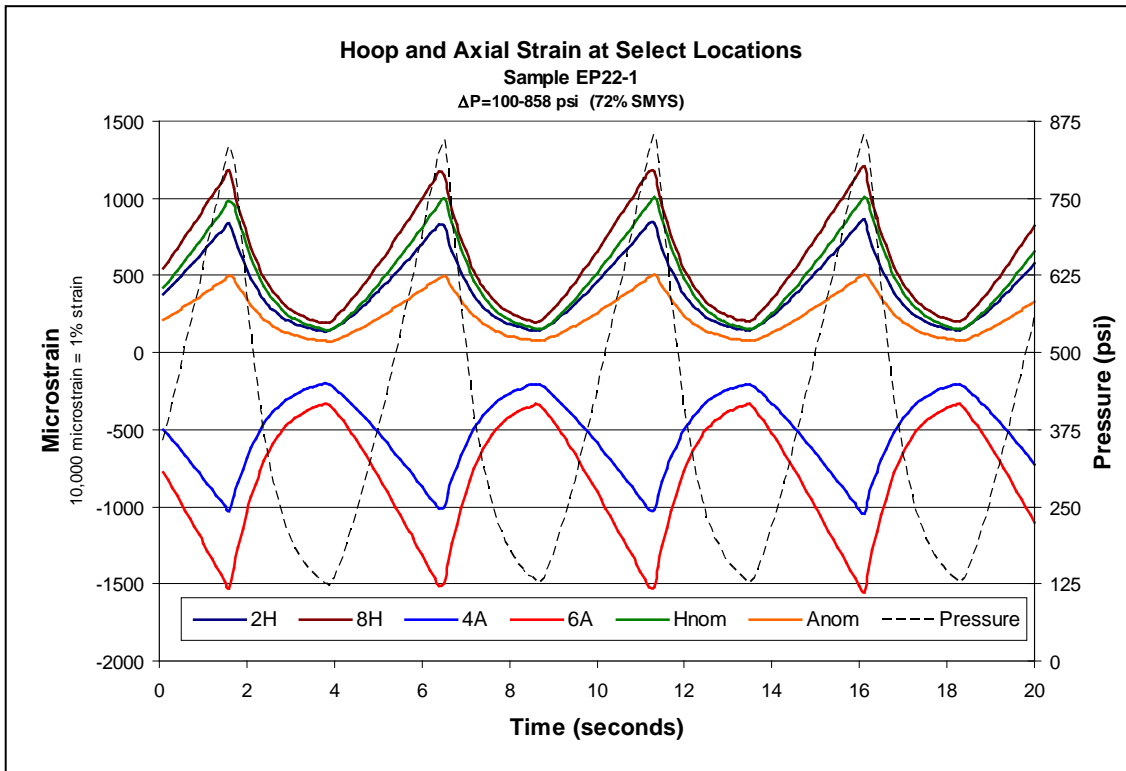
**Figure 4 – Alternating hoop and axial strain gage results for Sample EP22-1**  
 (Gages 1 - 4 REPAIRED and Gages 5 - 9 are UNREPAIRED | the nominal hoop and axial strains are Hnom and Anom)

The results from this effort are provided in Table 3. Note that the presented results are for the axial strain gage results. From previous research efforts and those demonstrated in this study, the maximum principal strains in the wrinkles are axially-oriented when the pipe is subjected to cyclic internal pressure. This differs from conventional pipe mechanics where the circumferential stresses and strains dominate for the non-deformed geometric condition. Also included are the plotted alternating hoop and axial strain gage results for Sample EP22-1 in Figure 4.

- As expected, the maximum strains are measured in Sample EP30-1 where 40 percent of the wall thickness was removed to simulate corrosion. This increased strain results in fatigue life reduction.
- The contribution of the composite materials reduces strain in the reinforced wrinkles. On average, the strain reduction is 42 percent. Considering a fourth order relationship between cycle life and strain range, a 30 percent reduction in stress effectively increases fatigue life by a factor of approximately 4.
- Elastic stresses are computed by multiplying the measured strain ranges by 30.

One important observation concerns the range of strains. Even though wrinkles (and dents) involve plastic deformation in their formation process, once several pressure cycles are applied to the sample a “shakedown” to elastic condition exists. This means that even though the defects are plastically deformed with additional pressure cycles an elastic response from the deformed region is likely. This trend was clearly evident in the recorded strain gage data. This simplifies efforts associated with estimating fatigue life from alternating stresses.
