## USING TESTING METHODS TO EVALUATE SUBSEA PIPELINE PERFORMANCE AND INTEGRITY

Chris Alexander  
Stress Engineering Services, Inc.  
Houston, Texas  
[chris.alexander@stress.com](mailto:chris.alexander@stress.com)

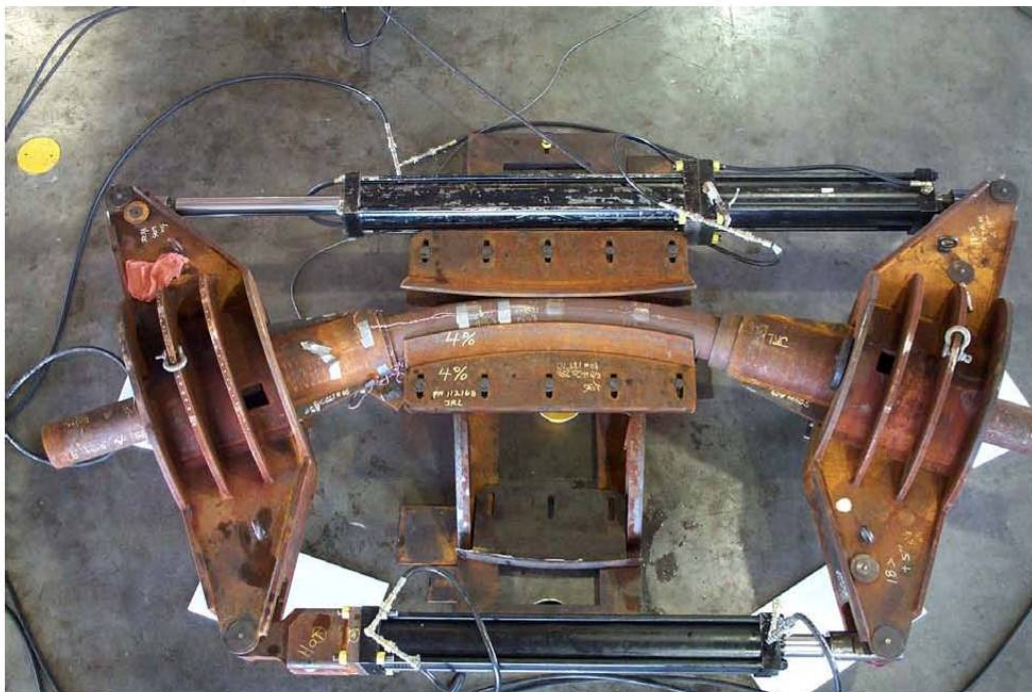
Figure 2 – Photograph of pipe bent to simulate 4 percent bending strain [1]

Several testing systems have been designed to specifically simulate pipe bending. The first is a simulator designed to induce strains associated with the reeling or S-lay process. **Figure 1** and **Figure 2** include a schematic drawings and photograph of a bent pipe, respectively. As shown, this particular system induces a pure bending moment across the given pipe section. The second test set-up permits a pipe sample to be simultaneously subjected to internal pressure, axial tension, and bending using a four point bend set-up. A schematic and photograph are shown in **Figure 3**. This latter configuration is used extensively because of the ability to evaluate simultaneous loading and evaluate the effects of any particular loading variable.

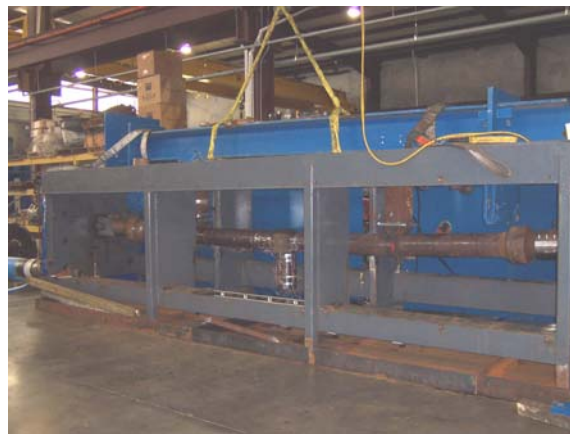
Figure 3 – Schematic and photograph of four point bending test set-up

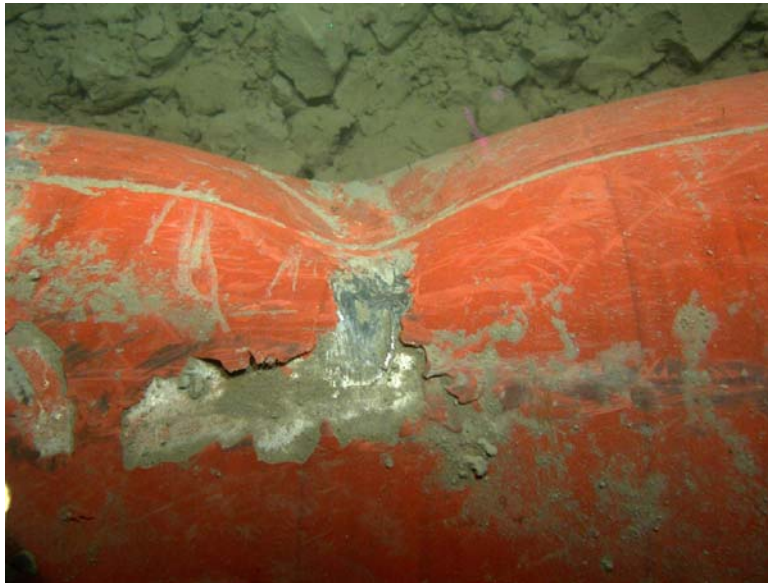
Figure 5 – Photograph of dent in 20-inch Shell URSA gas pipeline [3]

The Ursa gas export line is made of 500 mm (20-inch) OD x 18 mm (0.75-inch) WT, API 5L-X60 DSAW pipe. The maximum operating pressure of the line is 155 Bar (2200 psi), and external pressure is 95 Bar (1350 psi). At time of anchor dragging the line, it was operating at 77.4 Bar (1100 psi). The dent, shown in **Figure 5**, was in the range of 57 mm to 70 mm. (approximately 2 ¼ - 2 ¾ inches) deep.

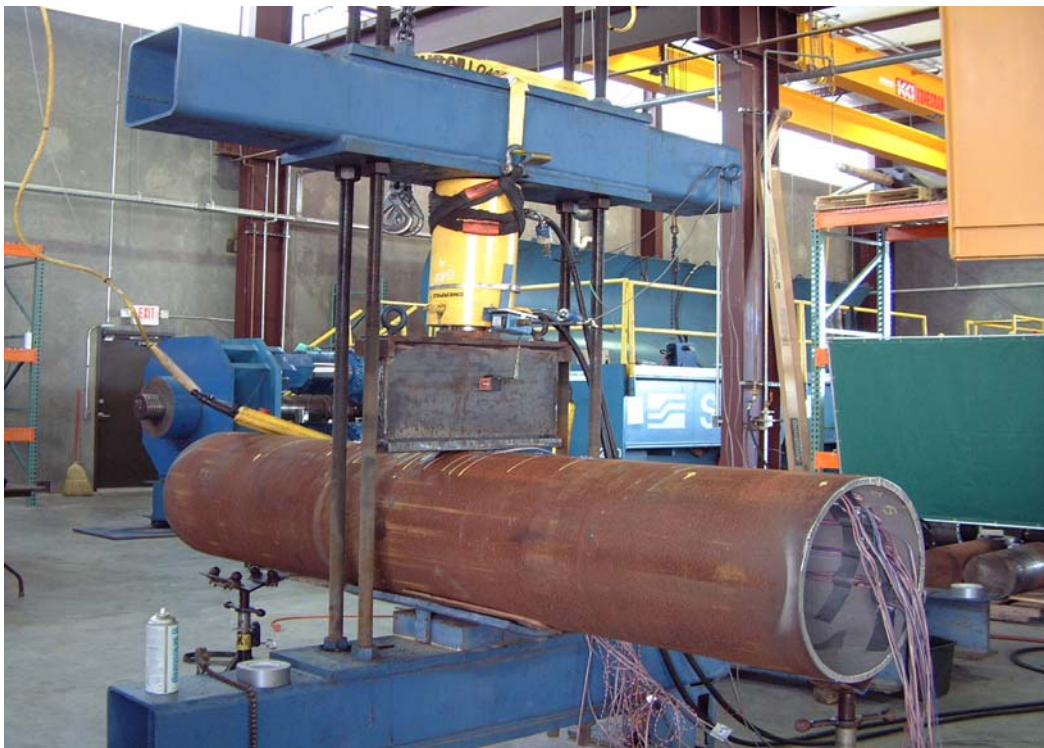
Figure 6 – Photograph of dent installation rig [3]

In order to estimate the future performance of the damaged pipeline, full-scale testing was conducted. Dents were installed in 10-ft long pieces of 20-inch x 0.75-inch, Grade X60 pipe material. **Figure 6** shows the dent installation rig that was used to general dents that replicated the actual dent profile [3].

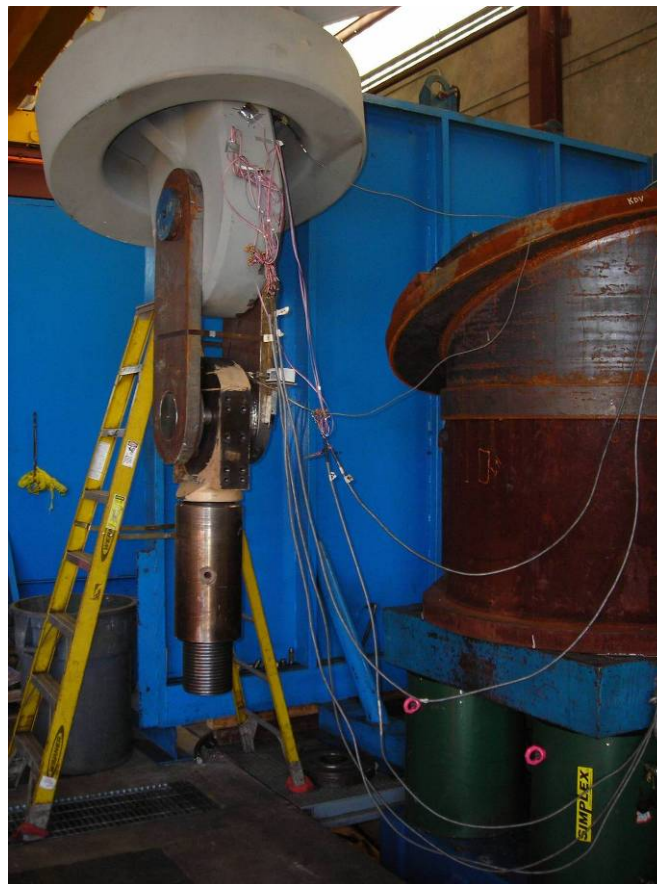
**Figure 8 - Assembled cross-haul bucket and reaction shaft [4]**

**Figure 7** is a schematic of the test set-up, while **Figure 8** is a photograph showing the cross-haul bucket lifted prior to testing. Shown in **Figure 9** is the test set-up for the 10-inch/8-inch cross-haul bucket that includes the test fixtures and the vertically-positioned hydraulic cylinders. Both of the buckets were loaded to target levels. During testing the maximum von Mises stresses measured by the strain gages for the 8-inch/10-inch and 10-inch buckets were 38 ksi and 50 ksi, respectively. The maximum strain was very localized and only occurred at the bottom of the hole near the point of contact with the loading pin.

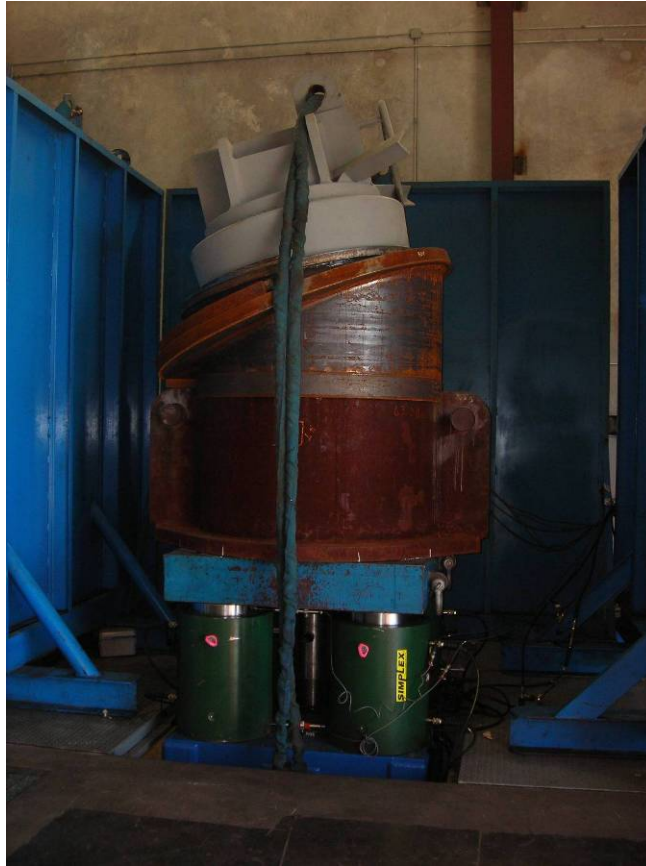
Figure 9 - Test set-up for the 10-inch / 8-inch cross-haul bucket [4]

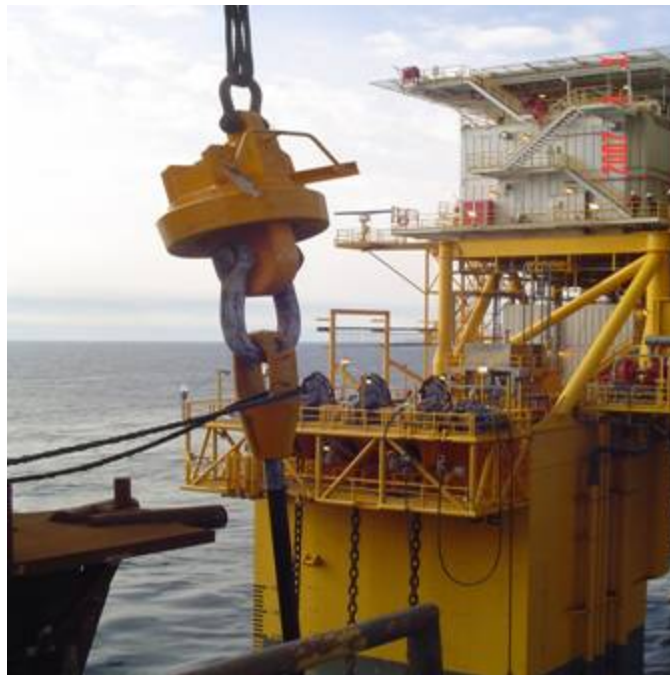
Figure 10 – Cross Haul Bucket during SCR Installation [4]

**Figure 10** is a photograph of the Cross Haul Bucket during SCR installation. This test program was a critical part of the successful deployment of these devices as the results assured operational engineers that they could serve their intended purpose and safely lift risers from 8,000-ft water depths.

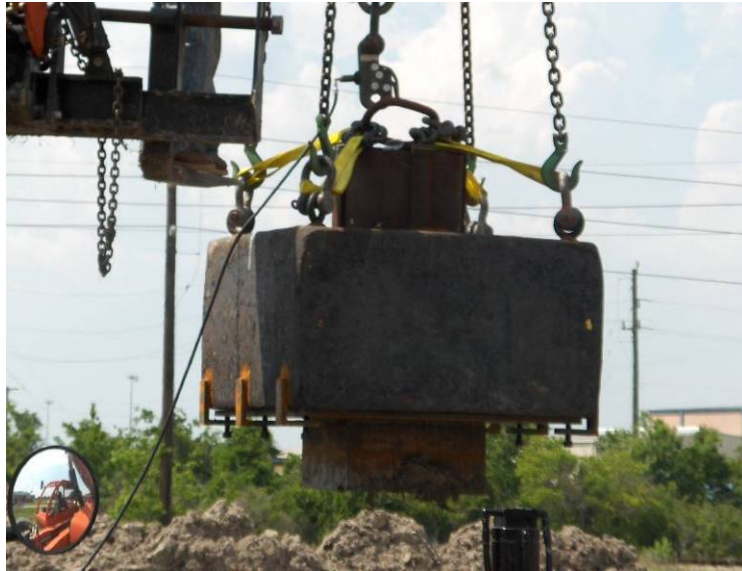
Figure 11 – Photograph of weight serving as dropped object [5]

Using insights gained from the quasi-static tests and preliminary finite element work, efforts were focused on full-scale drop tests. The drop tests used a forging weighing 23,850 lbs dropped from a height of 25.2 feet (measured from top of the PPS to dropped object center of mass) resulting in an impact energy of 815 kJ. A photograph of the dropped object is shown in **Figure 11**. The primary objectives of the full-scale drop tests were to demonstrate several important elements:

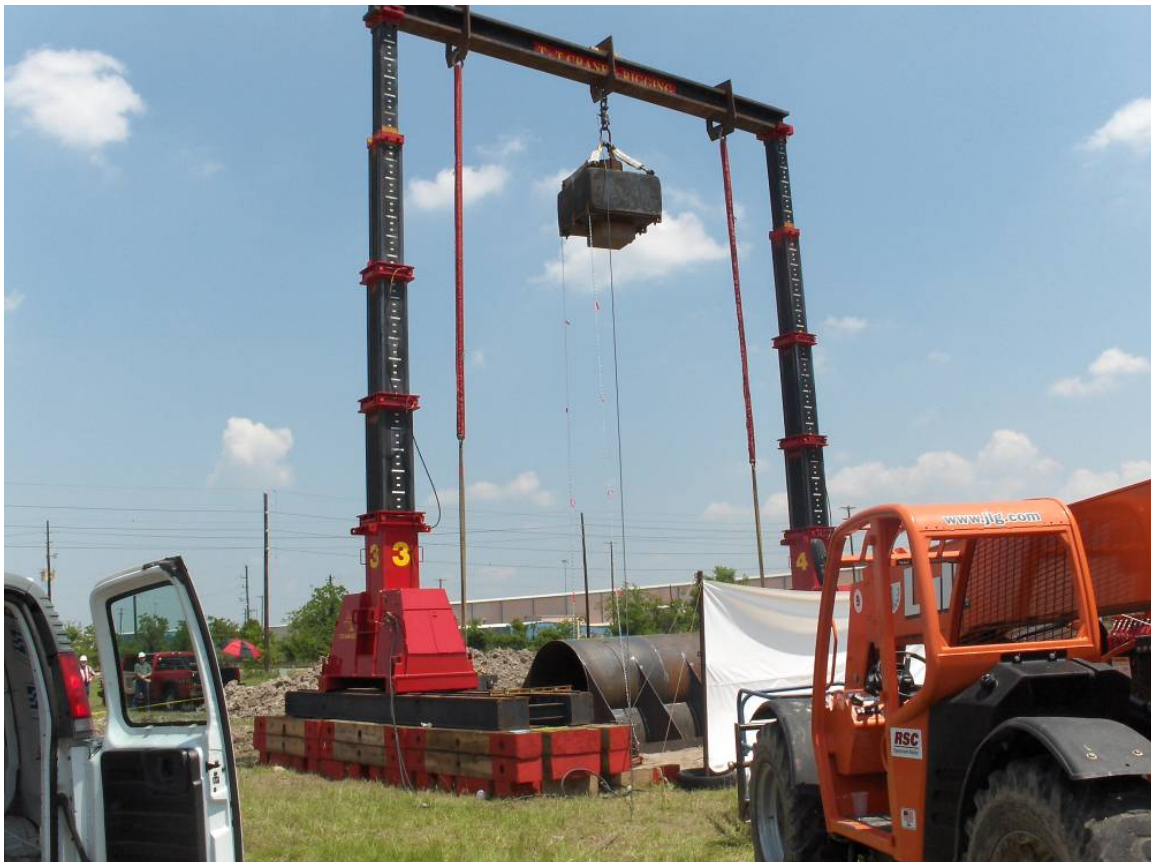
Figure 14 – Photograph showing gantry jack crane used to drop weights [5]

**Figure 14** is a photograph showing the set-up for the full-scale testing. As shown, a gantry crane capable of lifting objects to heights up to 35 feet was used. The spacing between the gantry jacks was deemed sufficient to prevent contact with the dropped object after impact. The PPS test pieces were also oriented in such a way as to increase the likelihood that their post-impact response would direct them away from the gantry crane jacks.

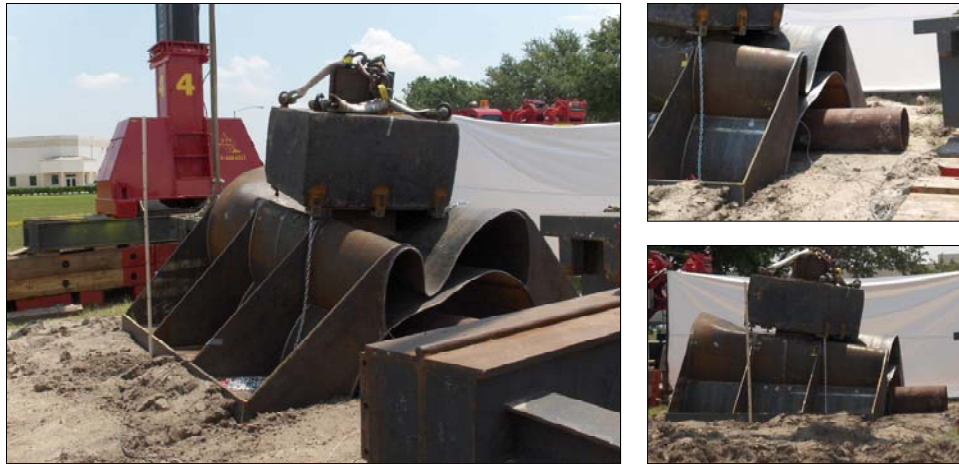
Figure 15 – Photographs from Test #1 drop test [5]

**Figure 15** through **Figure 18** provide photographs for Tests #1 through #4, respectively. The following observations are made in viewing the visual aspects of the drop tests:

- Tests involving the full PPS design (Tests #1, #2, and #3) demonstrate that the design had sufficient rigidity to prevent the prevent damage to the pipe.
- The PPS design without the upper shell (Test #4) clearly demonstrates the importance of the upper shell. Contact with the pipe was made in this test.
- The Submar mats act to distribute load to the overall PPS structure as shown in comparing the less severe damage shown in **Figure 17** (Test #3) to more extensive damage observed in **Figure 15** (Test #1).

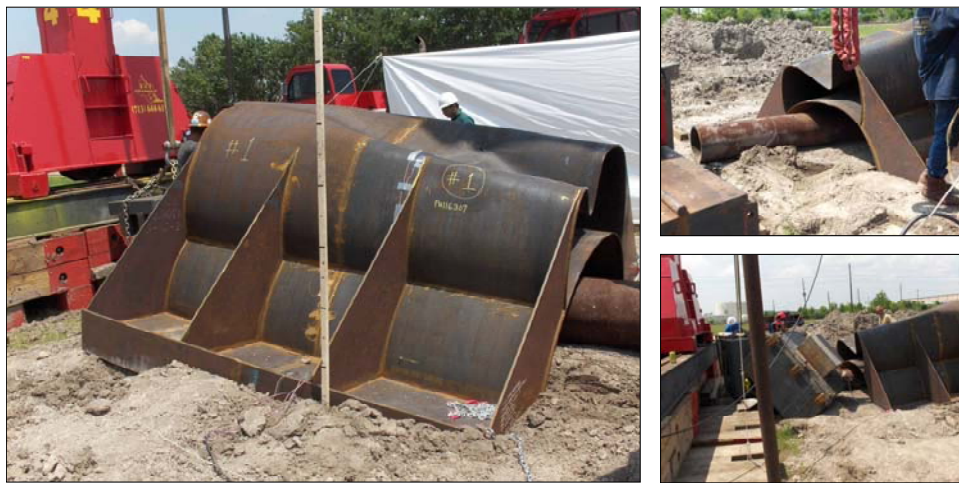
Figure 16 – Photographs from Test #2 drop test [5]

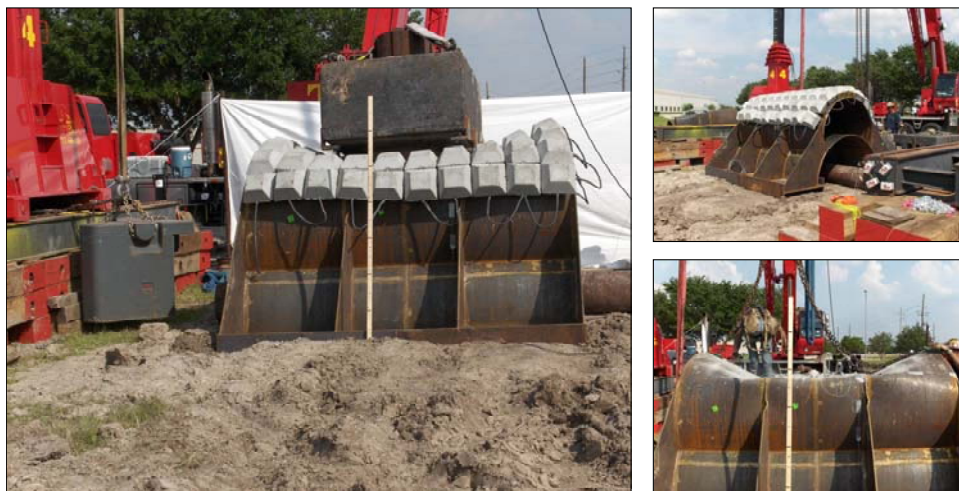
Figure 17 – Photographs from Test #3 drop test [5]

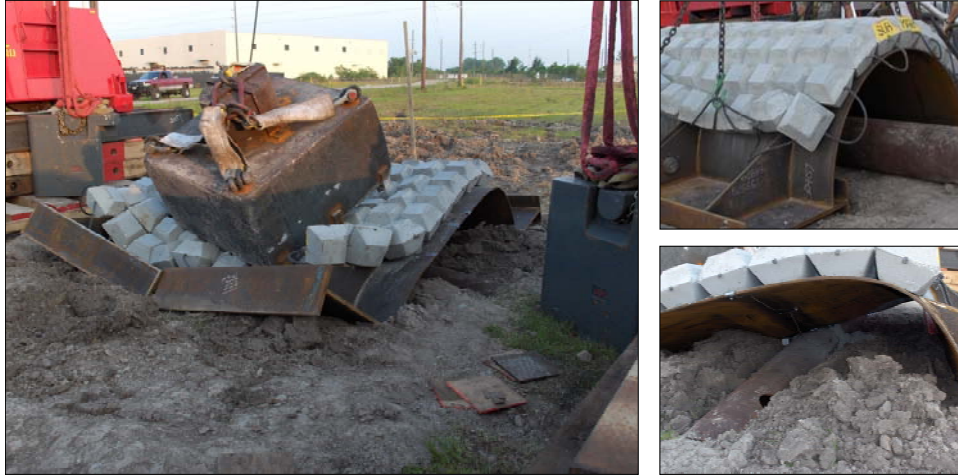
**Figure 18 – Photographs from Test #4 drop test [5]**

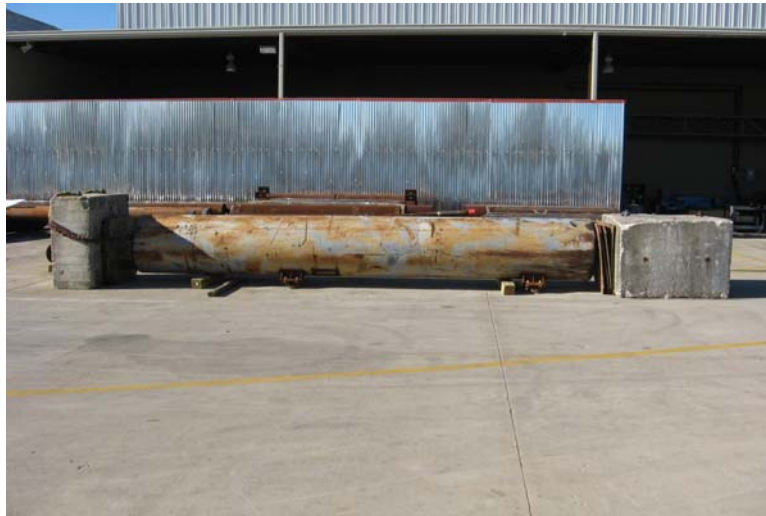
**Figure 19 – Burst test set-up showing pipe enclosure and concrete blocks**

**Figures 19** and **20** are photographs showing the test set-up. **Figure 21** provides maps showing the locations of the strain gages. **Figure 22** plots the strain gages results for the girth weld test sample. **Figures 23** and **24** are photographs showing the failure in the base pipe and girth weld test samples, respectively. It is significant to note that both of these failures resulted in a classic “fish mouth” appearance characteristic of a ductile overload condition.

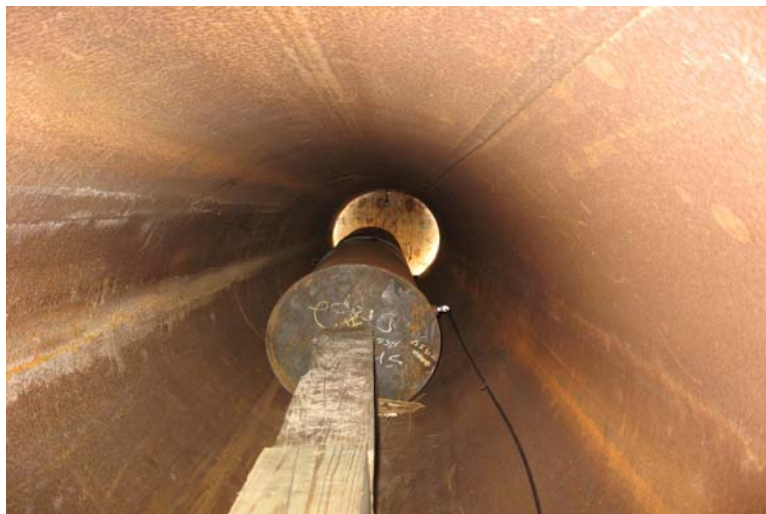
**Figure 20 – Inside view of test sample in pipe enclosure**

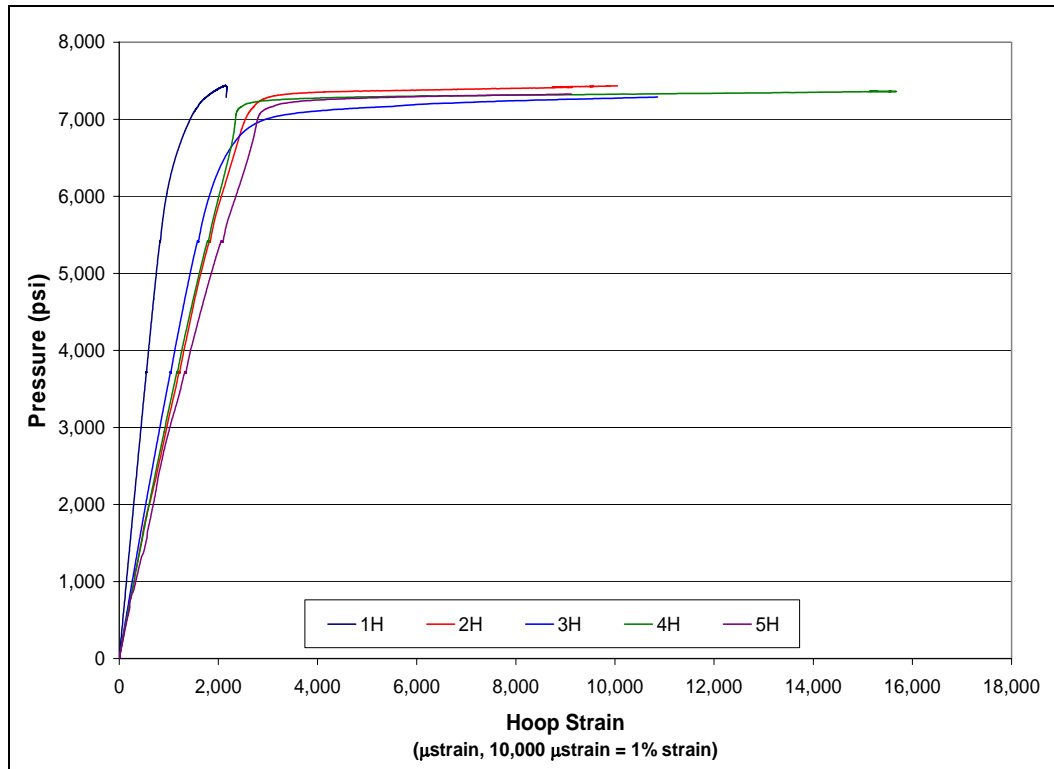
Figure 22 – Hoop strain measured in the girth weld test sample  
(refer to Figure 21 for strain gage location numbers)

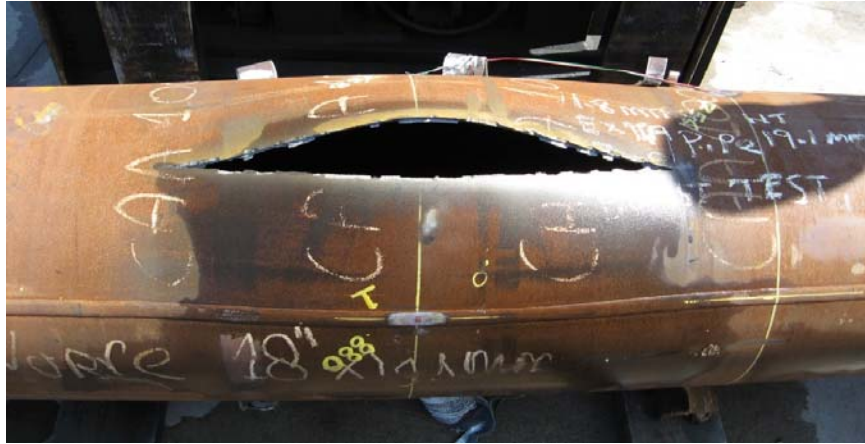
Figure 23 – Failure in the base pipe sample

The base pipe sample failed at a burst pressure of 7,473 psi (1.38 times SMYS and 2.0 times MAOP). The second sample, the girth weld sample, failed at the center of the sample after achieving a pressure of 7,437 psi (1.37 times SMYS and 2.0 times MAOP). The longitudinal seam and girth welds did not contribute to the failures in either of the two test samples.

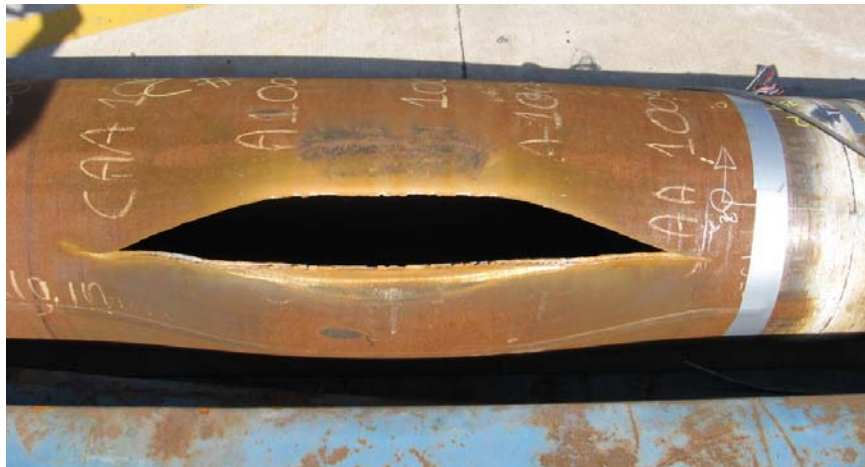
Figure 24 – Failure in the girth weld sample
