DEVELOPING STRESS INTENSIFICATION FACTORS FOR COMPOSITE REPAIR SYSTEMS USED TO REPAIR DAMAGED PIPE

Chris Alexander
Stress Engineering Services, Inc.
Houston, Texas
chris.alexander@stress.com

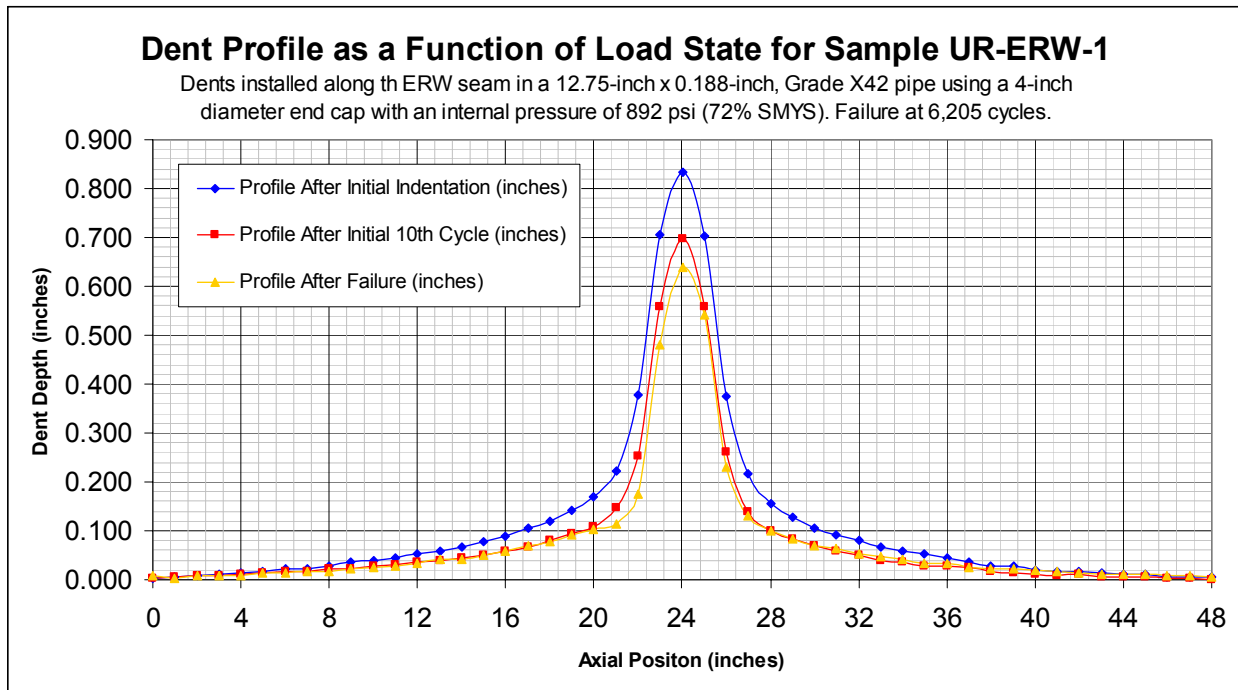
Figure 2 – Dent profile for unrepaired 15% dent in ERW seam
(residual initial dent depth of 6.54% with final post-failure dent depth of 5.01%)

- e. Remove pressure and measure profile of dent as shown in **Figure 2**. These measured data can be used to calculate local bending strains in the dent.

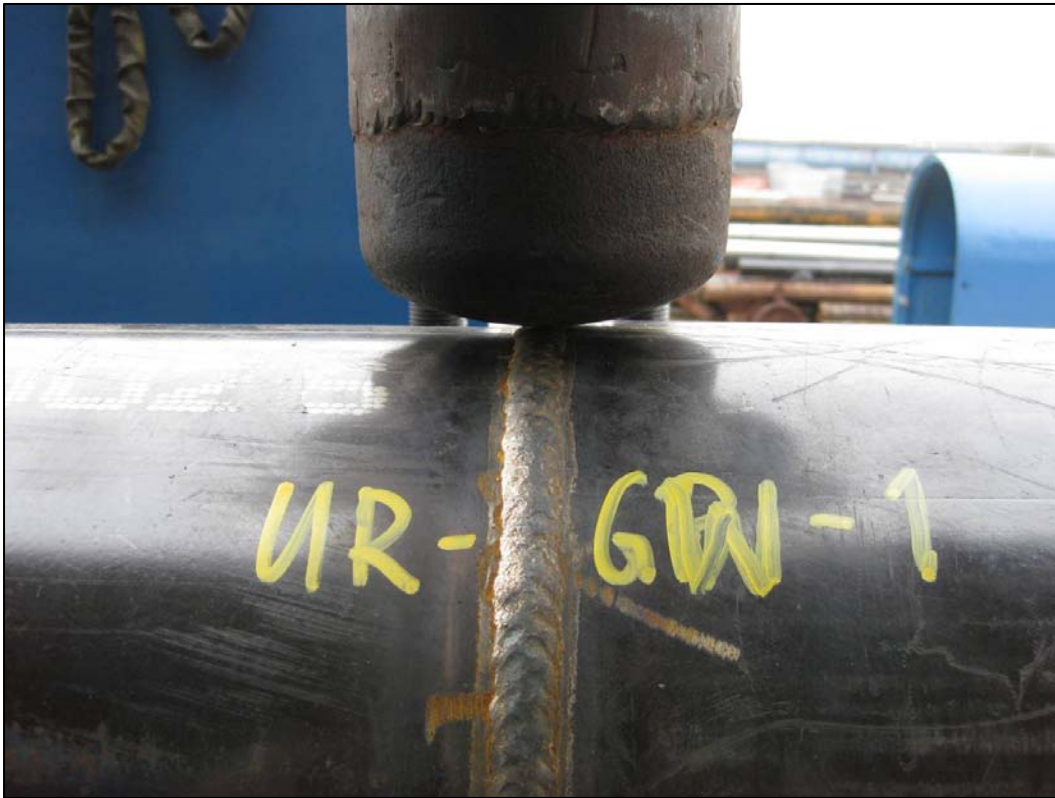
Figure 3 – Close-up view on indenter on girth weld

- g. Continue process (steps a through c) and install five (5) remaining dents – all dents will be made with internal pressure.
 - h. Apply 10 pressure cycles from 0 to 100% MAOP (Maximum Allowable Operating Pressure) from 0 to 892 psi and measure all dent profiles. Figure 3 shows the indenter in position prior to denting, while Figure 4 shows the level of deformation that remained after the 10th pressure cycle had been applied to one of the girth weld samples.

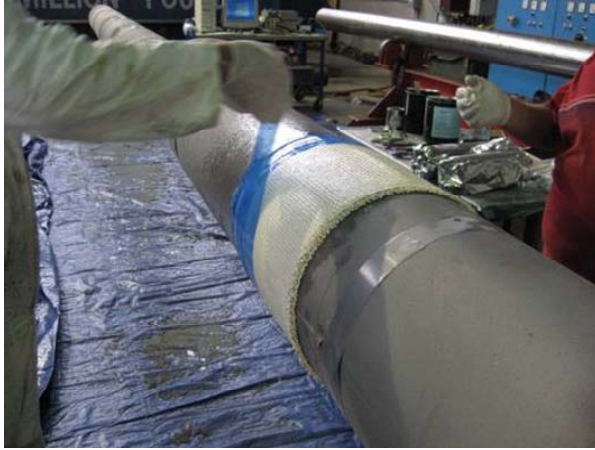
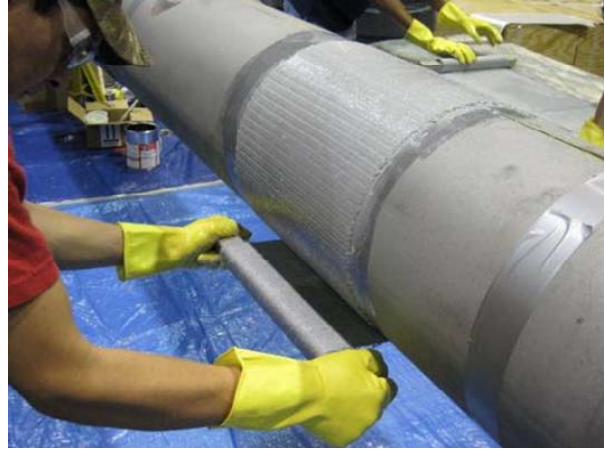
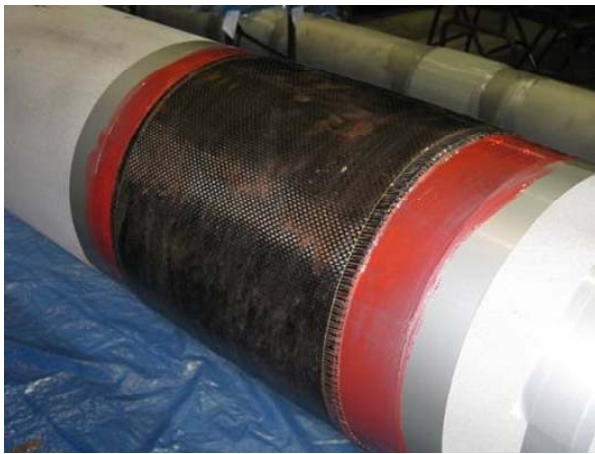
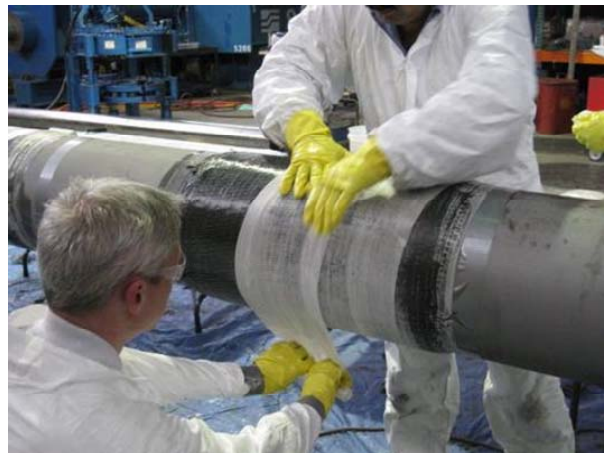
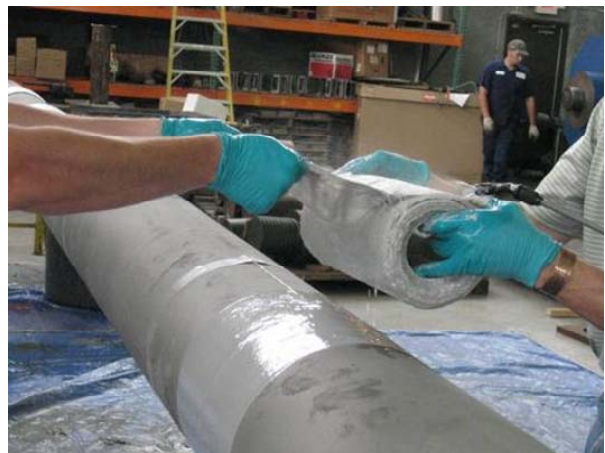
Figure 5 – Installation of composite systems that participated in dent repair program

9. Install strain gages near dents in transition area on “halo” region of dent. Refer to details shown in Figure 1 for strain gage locations and associated numbering.
10. As appropriate, install composite repair materials. Figure 5 provides photographs of the installation efforts for the manufacturers that participated in the current study.
11. Fatigue test samples to failure by applying cyclic pressure ranging from 0 to 100% MAOP (where MAOP is 72% of SMYS or 892 psi for the given pipe). Cycle samples to failure or 250,000 cycles, whichever occurs first.
12. Record strain gage data for 10 cycles at the following test intervals: start-up, 100, 200, 500, 1000, 2000, 5000, 10000,

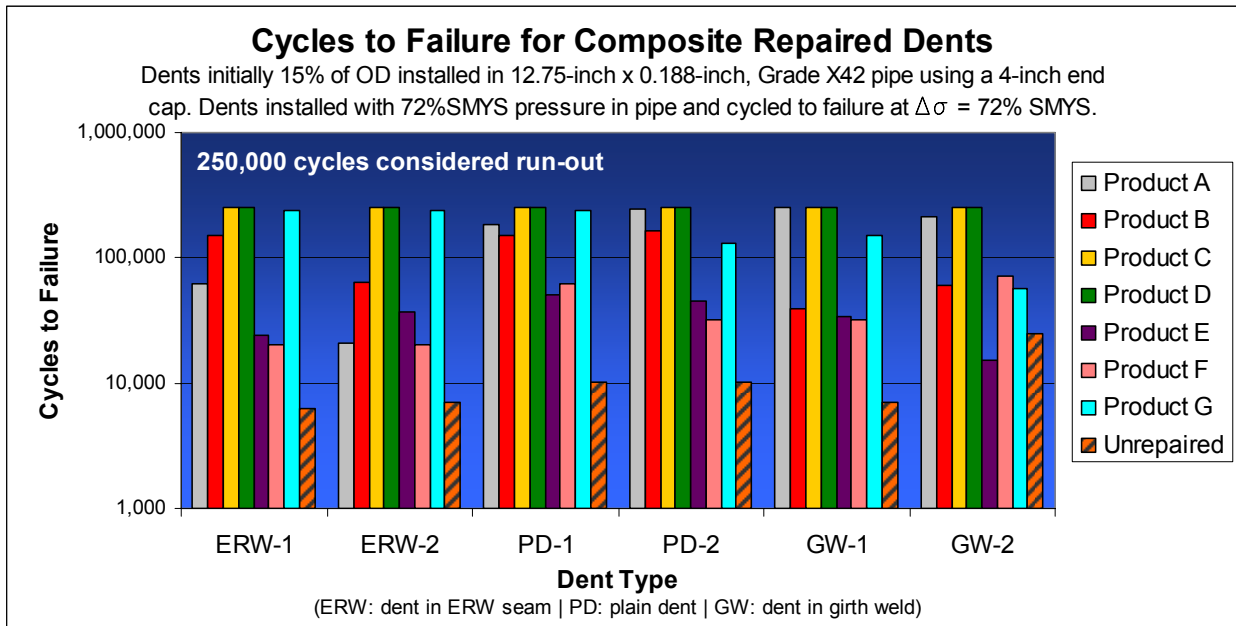
Figure 6 – Pressure cycle results for all dented test samples

were removed and the remaining pipe was welded back together so that pressure cycling could continue. Table 2 provides a summary of all fatigue test results, while Figure 6 provides a graphical representation of the same tabulated data. The last column in this table includes an average for all six dents associated with each repair systems, as well as the unrepaired dent set. Although the average value does not permit a direct comparison of test results for specific repair system/dent type combinations, it is a useful value for comparing the overall performance of the different repair systems relative to the unrepaired dents.

- The average cycles to failure for the unrepaired dent samples were 10,957 cycles. The target *cycles to failure* for the unrepaired dents was 10,000 cycles.
- Two of the seven systems had 250,000 cycles with no failures that included a carbon/epoxy system and a pre-cured E-glass system.

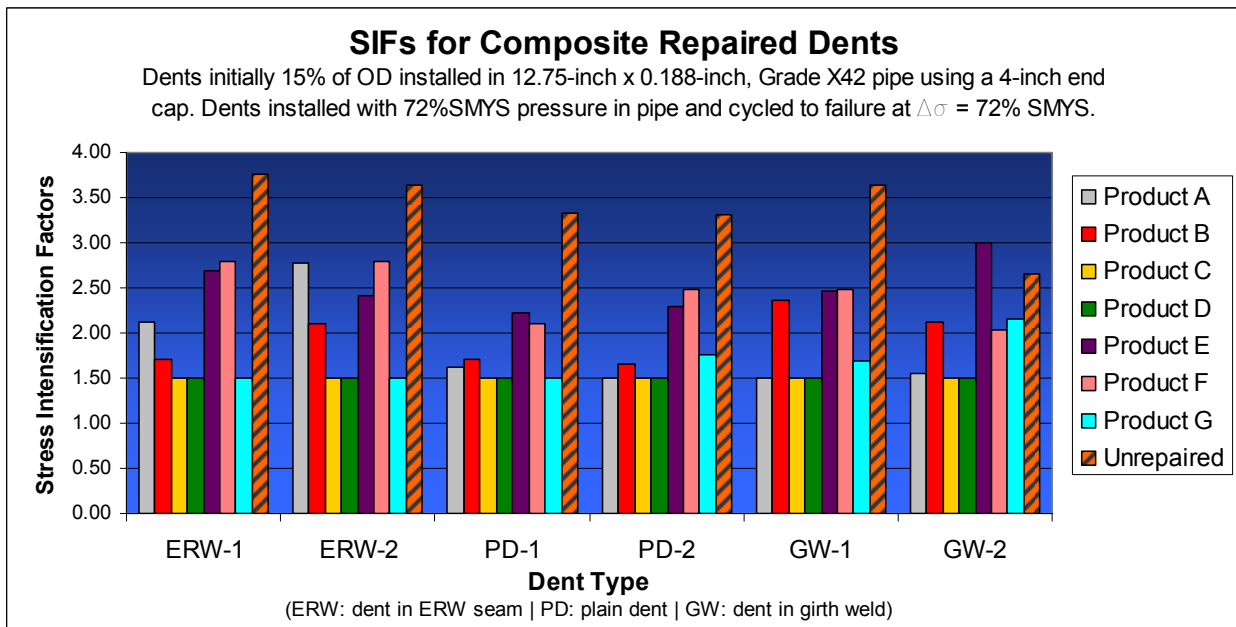
Figure 7 – Calculated Stress Intensification Factors (SIFs) for dented test samples

Provided in Table 2 is a listing of stress intensification factors (SIFs) that were calculated for each of the repaired dents as well as the unrepaired data set. Figure 7 provides a graphical representation of the same tabulated data. As observed, the maximum SIFs are those associated with the unrepaired dents (i.e. 3.76 for the unrepaired dent in an ERW seam, UR-ERW-1), while the minimum SIFs are those associated with the two repair systems that achieved run-out at 250,000 cycles (i.e. SIFs of 1.49 for Systems C and D).
