OTC-19653-PP

Methodology to Establish the Fitness for Continued Service of a Hurricane Damaged Export Pipeline in 1000 m of Water

D. Raghu (Shell Global Solutions US, Houston, TX), Richard Swanson (RCS Engineering, Houston, TX), Chris Alexander (Stress Engineering, Houston, TX)

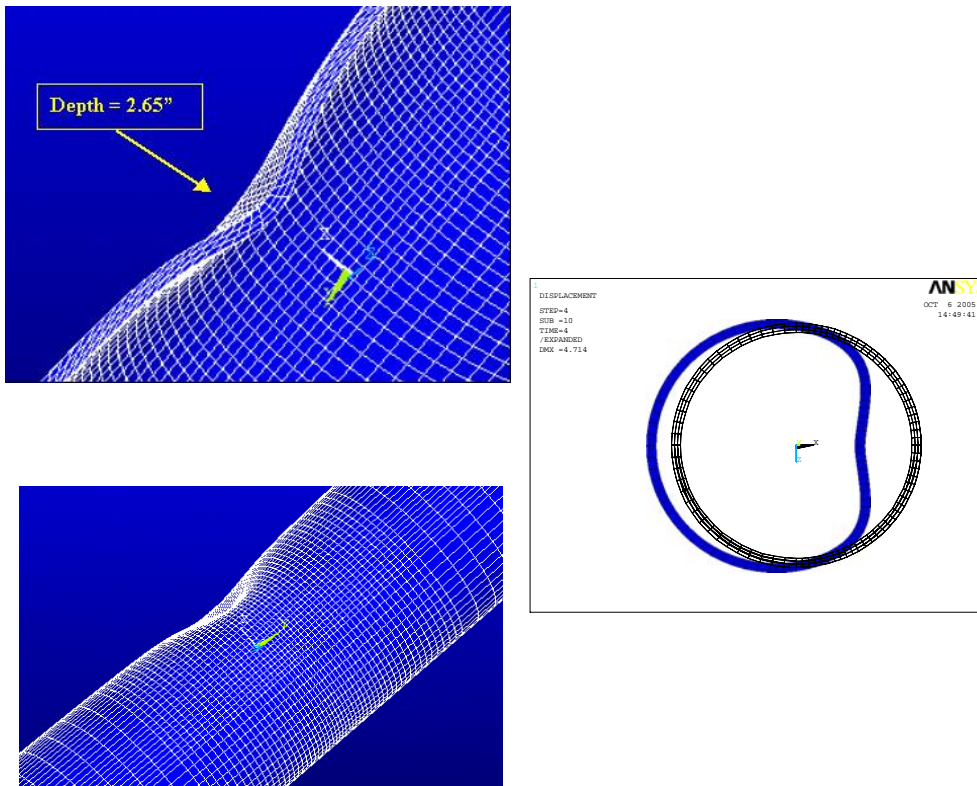
Figure 5 Overall Mesh For The Dented Pipe

Figure 5 shows the overall mesh for the dented pipe and that of the section, compared to the undented original section. The results shown here are for a dent at the lower bound of that thought to exist in the field. (Profiling the dented pipe proved to be difficult, thus some sensitivity to the dent size must be taken into account in both analysis and testing.)

Typical results of the analyses done for the Ursa gas pipeline are shown in Figures 5 and 6.

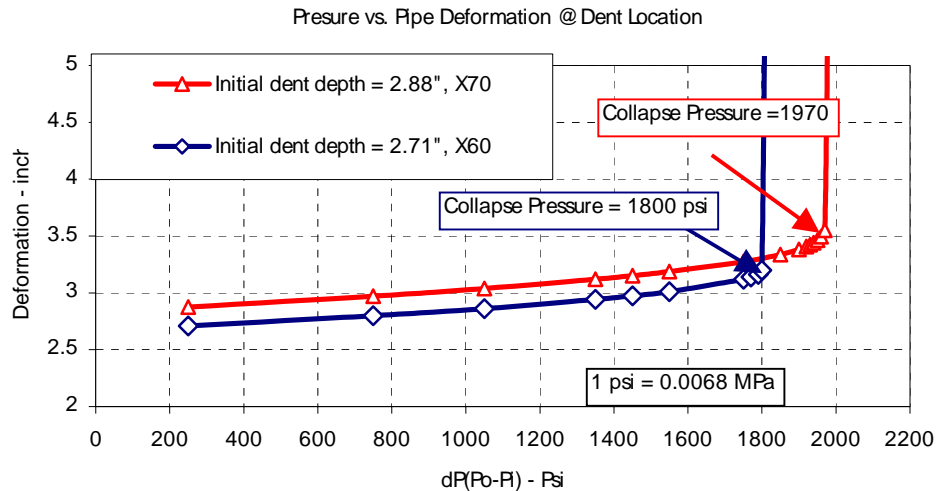
Figure 6. Collapse Pressure Sensitivity to Parameters

Figure 6 depicts the performance of the dent deformation as a function of the difference between internal and external pressure. Curves for three sizes of initial dent are shown, resulting in different collapse pressures. Note there is substantial reduction in collapse pressure as the dent size increases. The design collapse pressure for the un-dented pipe (with nominal ovality) is on the order of 15.16 to 17.23 Mpa (2200 to 2500 psi), giving a safety margin of about 75% in 900 m (3000 feet) of water. A 106.7 mm (4.2-inch) dent reduces this to 20%, which is not acceptable. Since the pipeline was damaged, the difference between internal and external pressures has been carefully controlled to avoid insufficient safety margin on collapse pressure.

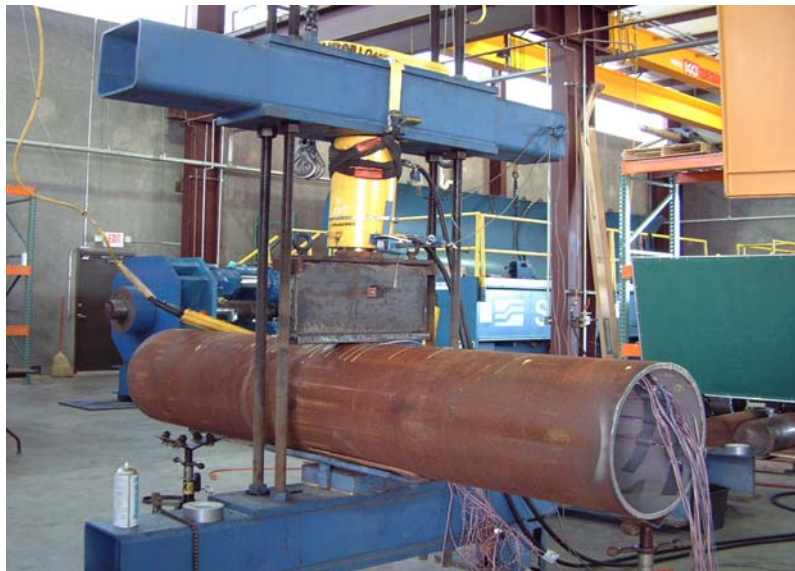
Figure 7 - Indenter installing dent in the test sample

The profile of the test dents was based on the dent profile of the actual dent in the subsea URSA pipeline. Using this profile, a carbon steel indenter was fabricated to achieve the intended dent shape. A hydraulic ram was used to force the indenter into the pipe sample. During the denting process, force as a function of displacement was recorded.

Figure 7 is a photograph taken during the dent installation process. The average dent depth was 2.8 inches and the average force was approximately 1779 kN (400 kips). The observation from these results is that it takes a significant force to create the indented dent depths. Figure 8 is a plot that provides dent force as a function of dent depth for Samples #2 through #5. If one is to calculate energy, Sample #2 has the greatest area under the curve corresponding to an energy level of 123.2 kJ (90.8 kip-ft).

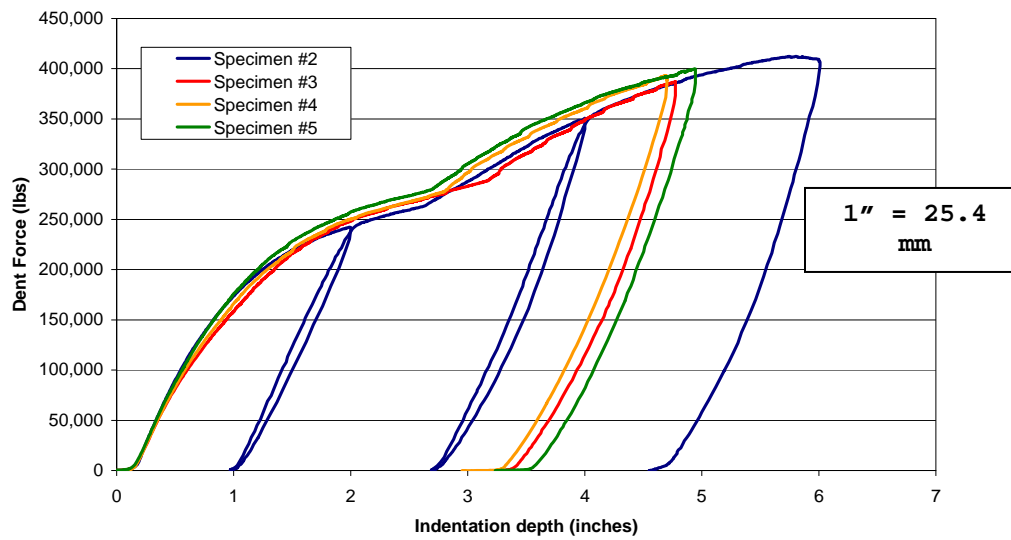
Figure 8 - Dent force as a function of dent depth for Samples #2 - #5

In reviewing the data provided in Figure 8 there are several important observations. First, there is good repeatability among the different test results indicating consistency in the test program. Secondly, the load-deflection response was similar to results from the finite element work, confirming the validity of the plasticity model used in the FEA.

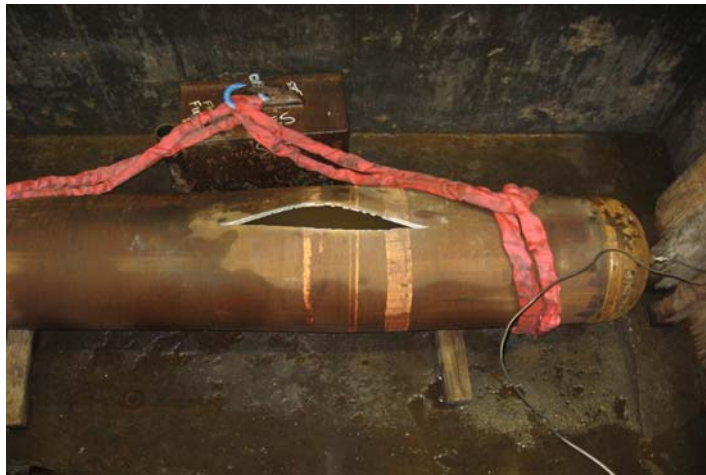
Figure 9 - Failure of Dented Sample

In addition to the fatigue tests, a burst test was performed on a sample. The intent was to determine the static pressure capacity of a dent. The pipe burst at a pressure of 6,419 psi and occurred 180 degrees from the dent as shown in **Figure 9**.
