EXPERIMENTAL TESTING OF A COMPOSITE GASKET WITH INTERNAL PRESSURE, BENDING, AND THERMAL LOADS

Christopher R. Alexander
Stress Engineering Services, Inc
Houston, Texas

Thomas C. Wallace
Pikotek
Lakewood, Colorado

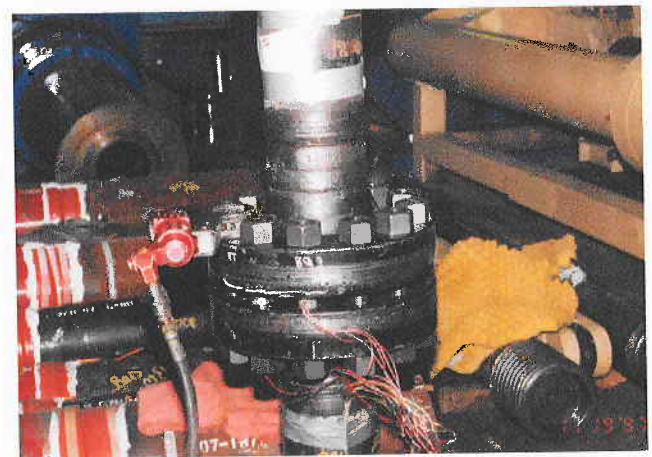
Figure 2 Flange assembly during makeup

The flange assemblies were constructed by welding end caps to the flanges. Ports were drilled and tapped in the end caps to accommodate the necessary pressure equipment. Attached to each of the two end caps were solid bar segments for the purpose of applying bending to the flanges. Also welded to these solid bar joints were end caps to match the load frame for conducting the bend test. **Figure 2** provides a photograph of the assembly during the process of make-up.

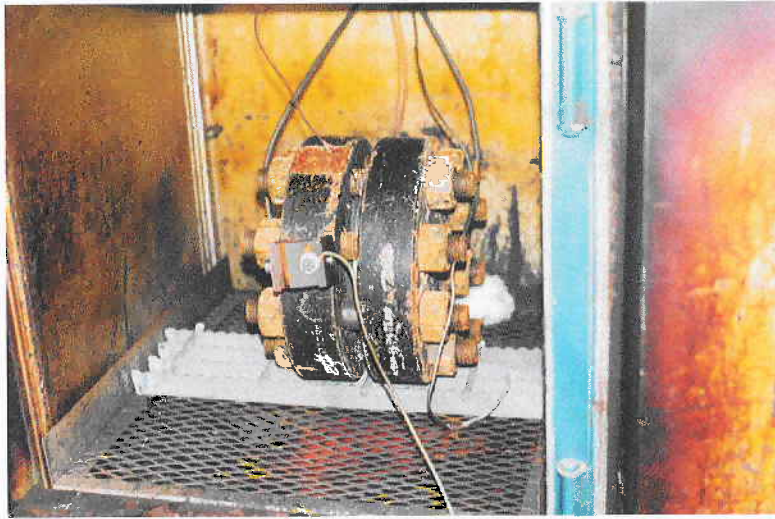
Figure 7 Flange assembly located in heating and cooling chamber

The principal hardware components used in the thermal cycle test program are shown in **Figures 6** and **7** and are listed as follows,

- Set of 2-in 2500# blind flanges with appropriate bolting (eight 1-in 8UN studs)
- Electric oven to heat flanges to 300°F
- Liquid nitrogen system to cool flanges to 0°F
- Nitrogen gas pressure system
- Thermocouple and pressure transducer to monitor flange temperature and pressure
- Computer system to record data during testing.

The blind flanges were made up to axial bolt stresses of 40 ksi, which for the 1-in 8UN bolts corresponds to a bolt torque of 361 ft-lbs (refer to Appendix D, *Recommended Flange Bolt Torque*, of API Specification 6A). After make-up of the flanges, the test assembly was placed in the electric oven and the necessary hardware was attached.

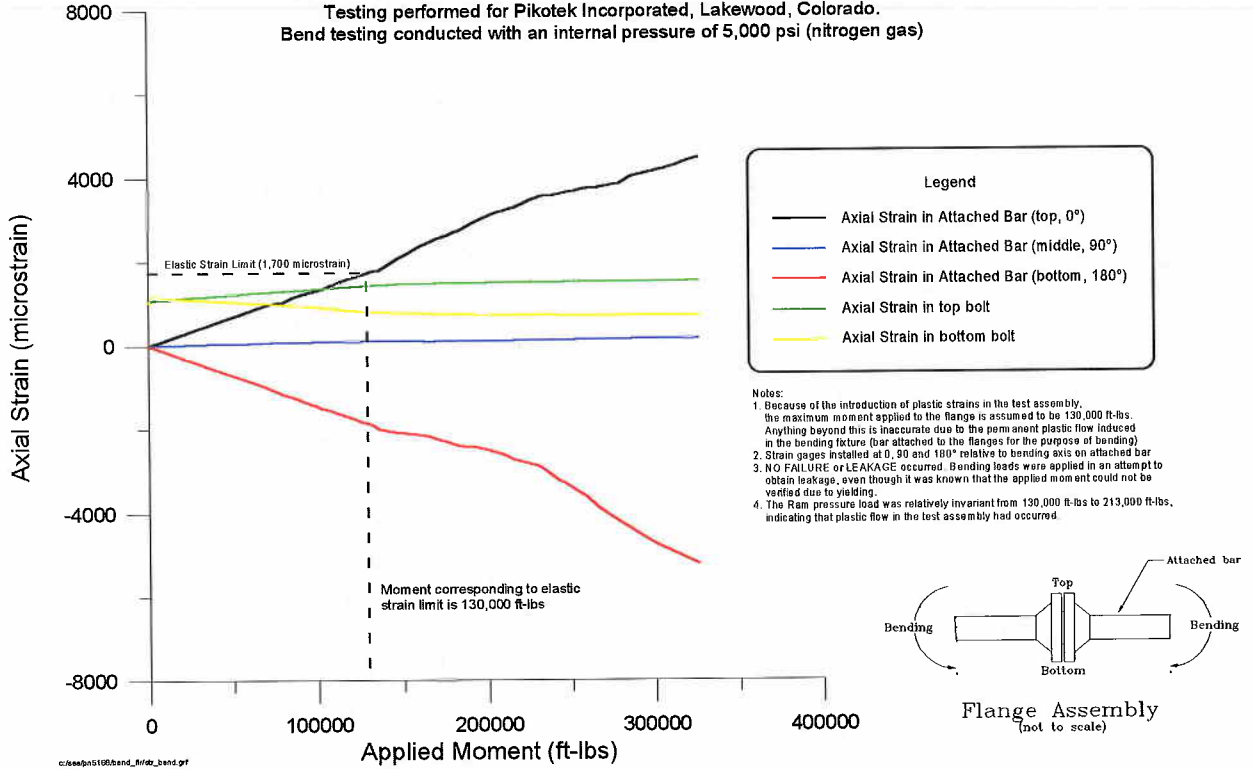
STRAIN AS A FUNCTION OF APPLIED BENDING MOMENT

Bending test conducted on the Pikotek 6" ANSI Flowlok HP flange gasket at Stress Engineering Services, Inc, Houston, Texas on January 6, 1998.
 Testing performed for Pikotek Incorporated, Lakewood, Colorado.
 Bend testing conducted with an internal pressure of 5,000 psi (nitrogen gas)

Figure 8 Strain gage results for bending load tests

There are several important observations in studying **Figure 8**,

- The strains in the bolting change as a direct result of the bending moment. The strain in the top bolt at 0° increased while the strain in the bolt at 180° decreased.
- The changes in strain between the nitrogen pressure testing alone and the flange assembly subjected to the 130,000 ft-lbs. bending moment are summarized,

<u>Axial Strain in Top Bolt</u>	1079 $\mu\epsilon$ (N ₂ pressure)
	1489 $\mu\epsilon$ (Bending)
	Net change of +410 $\mu\epsilon$
<u>Axial Strain in Bottom Bolt</u>	1054 $\mu\epsilon$ (N ₂ pressure)
	748 $\mu\epsilon$ (Bending)
	Net change of -306 $\mu\epsilon$

Figure 8 data is plotted for bending moments exceeding 130,000 ft-lbs. It should be noted that plastic flow initiated in the bars (solid) attached to the flanges at this bending moment. The exact value of the bending moment could not be measured accurately. Deflection continued with additional stroke of the hydraulic cylinders at a nearly constant pressure. The onset of plastic deformation is theoretically validated by rearranging the bending stress calculation as shown below,
