Proceedings of the ASME 2014 Pressure Vessels & Piping Conference PVP2014

PVP2014-28226

INTENTIONAL DESTRUCTIVE TESTING: A MEANS FOR ESTABLISHING MECHANICAL INTEGRITY IN PLANTS, FACILITIES, AND PIPELINES

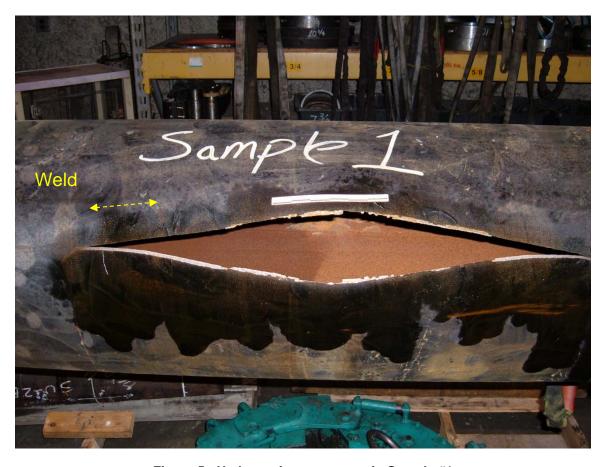
Figure 5 - Hydrostatic test rupture in Sample #1 The location of the longitudinal seam weld is also shown.

psi. Figure 5 is a photograph showing the hydrostatic test rupture in Sample #1; note the location of the longitudinal seam weld that occurred outside the failure. Table 1 lists the test pressure results for all three burst samples.

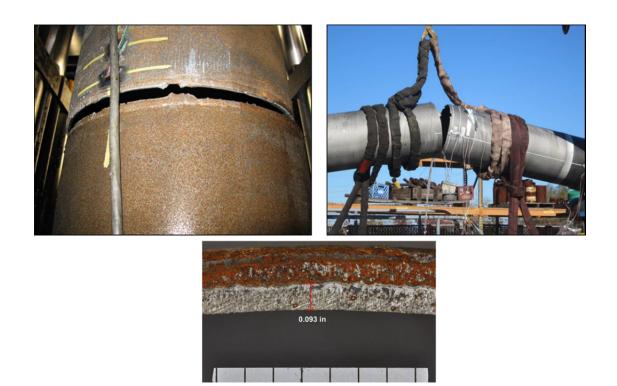
Figure 7 – Bend test results for unreinforced test sample

pipe occurred outside of the reinforcement. These results demonstrate that the stiffness of the reinforced sections are not only greater than the base pipe, but of sufficient magnitude to ensure that wrinkles form outside a composite-reinforced section when subjected to bending loads. Figure 7 includes photographs of the unreinforced bend sample, including a cross-section of the weld after failure. The sample shown in this figure was subjected to increasing bending loads until a failure occurred.

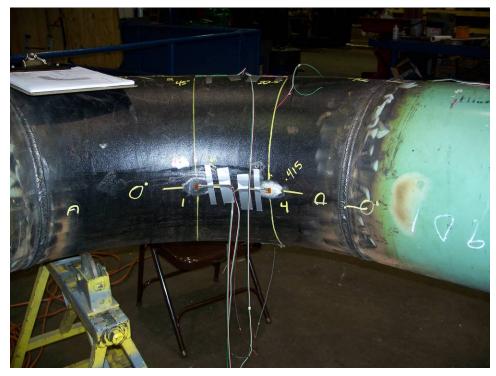
Figure 11 – Photograph of strain gages being installed on the elbow test assembly

Questions were posed regarding the integrity of elbows purchased for use in a proposed jet fuel hydrant system. The system was expected to operate at a steady state pressure of 150 psi with maximum surge pressures of 50 psi (i.e. maximum expected pressure of 200 psi). A burst test was performed on a 16-in x 0.375-in, Grade WPB 90° long radius elbow. As shown in Figure 10, locations for seven strains gages were selected to maximize the number of measurements in the elbow, but also monitor strain in the attached piping. Figure 11 is a photograph the installed strain gage on the intrados of the bend.

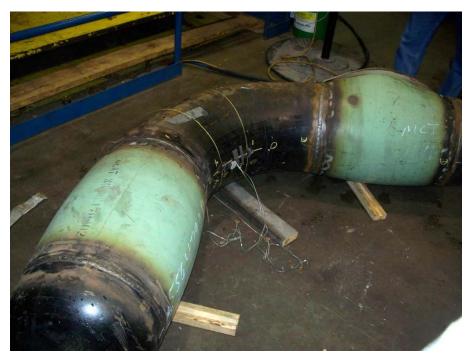
Figure 12 – Photograph of the elbow after burst testing

The burst test included 5 minute pressure holds at 72% SMYS (1,181 psi) and 100% SMYS (1,640 psi). Strain gage readings were taken at a rate of 1 scan per second continuously during the duration of the test. After the two pressure holds, the test assembly was pressurized to failure where a maximum pressure of 3,094 psi was achieved. The failure in the test assembly did not occur in the long radius elbow, but took place in one of the attached pipe segments as shown in Figure 12. It appeared, based on strain gage readings, that the pipe material likely had a lower yield than the material used in the elbow.

Considering that a maximum pressure of 3,094 psi was reached in the test assembly, a safety factor of 15.5 exists on burst when assuming a maximum operating pressure of 200 psi. This program, although relatively simple to execute, was effective in confirming the integrity of the elbows in question and providing the operator confidence that the quality of the purchased elbows was sufficient for their intended service.
