# Evaluation, Repair and Rehabilitation of Pipelines Conference and Exhibition

## Using Composite Materials to Reinforce Onshore Pipelines: New Insights and Lessons Learned

**Chris Alexander**  
Stress Engineering Services, Inc.  
Houston, Texas

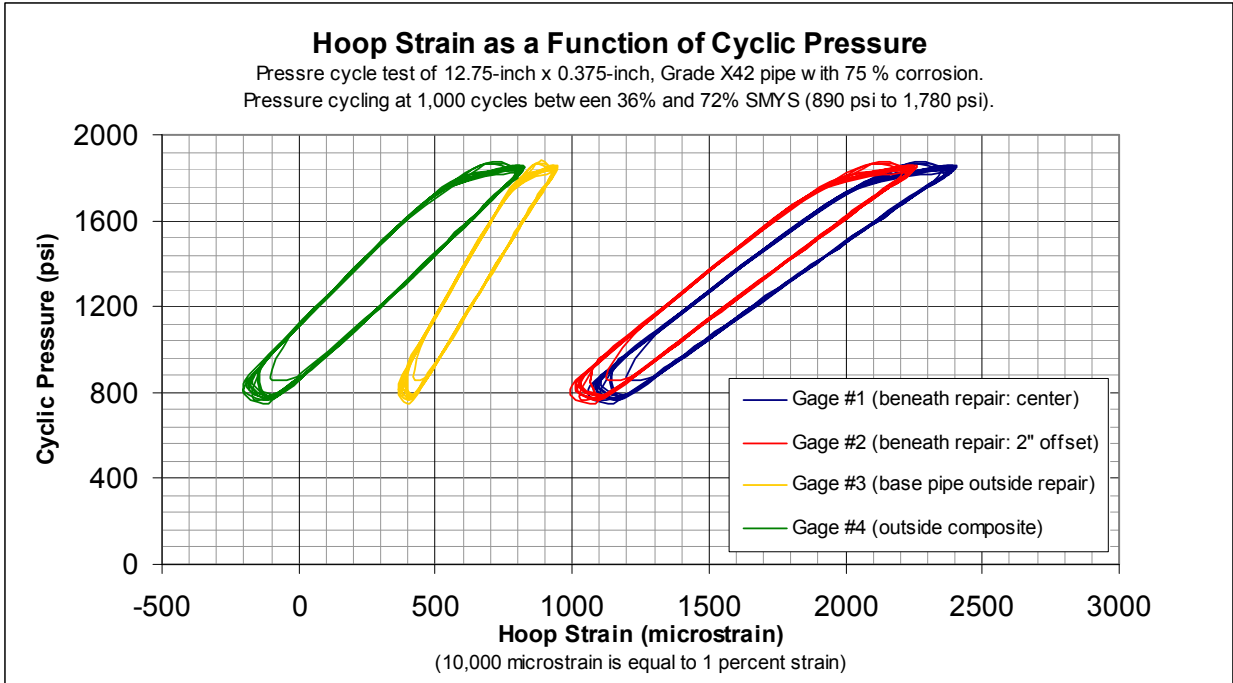
Figure 2 – Hoop strain as a function of cyclic pressure for corroded fatigue test sample

**Figure 2** and **Figure 3** show hoop strain as functions of cyclic pressure and cycle number for one of the corroded fatigue test samples (the E-glass system that achieved 259,537 cycles to failure), respectively. Of particular note in **Figure 3** is the change in strain range and maximum strain that occur as functions of cycle number. As observed, the maximum strain increases with increasing cycle number, while the strain range remains relatively constant over the period of measurement, which for this case happened to be almost 100,000 cycles.

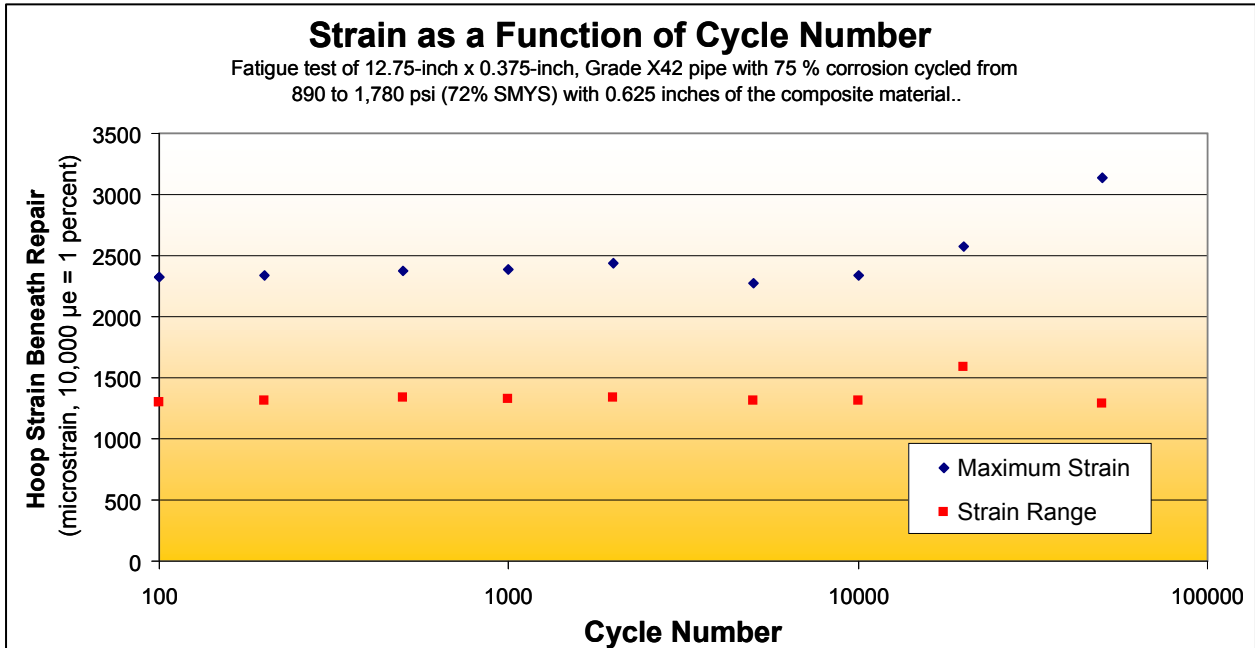
Figure 3 – Hoop strain as a function of cycle number for corroded fatigue test sample

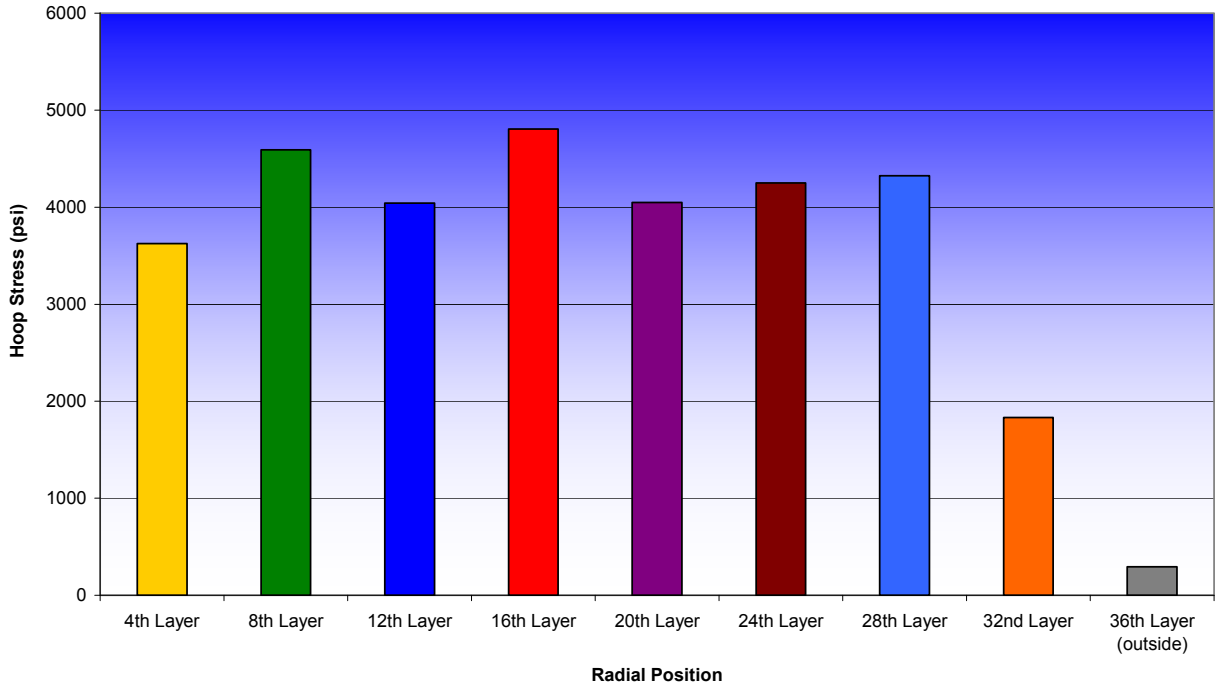
**Figure 4 – Hoop Strain at 72% SMYS as a Function of Radial Position for System #1**  
 (Hoop stress calculated as the product of the measured strain and the composite's elastic modulus)

**Figure 4** and **Figure 5** plot hoop strain in the composite materials at 72% SMYS for Systems #1 and #2 as a function of radial position, respectively. **Figure 6** plots hoop stress as a function of internal pressure using data collected during testing for System #2. Included in this plot are average hoop strain data collected for 12 composite repair systems participating in the Pipeline Research Council International, Inc. (PRCI) MATR-3-4 long-term composite reinforcement study.

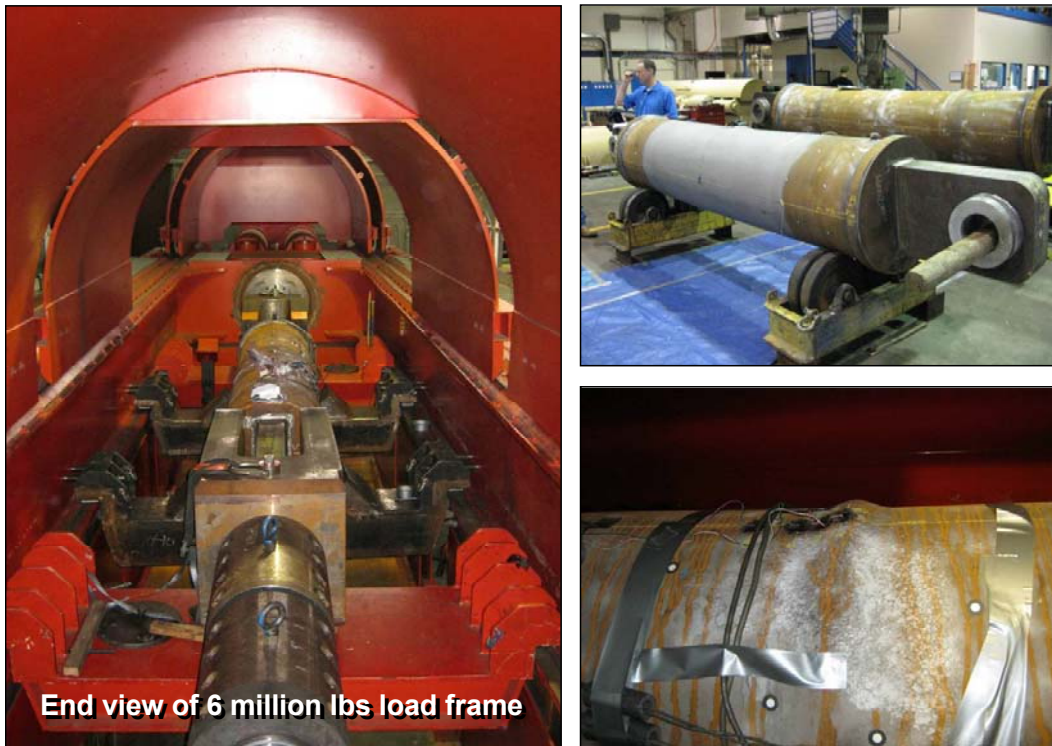
Figure 7 – Photographs showing testing set-up for wrinkle bend testing

It is recognized throughout the transmission pipeline industry that failures in wrinkle bends have occurred. While identifying the causes and contributors to wrinkle bend failures are the subjects of several ongoing studies, in 2010 six full-scale tests were conducted to evaluate the performance of wrinkle bends, including the assessment of composite materials (3 sets with each set having one reinforced and one unreinforced test sample). **Figure 7** and **Figure 8** are photographs showing the test set-up and composite installation, respectively.

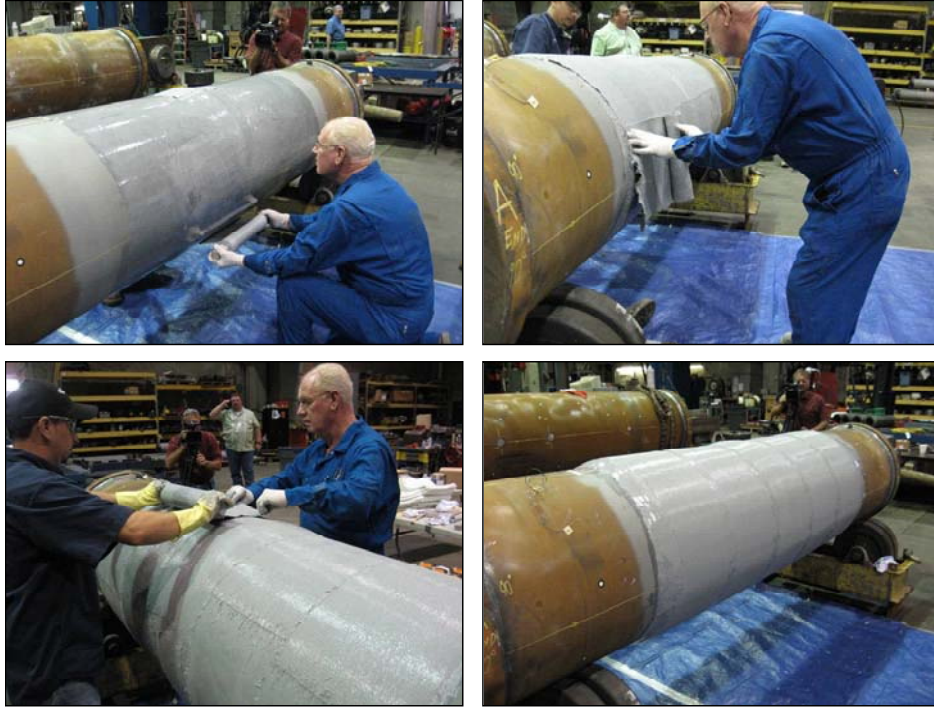
Figure 8 – Photographs showing installation of composite materials on wrinkle bend samples

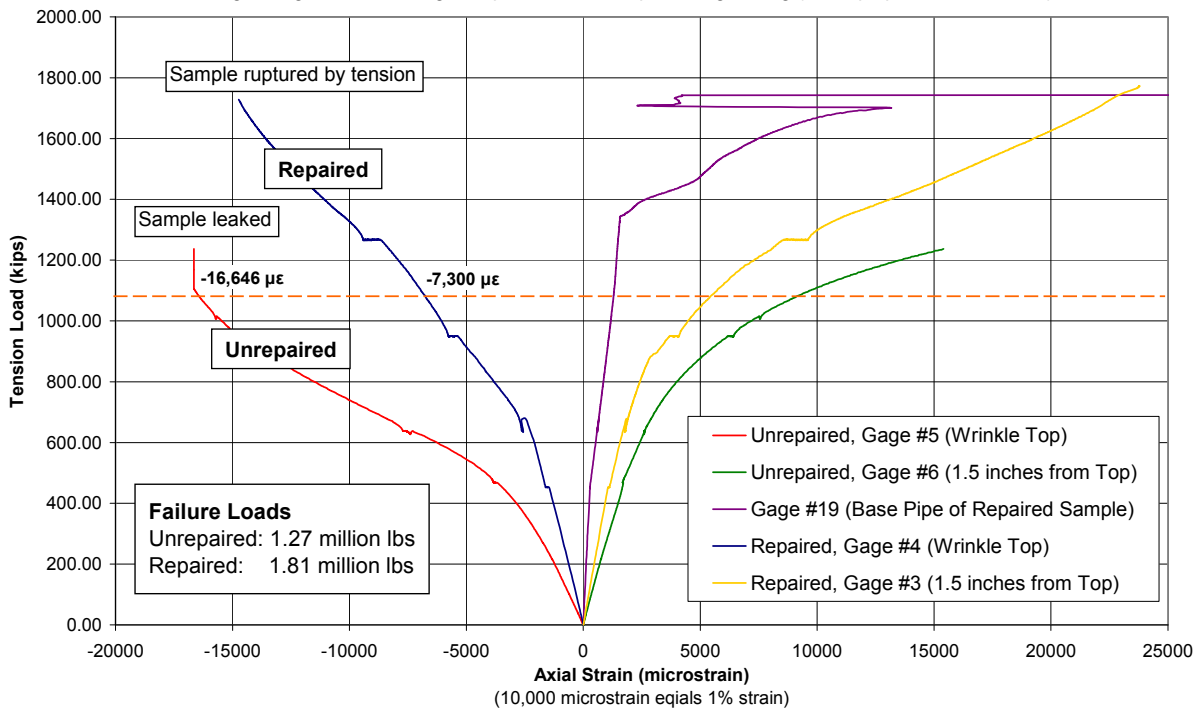
26-inch x 0.313-inch, Grade X52 pipe having wrinkle bends with strain gages installed on pipe and monitoring during tension loading with pressure of 900 psi during testing (455 kips pressure end load).

Figure 9 – Axial tension versus strain for the reinforced and unreinforced wrinkle bend test samples (The *Tension Load* is the sum of tension loading from the load frame and the end load due to internal pressure)

**Figure 9** plots axial strain as a function of axial tension loading. Provided below are several noteworthy observations made in reviewing the data plotted in **Figure 9** that was generated during the course of this study.

- At an axial stress of 36% SMYS (455 kips), the following strains were measured (where 10,000 microstrain,  $\mu\epsilon$ , equals 1% strain):
  - Base pipe without wrinkle bend (calculated): 593  $\mu\epsilon$

- Unreinforced wrinkle bend ( $h/L = 0.123$ ): -3,508  $\mu\epsilon$
  - Reinforced wrinkle bend ( $h/L = 0.137$ ): -1,611  $\mu\epsilon$
- While the reduction in strain provided by the composite material is critically important, it should also be noted that the composite material increased the ultimate load capacity of the pipe having wrinkle bends. Corrosion pitting in both samples was on the order of 30%, yet the composite-reinforced sample increased the tensile capacity to achieve a stress level in the base pipe on the order 71 ksi (i.e. 1,815 kips / [ $\pi \cdot 26$  inches x 0.313 inches]). This stress level is in excess of the minimum tensile strength of the Grade X52 pipe material (i.e. 66 ksi) assuming that no corrosion is present.
