## ADVANCED INSIGHTS ON COMPOSITE REPAIRS

### ABSTRACT

In response to inquiries from pipeline operators regarding the long-term performance of composite materials, manufacturers have performed additional tests to evaluate the performance of their composite repair systems. Insights were gained through these additional tests that demonstrated the long-term worthiness of the composite system. Of particular importance were two types of tests. The first involved the application of strain gages between layers of the composite repair system that was used to reinforce a corroded pipe test sample. As the sample was pressurized the strain gages permitted a comparison between the measured values and design stresses per the ASME PCC-2 design code. The second series of tests involved pressure cycling a 75% corroded sample to failure. In addition to the inter-layer strain measurements, the pressure cycling provides an important insight regarding the long-term performance of the composite repair.

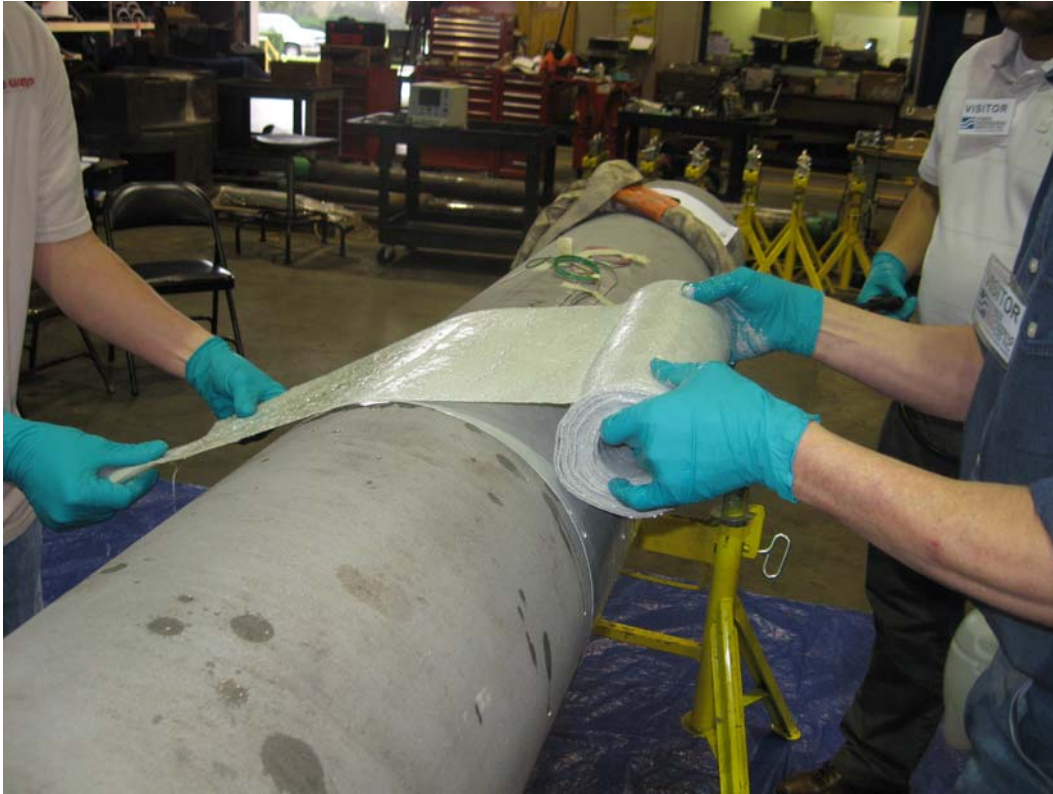
**Figure 2 – Installation of composite repair on 75% corrosion burst test sample**

Figure 2 shows the installation of the composite repair on 75% corrosion burst test sample, while Figure 3 is a photograph of the same sample after pressurization. Note that the failure occurred outside of the repair.

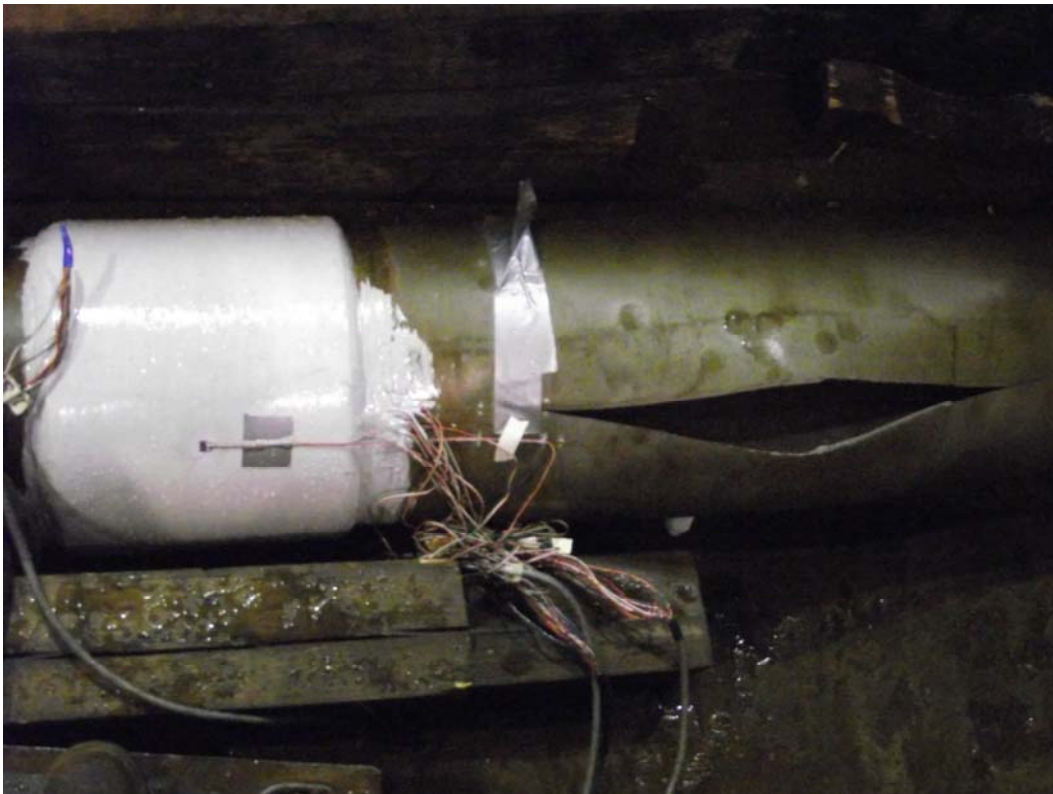
**Figure 3 – Photograph of failure in 75% corrosion burst test sample**

The burst sample was pressurized to failure and failed at a pressure level of 4,440 psi. The failure occurred in the base pipe outside of the repair. The strain gage results that were monitored during testing at a rate of 1 scan per second. The strain gage readings in the corroded region of the pipe beneath the repair are compared to the average strain readings from the PRCI long-term study, including the following observations.

As noted previously, the failure in the test sample occurred outside of the repair. The repair involved 36 layers of A+ Wrap (0.76 inches thick). The significance in the failure having occurred outside of the repair is that these results indicate that the repair is at least as strong as the base pipe. Additionally, at the failure pressure the hoop strain in the reinforced corroded region was on the order of 2.5 percent, whereas the strains in the base pipe outside of the repair were in excess of 10 percent (based on the final measured circumference at the failure location of the pipe).

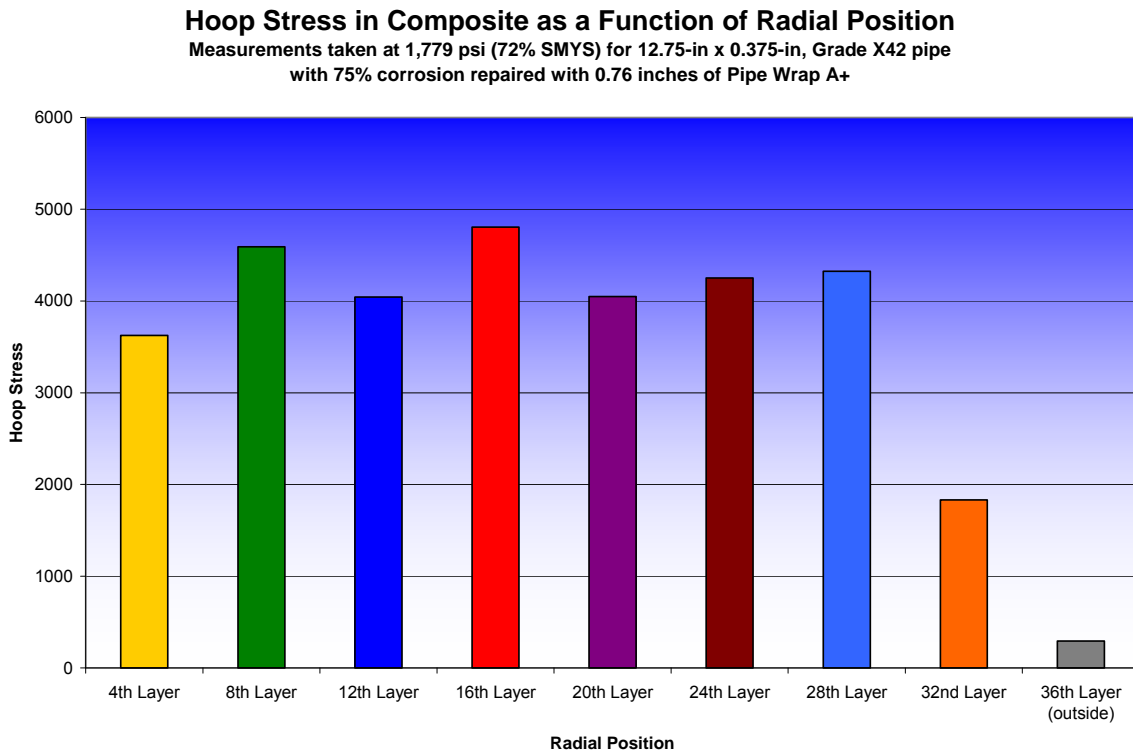
**Figure 5 – Hoop Stress\* in Composite as a Function of Radial Position**  
 (Hoop stress calculated as the product hoop strain and the elastic modulus of 3.01 million psi)

Figure 5 plots hoop stress as a function of layer. The hoop stress in the composite was calculated as the product hoop strain and the elastic modulus of 3.01 million psi. The strain gage installed on the filler material quit working when the internal pressure was 2,097 psi. At MAOP (72% SMYS), the difference in hoop strain between the bottom and top of the filler material was 407 microstrain, and the difference between underneath the filler and the 4th layer was 1,772 microstrain. At SMYS, the difference in hoop strain between underneath the filler material and the 4th layer was 3,736 microstrain. The hoop strain remained relatively constant through the composite (layers 4-28), but diminished toward the outer layer (layers 32 and 36). The average and maximum stresses measured in the composite material at the 72% SMYS design pressure (1,780 psi) were 3,940 psi and 4,806 psi, respectively.
