IPC2016-64213

FULL-SCALE ELEVATED TEMPERATURE TESTING OF COMPOSITE REPAIRS IN BENDING AND COMPRESSION

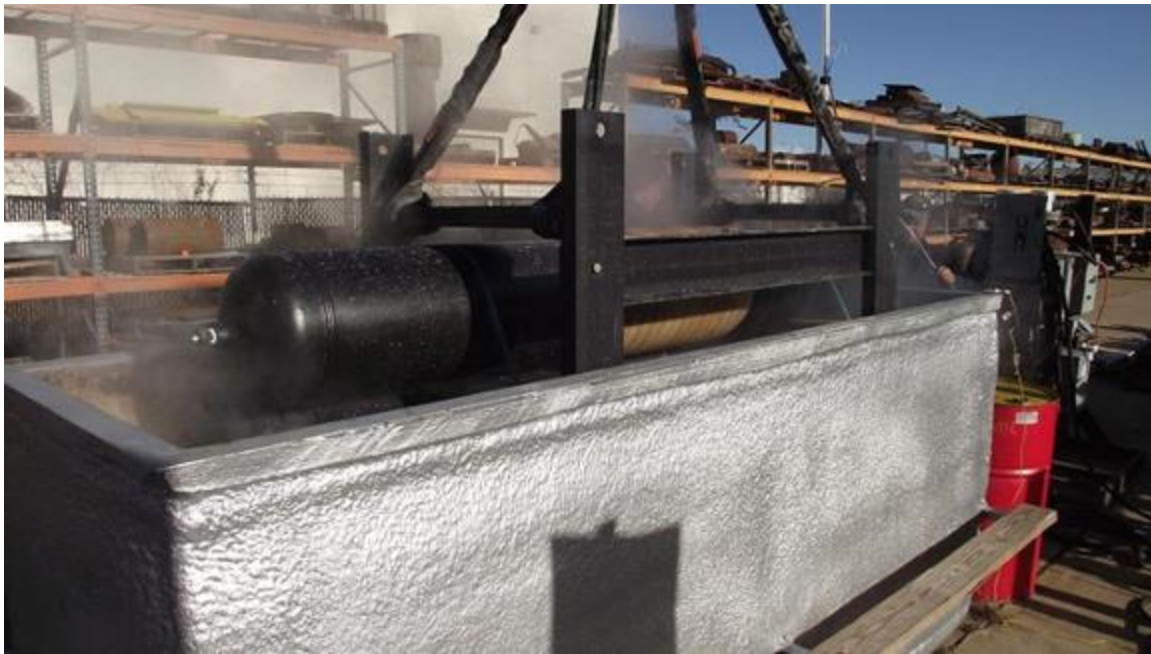
Figure 4: Samples being submerged for 1,000-hour soak

Samples that achieved the required strain criteria in internal pressure testing at 100% SMYS were subjected to a long-term 1,000 hour exposure study which included full immersion at 120 °C to simulate external environment attack followed by short-term pressure-to-failure testing. Figure 4 is a photograph showing one set of samples being submerged. The immersion

water solution had 7% chloride and 2.5% sulfate weight percent concentrations. The same sample geometry and strain gage layout was maintained for 1,000 hour testing from earlier pressure testing.

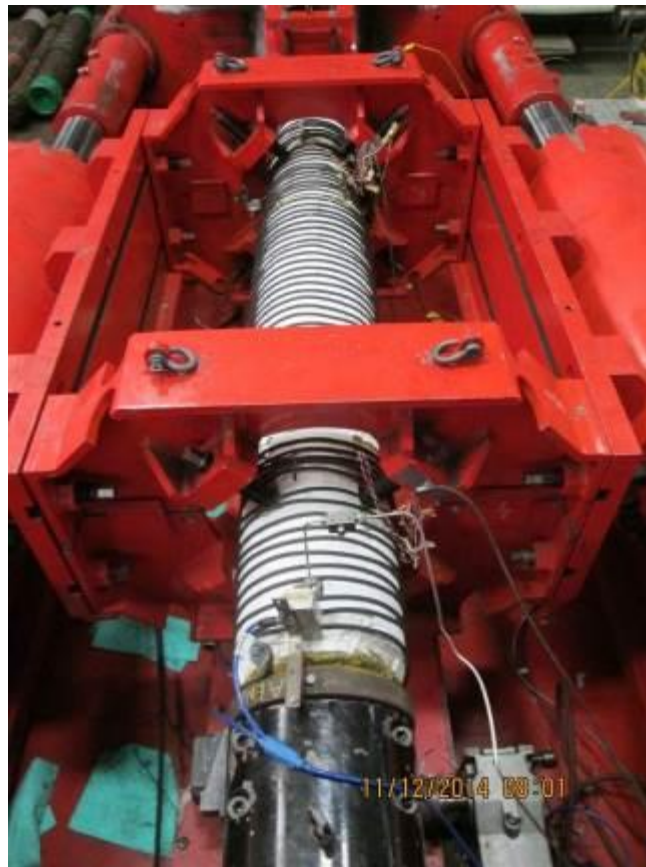
Figure 7: Compression sample in load frame

The samples used in full-scale compression testing were 12.75-inch x 0.375-inch, Grade X60 pipes that contained an 8-inch x 12-inch region machined to simulate 50% corrosion. A schematic of the samples is shown in Figure 5. Strain gages were installed in the corroded region to compare the strain reduction provided by each respective reinforcing system. The layout of these strain gages is shown in Figure 6. A photograph of a compression sample installed in the load frame is given in Figure 7.

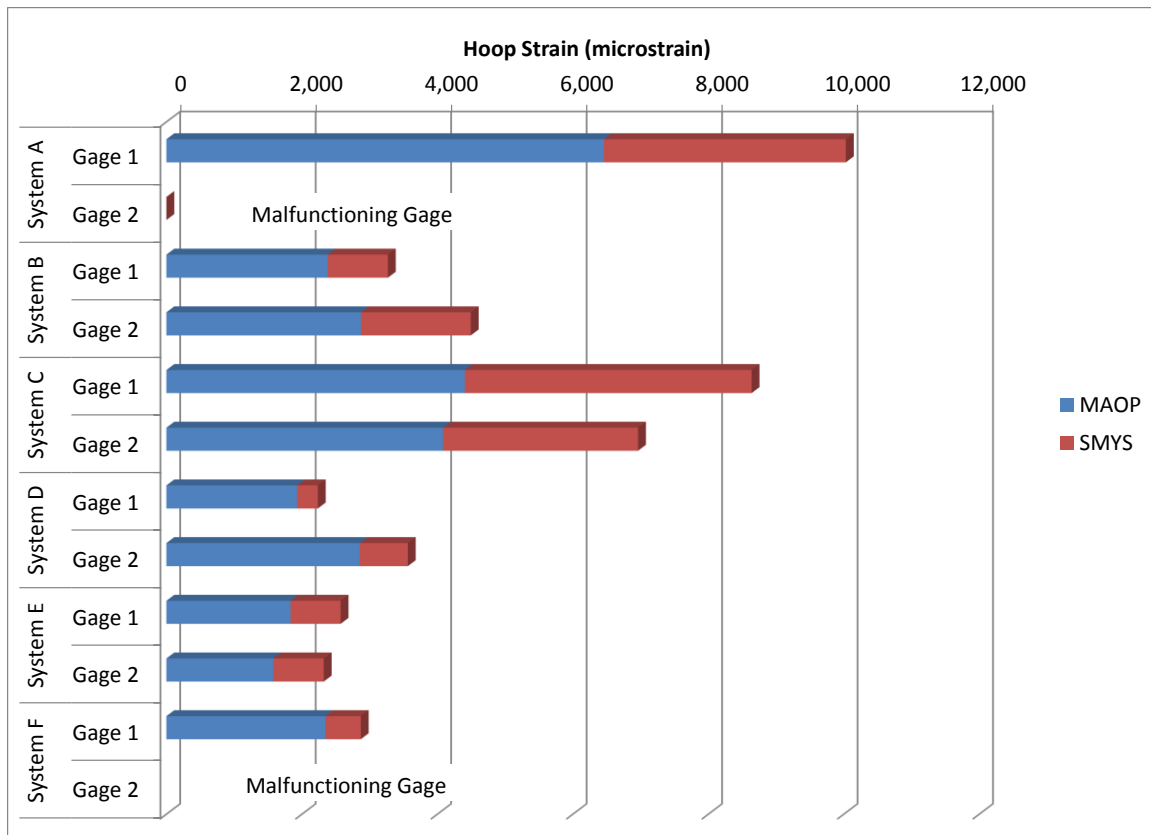
Figure 9: Hoop strain measurements for all systems during internal pressure testing

The results of the pressure test at 120 °C are shown in Figure 9. It can be seen that Systems D, E, and F were the only repairs to remain within the 0.4% strain threshold, and thus, were the three systems selected for additional testing.

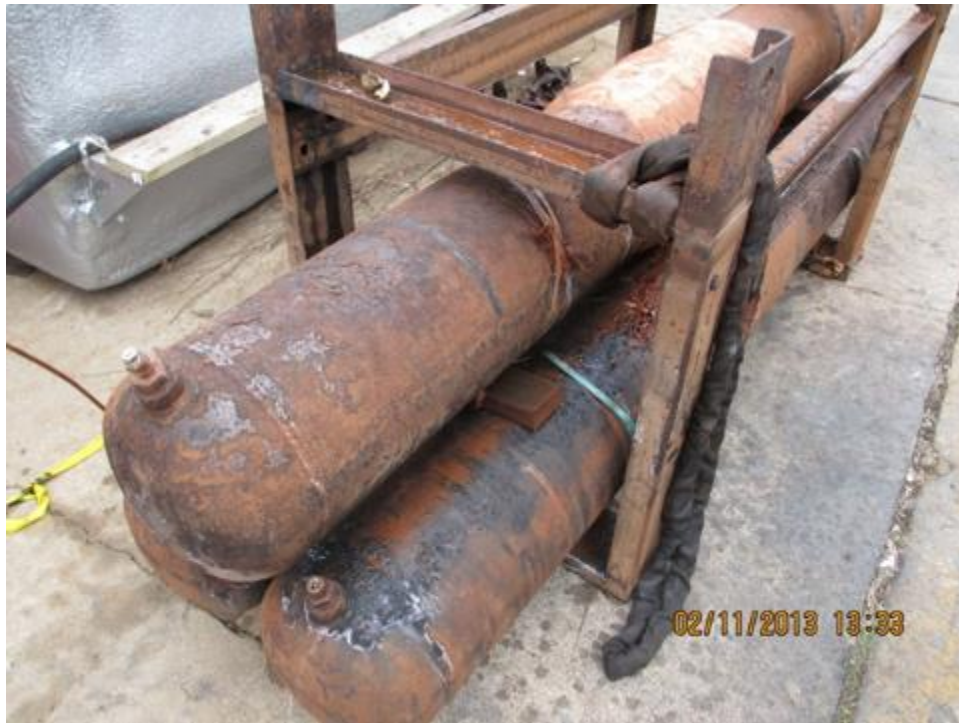
Figure 10: Samples following 1,000-hour soak at 120 °C in chlorinated water

Pressure-to-failure testing following the 1,000 hour soak showed similar failure pressures for each of the repair systems. A photograph of the samples being removed from the 1,000 hour soak is shown in Figure 10. System E exhibited the highest failure pressure with each system achieving a pressure in excess of 160% SMYS. The corresponding failure pressures are listed below in Table 1.

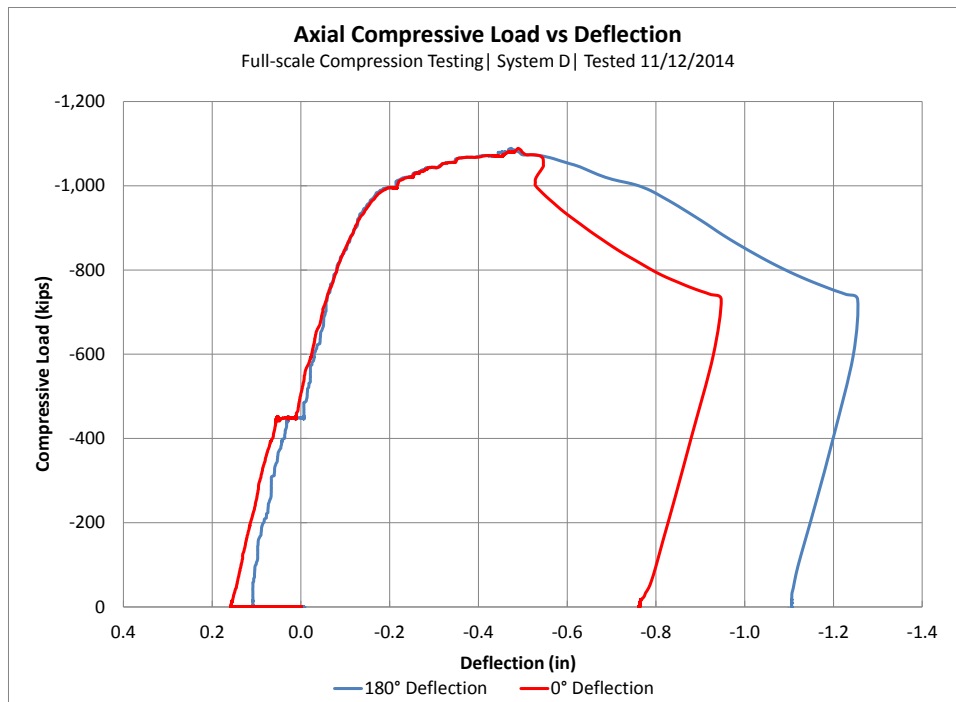
Figure 11: Full-scale compression to failure test – System D

Results of the compression testing at 120 °C showed that both of the tested systems (System D and System F) could survive the operator designated load conditions without gross short-term deformation. Analysis of the long-term life of samples under compressive loading was performed by FEA methods and is reported elsewhere [4]. Failure of the repair systems both occurred in the base pipe outside of the repair location. Plots of axial compressive load versus axial displacement for both samples are shown in Figure 11 and Figure 12.

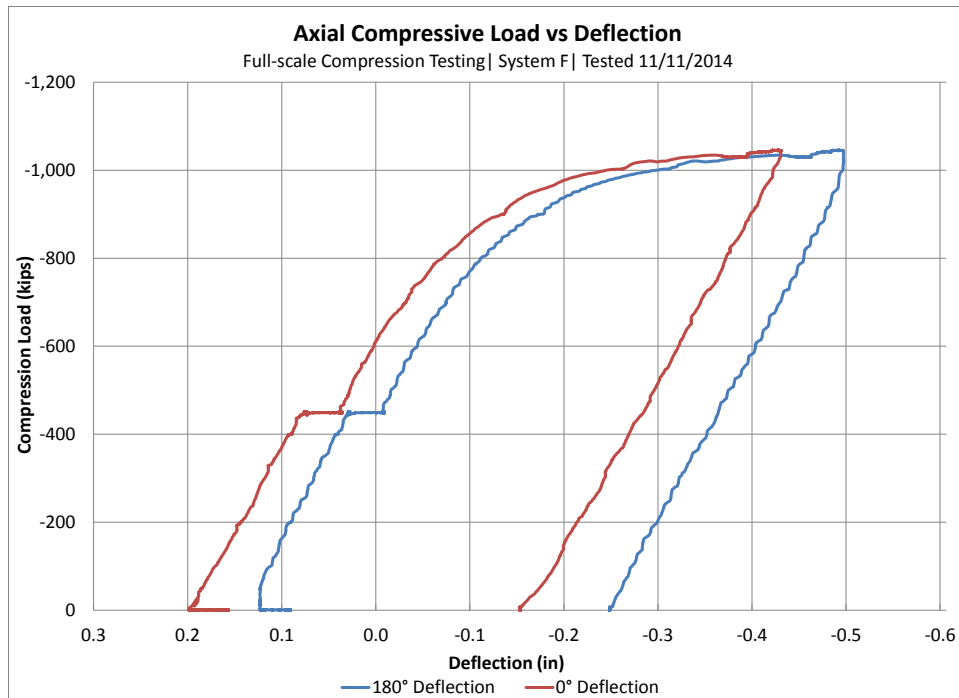
Figure 12: Full-scale compression to failure test – System F

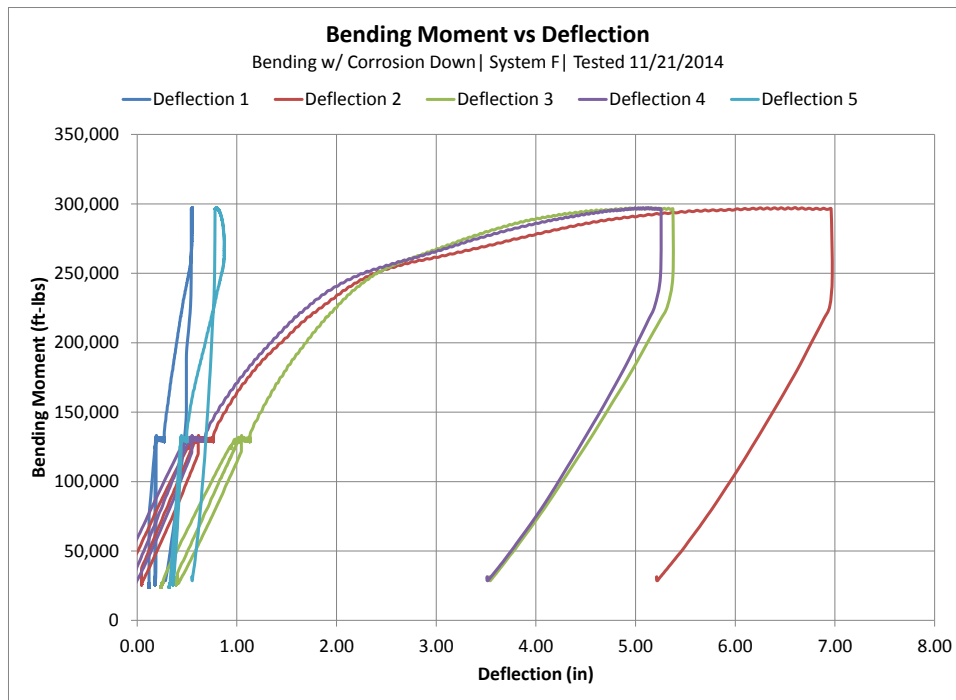
Figure 14: Full-scale bending to failure test – System F

The operator designed hold periods were successfully completed by both systems in full-scale bend testing. This result was achieved both with the simulated corrosion region in tension and in compression. As with the other tests in the program, both samples then exhibited failure loads in excess of the design load conditions. Plots of the bending moment versus deflection during bending to failure for both systems are shown in Figures 13 and 14. The maximum bending moment achieved by both systems is given in Table 3. Analysis of the long-term life of samples under bending loading was performed by FEA methods and is reported elsewhere [4].
