AN EXPERIMENTAL STUDY TO EVALUATE THE PERFORMANCE OF COMPETING FILLER MATERIALS USED WITH TYPE B AND STAND-OFF STEEL SLEEVES

Chris Alexander

Alan Beckett

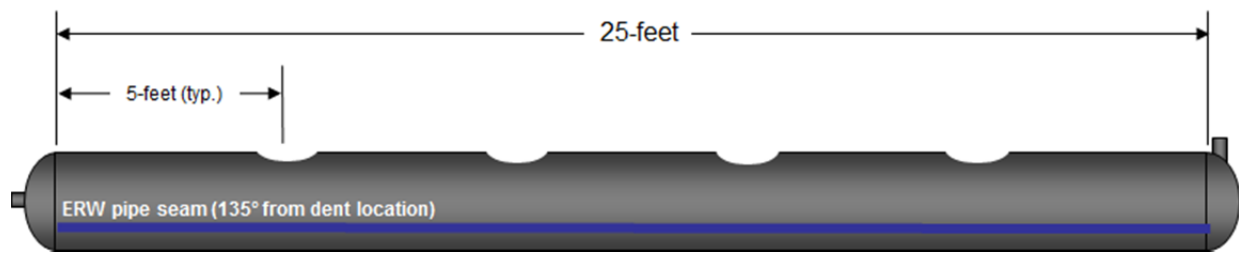
Figure 1: Sample Dent Locations

All testing was performed using 12.75-inch OD, 0.188-inch WT, Grade X42, API 5L pipe material. The test pipe section was 25 ft. long. Four dents were placed in the pipe at equally-spaced 5-ft. intervals as shown in Figure 1. The dents were installed according to the following steps:

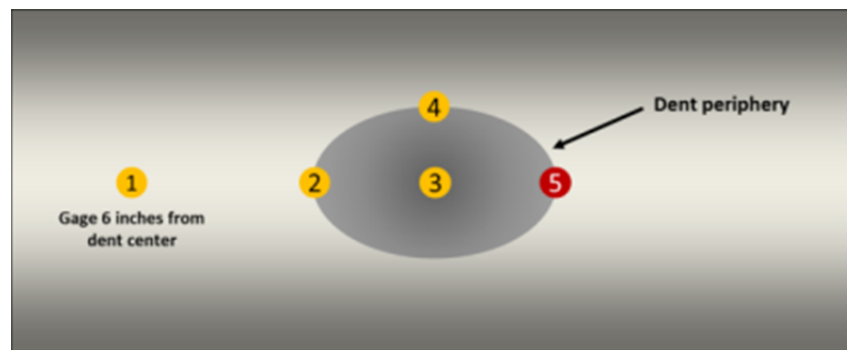
- Original strain gage location (used to measure pre-repair dent strains)
- Additional strain gage locations

Figure 2: Strain Gage Locations for each Dent

7. Install one strain gage on each dent periphery as shown in Figure 2; this is the high stress location.
8. Perform 1,000 pressure cycles on all dents with a range from 100–890 psi (8–72% SMYS).

9. Install additional strain gages on dents as shown in Figure 2.
10. Install Type B tight-fit and stand-off sleeves. The geometry of the stand-off sleeve is shown in Figure 3.

The stresses in the test pipe were compared for each of the dents during the static pressure hold. The hoop strains from Gage #1 on each dent (refer to Figure 2 for gage locations) were compared to strains in the test pipe. A plot of hoop strain vs. internal pressure is shown in Figure 12 for the regions near the dents and in the test pipe. It can be seen that the reinforced dents all showed lower hoop strains at higher pressures as a result of the reinforcement provided by the epoxy, epoxy grout, and cement grout filled sleeves.

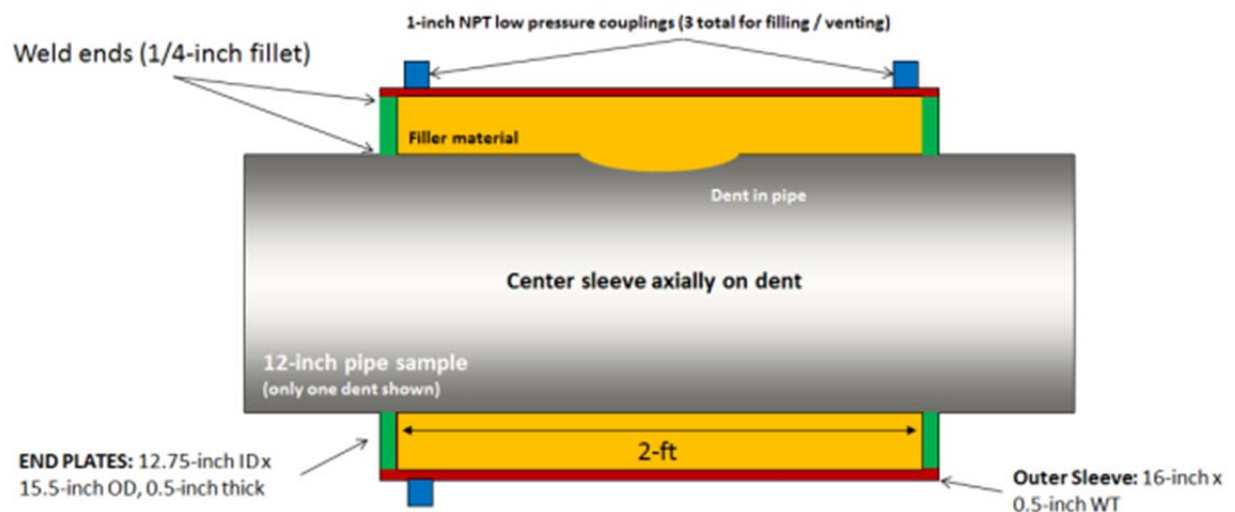
Figure 3: Stand-off Sleeve Dimensions

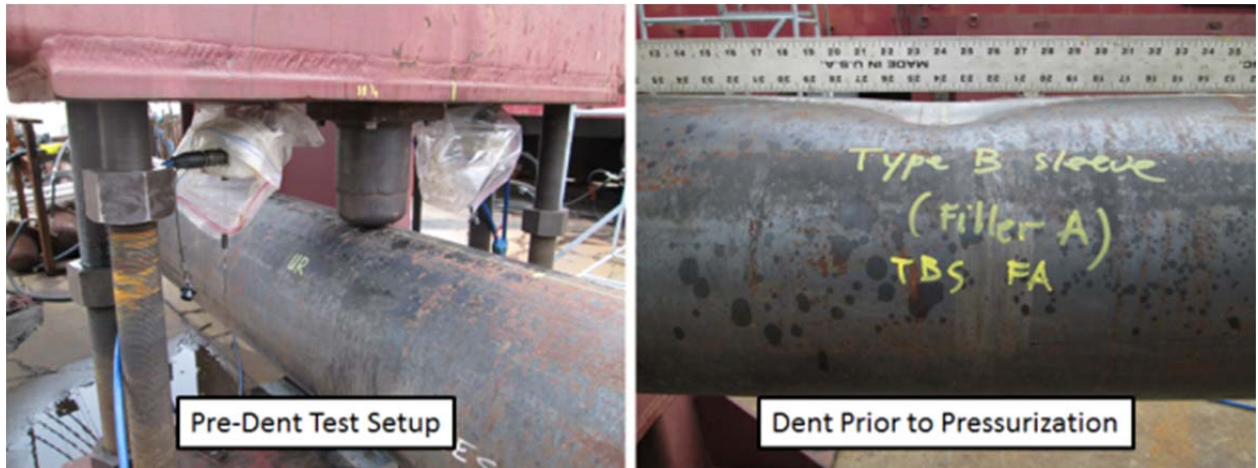
Figure 4: Dent Creation

A photograph of the indenter set-up used to create the dents is shown on the left in Figure 4. An example of a dent prior to re-pressurization (end of Step 5) is shown on the right in Figure 4. During the initial pressure cycling (Step 8), the SCF was measured for each dent using strain gages installed in the dented regions. A summary of the particulars for each dent is presented in Table 1. All dents were similar in terms of depth and SCF. All dents were located at the 12 o'clock position of the test pipe in relation to the sleeve's fill and vent ports.

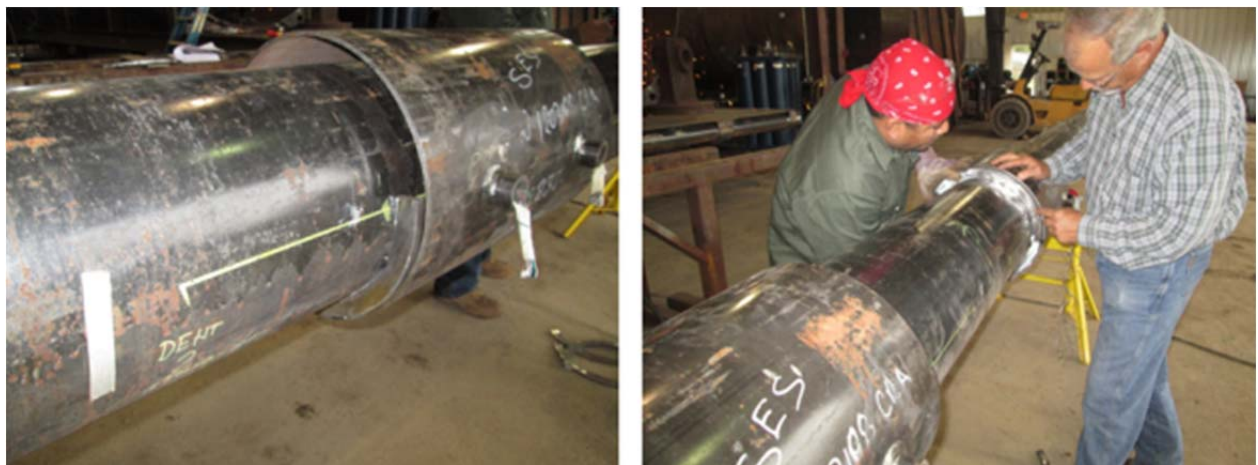
Figure 5: Stand-Off Sleeve Installation

After completion of the initial 1,000 pressure cycles, the sleeves to reinforce each dent were installed. Photographs of a typical stand-off sleeve installation are shown in Figure 5. In the case of the stand-off sleeves, the sleeve fabrication followed the design with no

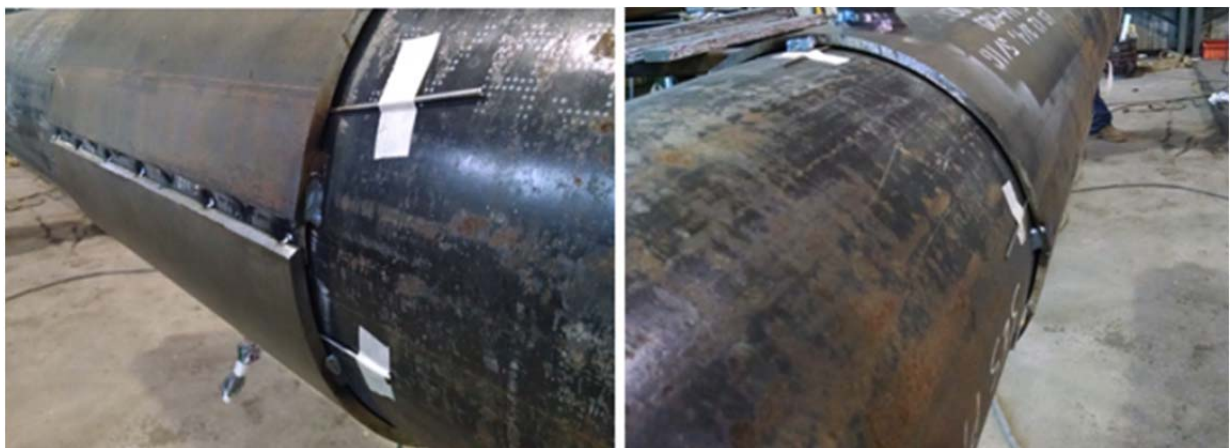
Figure 6: Type B Sleeve Installation

variation. For the Type B tight-fit sleeve, SES engineers worked with the sleeve fabricator to ensure that a small annular space was maintained between the pipe and the sleeve around the circumference of the pipe. A small gap was needed to permit full coverage of the epoxy within the sleeve and was created by using welding rods to position the sleeve off the pipe surface while it was welded into place. Photographs of the installation are shown in Figure 6. When the sleeve's longitudinal weld seam backing strips were positioned, intermittent small weld beads oriented in the circumferential direction were placed on the pipe side of the strips to preserve the annular space around the entire circumference of the pipe.

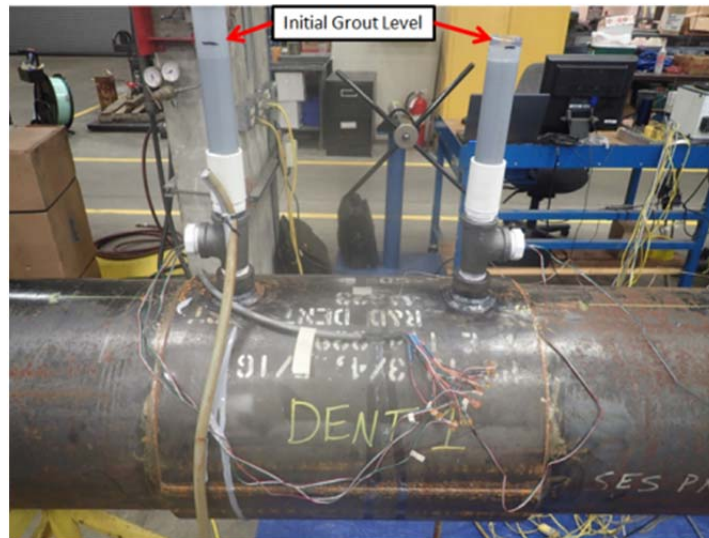
Figure 7: Dent #1, Armor Plate Epoxy Vent Lines

The filler material for Dent #1 was Armor Plate 999 2-component epoxy mixed and pumped into the sleeve annulus by representatives from Wil-Cor, Inc. A small pump was used to pump the pre-mixed epoxy through an approximately ½-inch diameter clear hose. Initially, the epoxy was pumped into the top of the sleeve. The outlet at the bottom of the sleeve was closed using the ball valve. After the sleeve annulus was initially filled, the pumping configuration was modified at the request of Alyeska such that the epoxy was pumped into the bottom of the sleeve with the top fill/vents open. The epoxy was pumped through the bottom until it was forced out of the vent tubes as shown in Figure 7. As can be seen in Figure 7, some settlement of the epoxy was noted during curing throughout the day as the epoxy level in the top of sleeve vent tubes decreased.

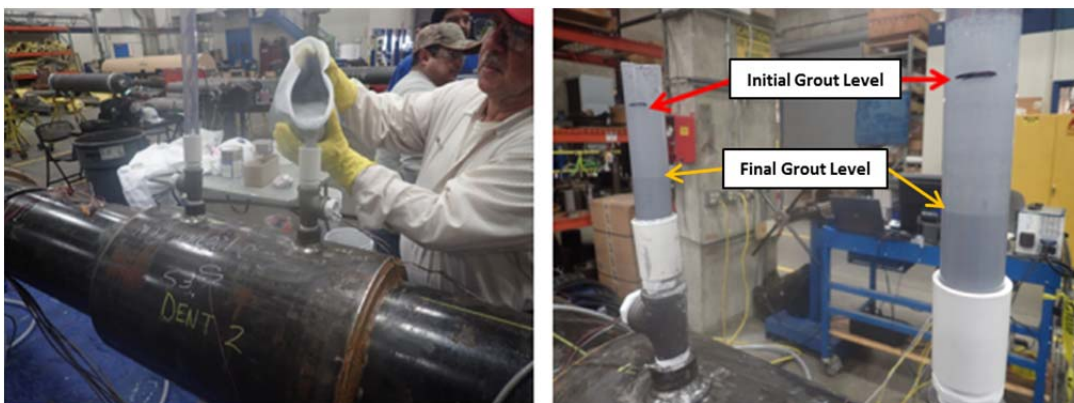
Figure 8: Dent #2, Armor Plate Epoxy Grout Installation

The filler material for Dent #2 was installed by pouring pre-mixed Armor Plate 999 epoxy grout into the stand-off sleeve through the fill/vent tubes at the top as shown in Figure 8. The mixing of the three components and pouring of the epoxy grout was performed by Wil-Cor representatives. After the filling process was completed, the valve at the bottom of the sleeve was opened. When the valve was opened, the epoxy grout was observed to readily flow out of the sleeve. In addition, the level of epoxy grout between the two vent lines was observed to equalize over time as shown in Figure 8. Similar to Dent #1, some settlement of the epoxy grout during curing was noted in Dent #2 throughout the day. Approximately 2 in³ of contraction of the filler material was observed in the vent tubes in Figure 8, which corresponds to approximately 0.14% of the total sleeve annulus volume.

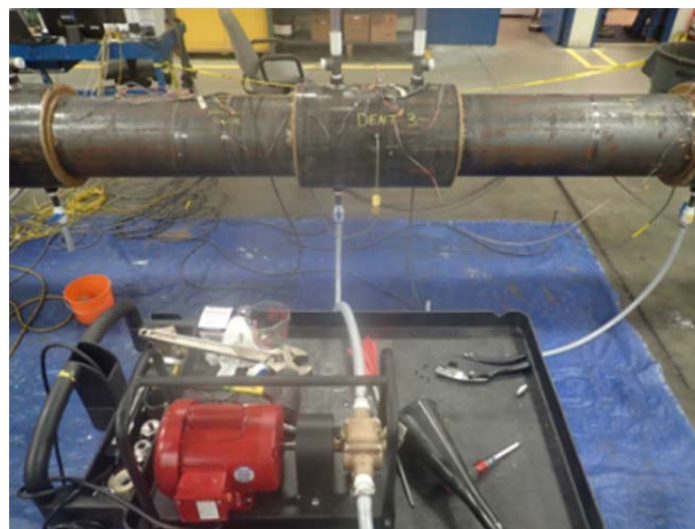
Figure 9: Dent #3, Five Star FLUID GROUT 100 Installation

The stand-off sleeve for Dent #3 was filled with Five Star FLUID GROUT 100. The usage instructions for the non-shrink cement-based grout recommended water contents between 4 and 6 quarts per 55 lb. bag. Higher water contents increase the flowability of the grout, but decrease the compressive strength. After discussions with Alyeska, it was decided to prepare the grout with 6 quarts of water. The grout was installed by SES technicians using a pump and a 1.25-inch diameter hose as shown in Figure 9. The fluid grout was pumped through the bottom port of the sleeve until it was pushed out through the vent lines at the top of the sleeve.

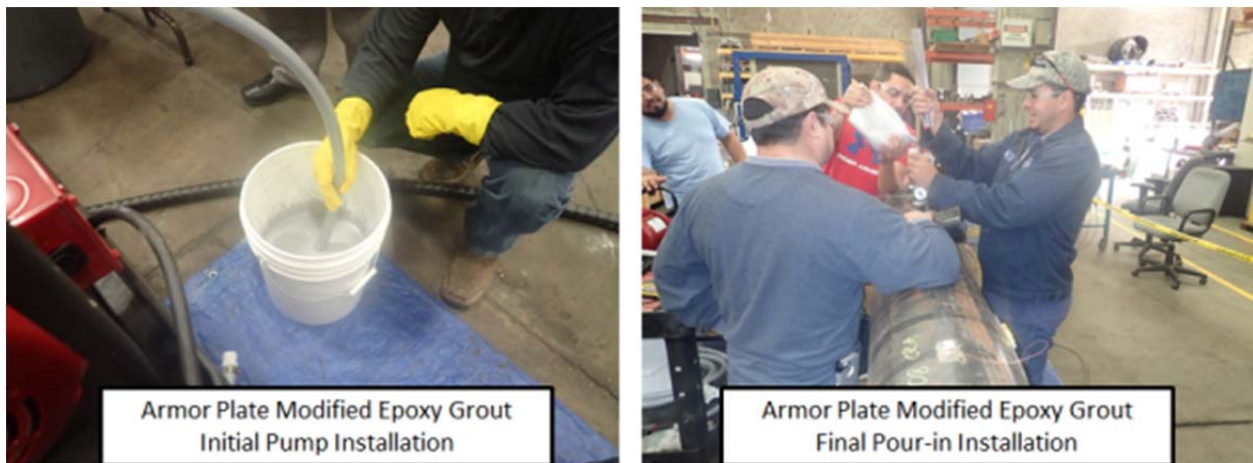
Figure 10: Dent #4, Armor Plate Modified Mix Ratio Epoxy Grout Installation

The stand-off sleeve for Dent #4 was initially attempted to be filled with a two-component epoxy filler material provided by another pipeline repair products supplier. However, the epoxy was found to be too viscous and cured too quickly to be pumped into the sleeve, and the filling attempt was unsuccessful. Consequently, the stand-off sleeve for Dent #4 was filled with a modified mix ratio of Armor Plate 999 epoxy grout, which consisted of a standard mix ratio of components Part A (resin) and Part B (catalyst) along with a reduced mix ratio of component Part C (inert aggregate filler, i.e., Cabosil¹). The modified epoxy grout mixture used approximately one-half of the Part C component material recommended for a typical application of 1-part mixed epoxy to 1-part inert aggregate. Initially, the modified epoxy grout was pumped into the bottom fill port of the sleeve by the same pump used for the cement-based grout as shown in Figure 10. However, the higher exothermic heat generated from the modified mix ratio epoxy grout destroyed the pump; the filling had to be completed by pouring the epoxy grout into the sleeve through the top fill/vent port lines as shown in Figure 10. The pumping and pouring of the epoxy grout for Dent #4 was completed by Wil-Cor representatives with some assistance from SES technicians.

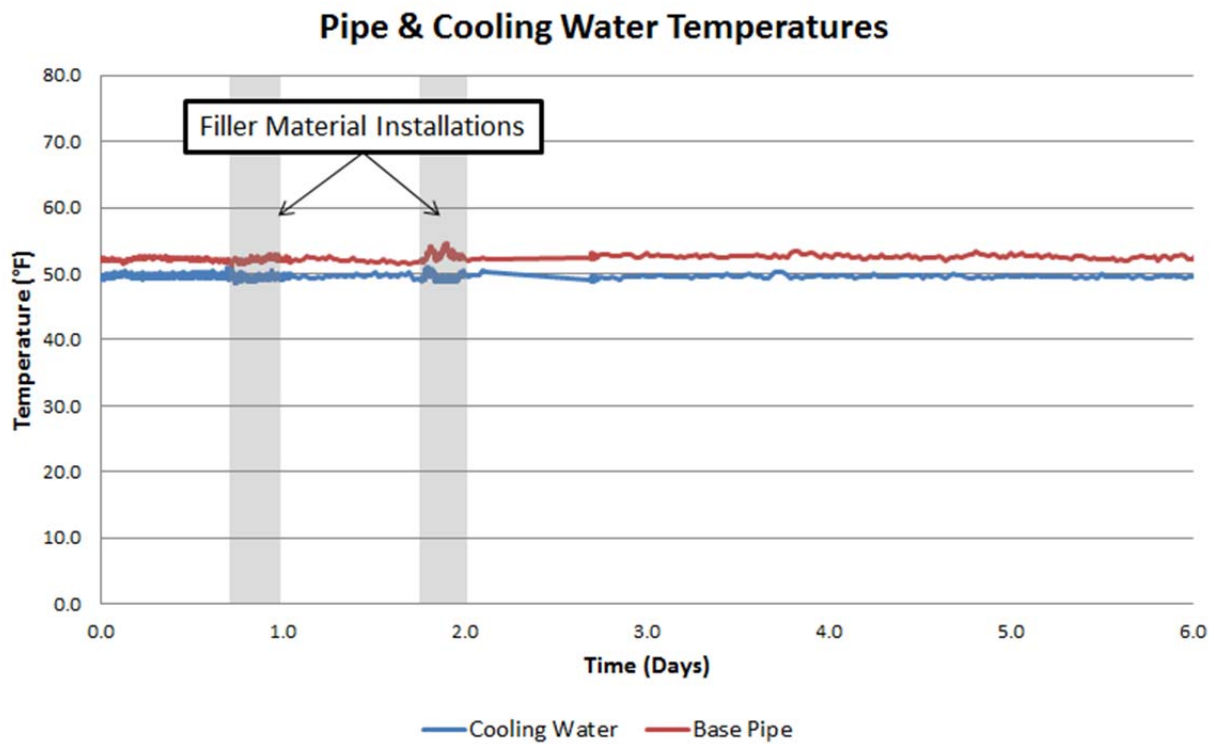
Figure 11: Cooling Water and Base Pipe Temperatures

A plot of the cooling-water temperature and pipe temperature for the duration of the chilling, filler material filling, and curing processes is shown in Figure 11. It can be seen that the pipe temperature was maintained below 55°F for the duration of filling all the sleeves. The intent was to achieve a pipe temperature 55°F, so a lower temperature was required in the water. The filler materials were installed on two days, and these time periods are noted in Figure 11. The filler materials in Dents #1–#3 were installed near the end of the first day, while the filler material for Dent #4 was installed near the end of the second day.

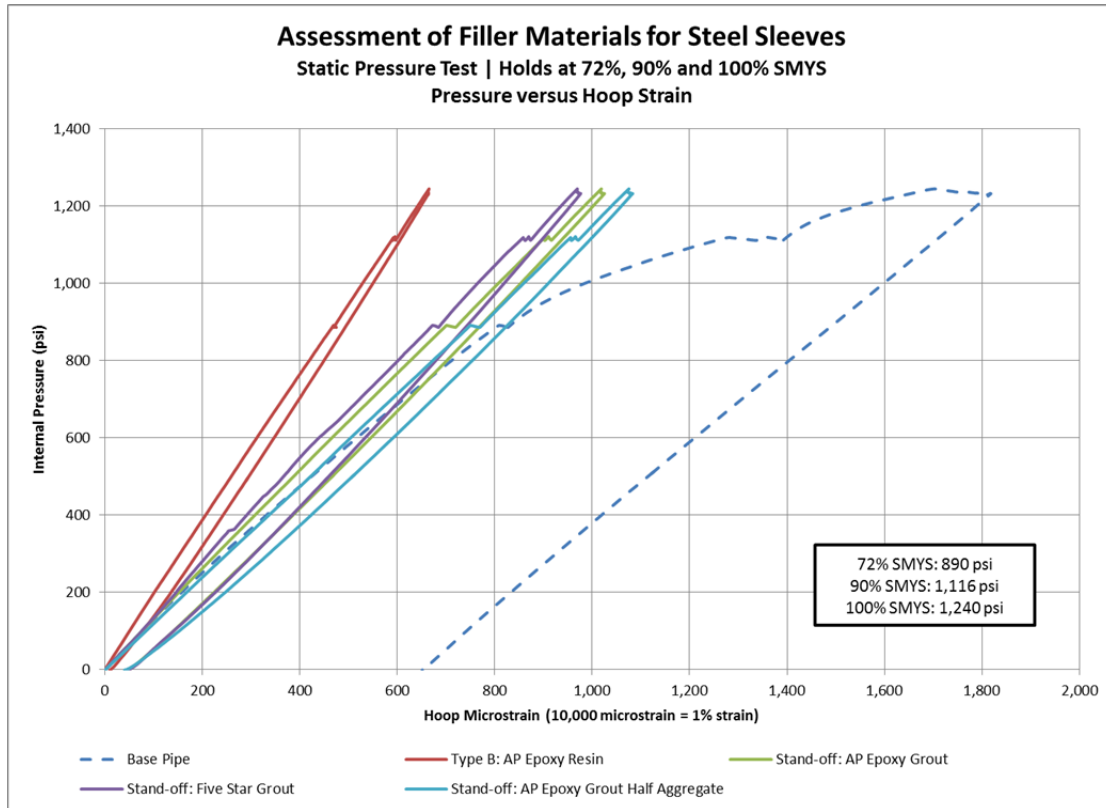
Figure 12: Hoop Strains during Post-Sleeve Static Pressure Test

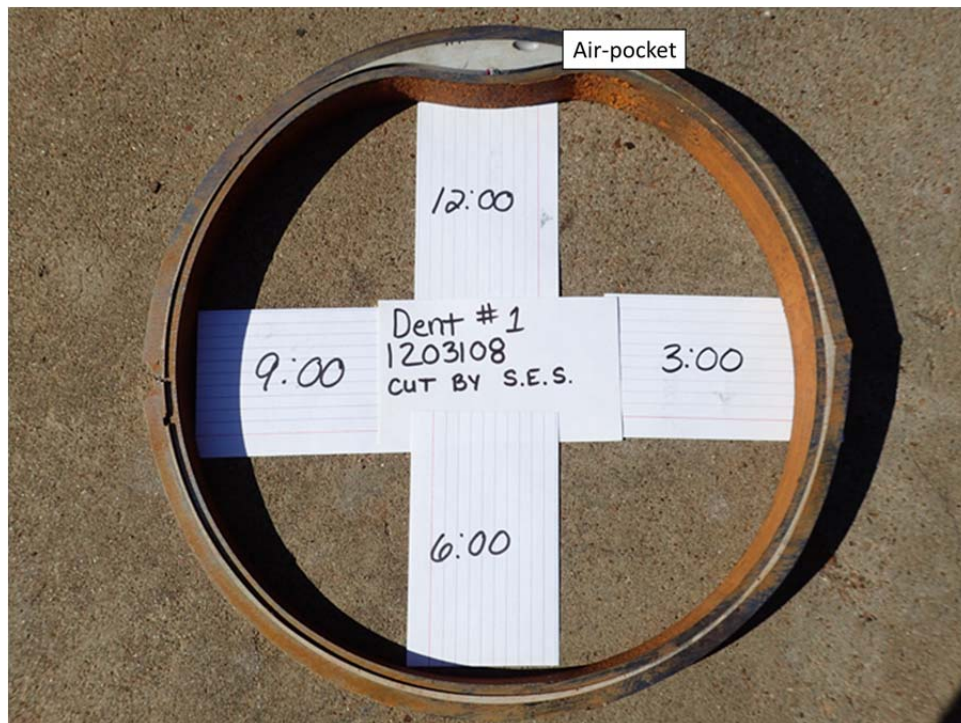
Figure 13: Dent #1 Cross-Section (Type B, AP Epoxy)

A photograph of the cross-section from Dent #1 is shown in Figure 13. The epoxy appeared to completely fill the annular space between the pipe and the Type B tight-fit sleeve around the entire circumference of the test pipe (despite the small annular space). One small air pocket was observed in the cross-section at the 12 o'clock position where the dent was located.

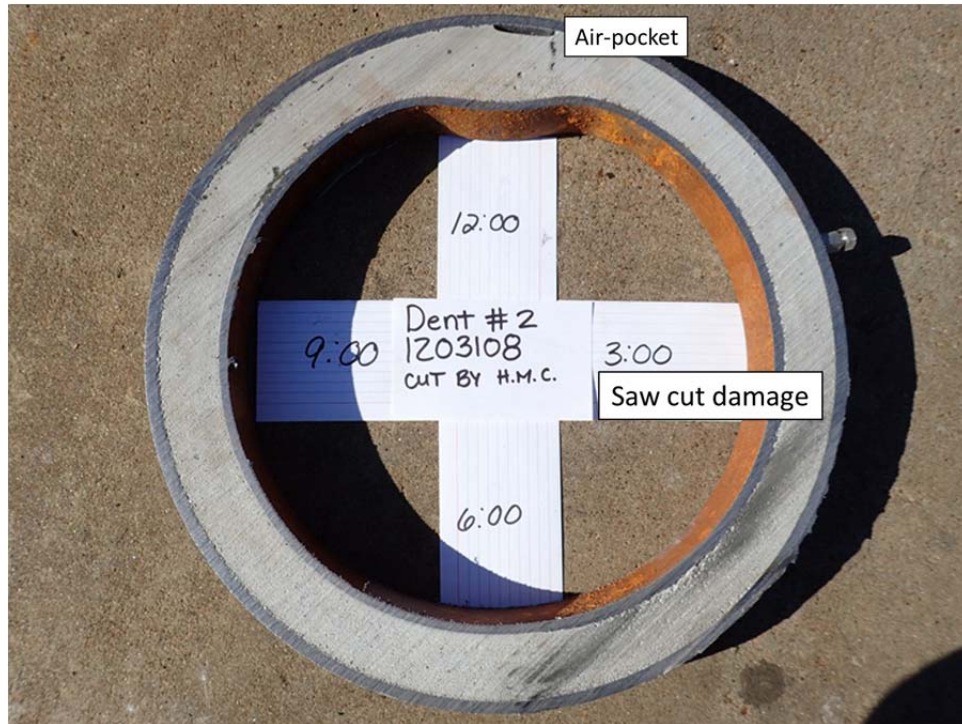
Figure 14: Dent #2 Cross-Section (Stand-off, AP Epoxy Grout)

A photograph of the cross-section from Dent #2 is shown in Figure 14. The epoxy grout filled the total annular space between the stand-off sleeve and the pipe. However, one air pocket was observed in the grout at the 12 o'clock position where the dent was located. This air pocket ran through the cross-section. The epoxy grout

material did not appear to be compromised near the region of the dent.

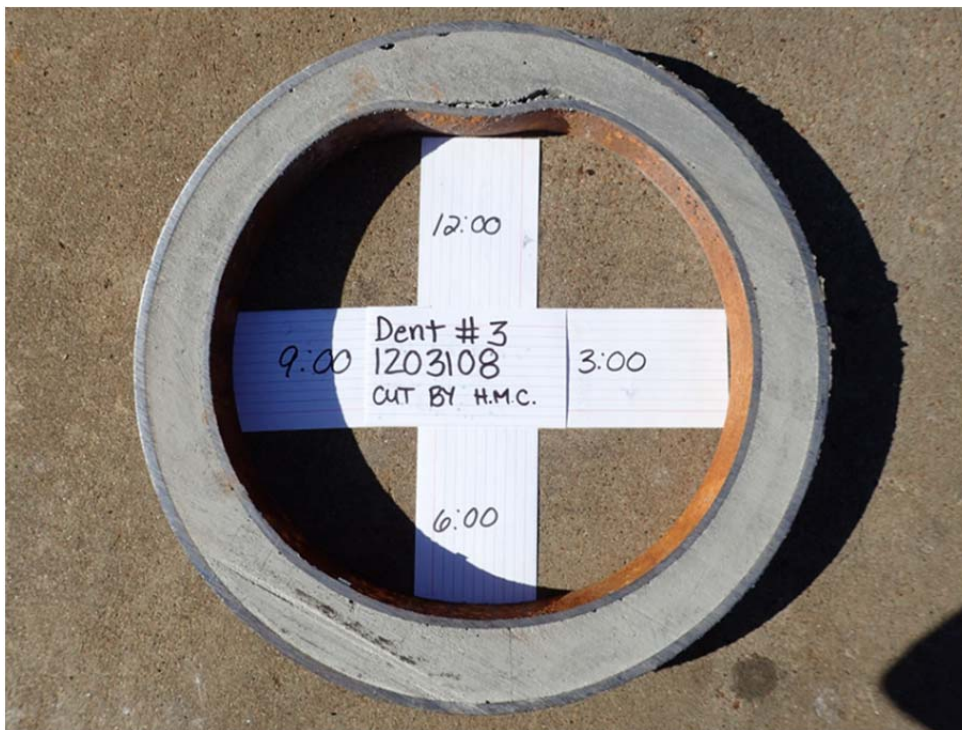
Figure 15: Dent #3 Cross-Section (Five Star FLUID GROUT 100)

A photograph of the cross-section from Dent #3 is shown in Figure 15. The cement grout filled the annular space between the stand-off sleeve and the pipe. A few small air pockets were observed near the top of the sleeve where the dent was located, although they were minimal in size when compared to the air pockets observed in the other three sleeves. It should be pointed out that the cement grout adjacent to the dent was damaged during the saw cutting process to remove the cross-section ring from the sleeve. This damage, which can be seen in Figure 15, was not believed to be a result of the pressure-cycling process. The cement grout material in the other regions of the annular space was in good condition without any observed separations.

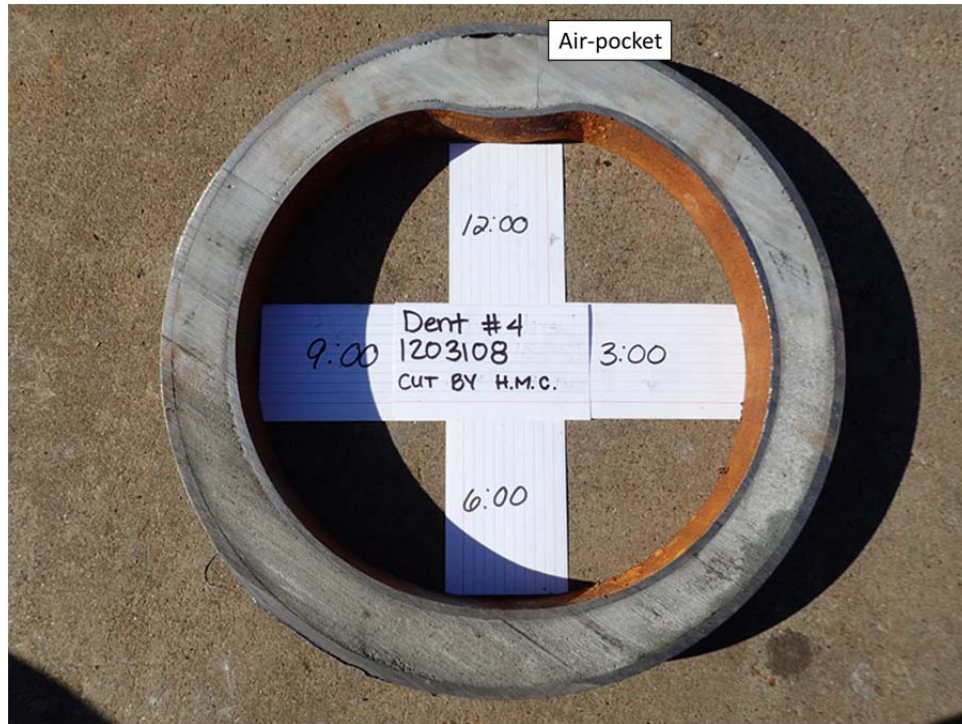
Figure 16: Dent #4 Cross-Section (AP Modified Mix Ratio Epoxy Grout)

A photograph of the cross-section from Dent #4 is shown in Figure 16. The modified mix ratio epoxy grout filled the annular space between the stand-off sleeve and the pipe. However, one air pocket was observed in the grout at the 12 o'clock position where the dent was located. This air pocket ran through the cross-section, and was similar to the air pocket observed in the Dent #2. It was also observed that the inert aggregate material in Dent #4 appeared to segregate and settle more toward the bottom of the sleeve. Photographs showing this segregation are provided in Figure 17. The photographs show the separation that appears at the 3 and 9 o'clock positions in Dent #4.

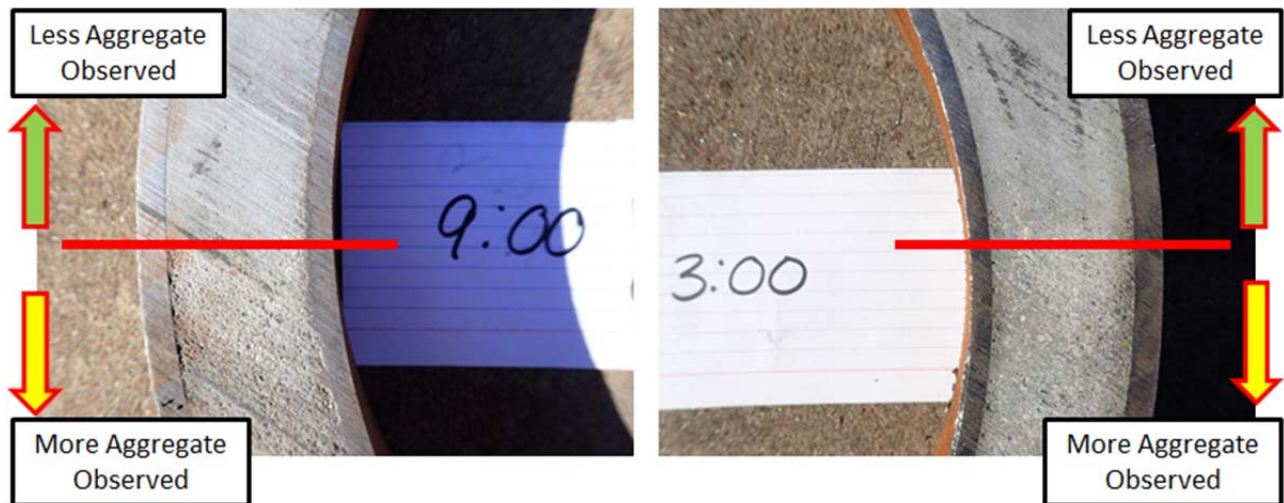
Figure 17: Aggregate Settlement in Dent #4 (AP Modified Mix Ratio Epoxy Grout)

As described previously, once cycling was complete, circumferential cross-sections were cut from the sleeves at the dent locations and examined to determine how well the filler materials filled the annular space and whether any degradation of the filler materials had occurred. The examination of the cross-sections did not appear to show any degradation of the filler materials after being subjected to 25,000 pressure cycles. The epoxy was able to fill the tight annulus within the Type B tight-fit sleeve. Some air pockets were observed in the stand-off sleeves filled with the epoxy grout, but these air pockets did not appear to affect the performance of the epoxy grout materials. In addition, the modified mix ratio epoxy grout also appeared to show some settlement of the aggregates into the lower half of the sleeve annulus.
