IPC2016-64211

EXPERIMENTAL STUDY OF ELEVATED TEMPERATURE COMPOSITE REPAIR MATERIALS TO GUIDE INTEGRITY DECISIONS

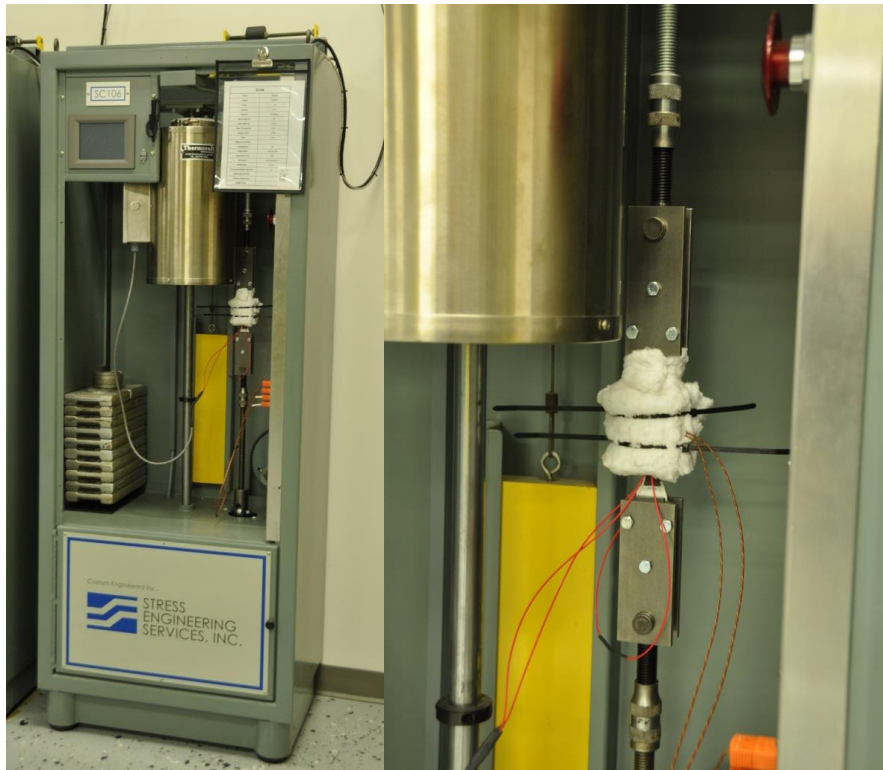
Figure 1: M3 Creep Frame / Loaded creep-rupture sample

All tests were conducted using Satec M3 lever-arm load frames with a maximum load capacity of 6,000 lbs on each sample (Figure 1). The load is generated by hanging steel weights from a lever arm with a 16:1 multiplication factor. The maximum load limit determined the gauge width required for the samples, as full 1-inch specimens of System D and System E would have required loads far exceeding the machine's capabilities.

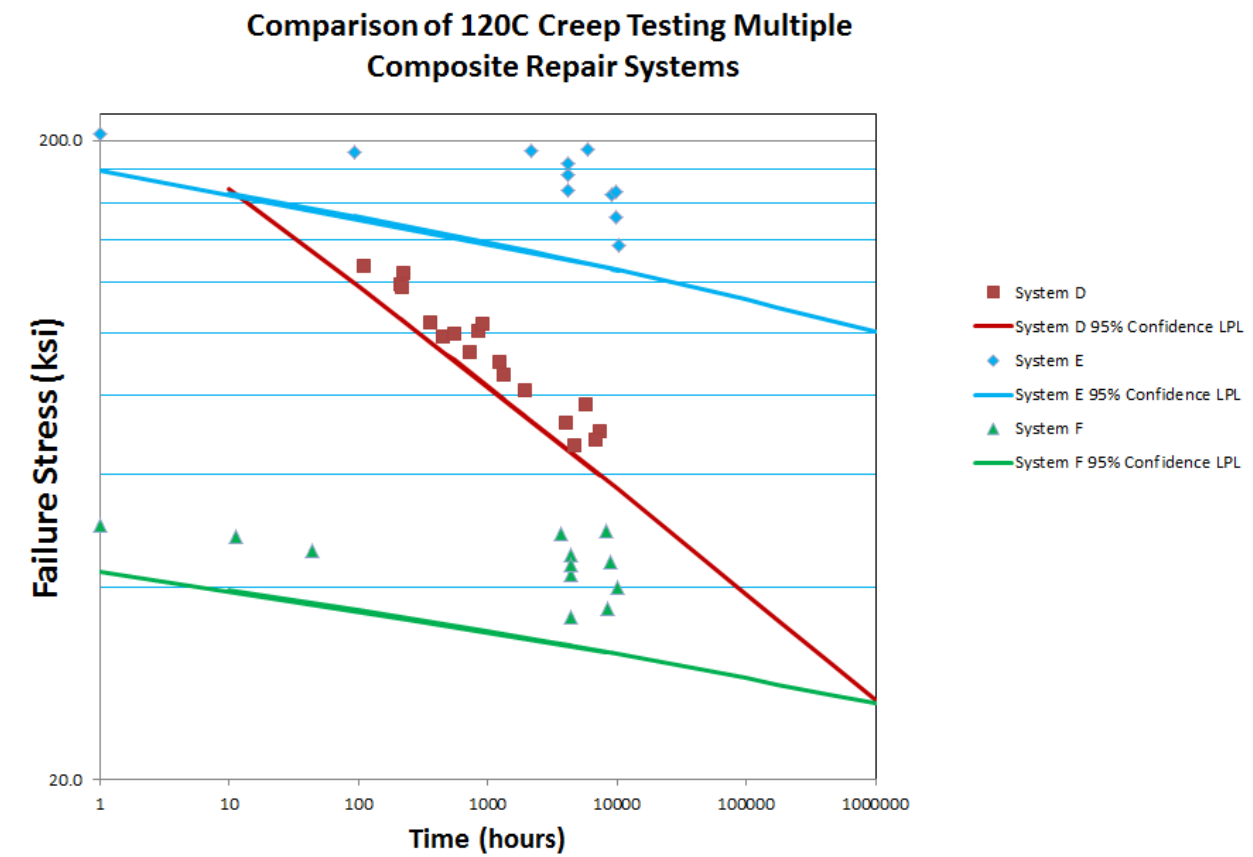
Figure 3B: Creep rupture results

System D was the only system that was able to achieve the required failure times to complete the D2992 test requirements. Creep-rupture results and corresponding 95% confidence curves are shown in

Figure 3B. It is noteworthy that System D showed a significantly higher regression slope than the other systems. This is surprising because it is a carbon-fiber system and the industry standard expectation is that carbon-fiber composites will not exhibit significant loss of strength in creep. Figure 3B summarizes the results of the System D creep-rupture testing. A photograph of a post-failure sample is shown in Figure 4.

System E exhibited the highest moduli and ultimate stresses of all the tested systems. The samples exhibited exceptional creep-rupture performance as indicated in Figure 3B. A photograph of a post-failure sample is shown in Figure 5.

System F exhibited good creep-rupture performance as indicated in Figure 3B. Most samples became “run-outs,” and were shut down after 10,000 hours. Some poorly performing plates of material were discovered that failed at loads of only 65% of the ultimate tensile strength (as measured by previous tensile testing). It is believed that these plates of material comprised lower resin content than the other sheets, as they exhibited unusual delamination of the entire gauge length face upon failure (Figure 6). Replacement sheets of material were provided by the manufacturer and these unusual failures were not observed with the new samples. A photograph of a post-failure sample is shown in Figure 7.

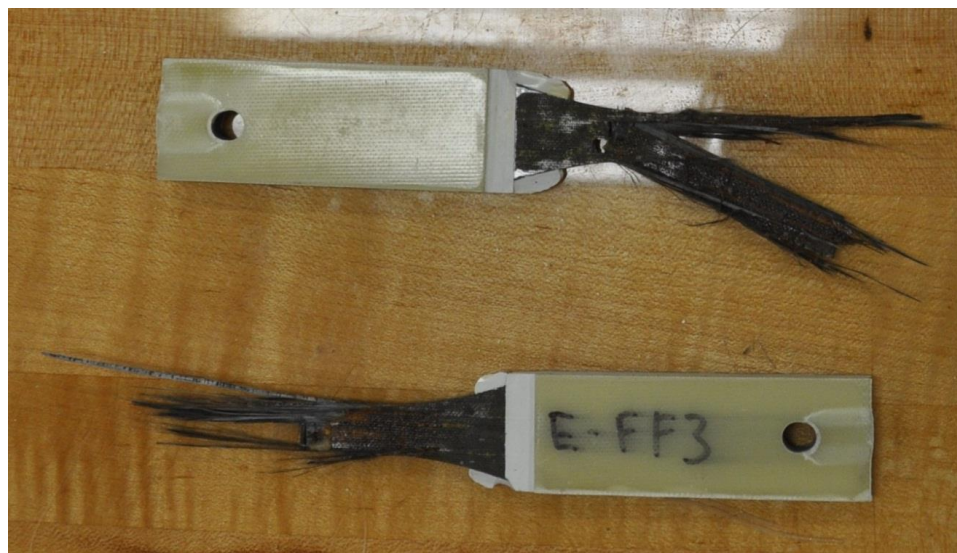
Figure 4: System D creep-rupture specimen – post failure

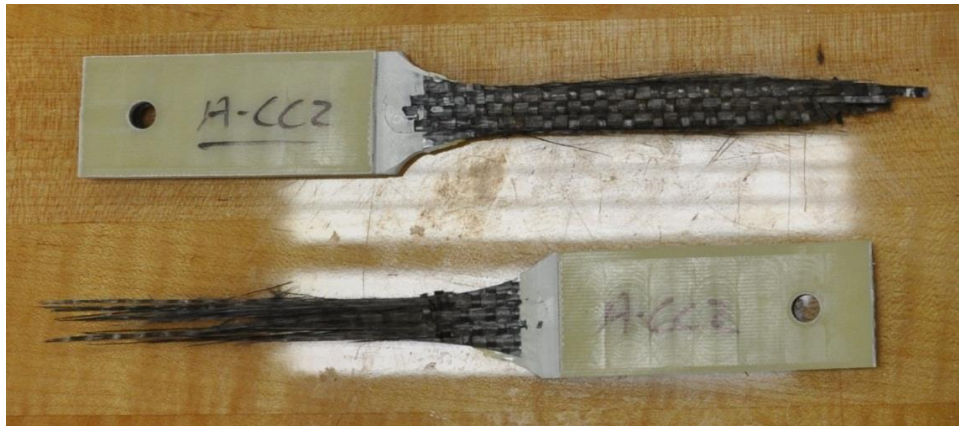
Figure 5: System E creep-rupture specimen – post failure

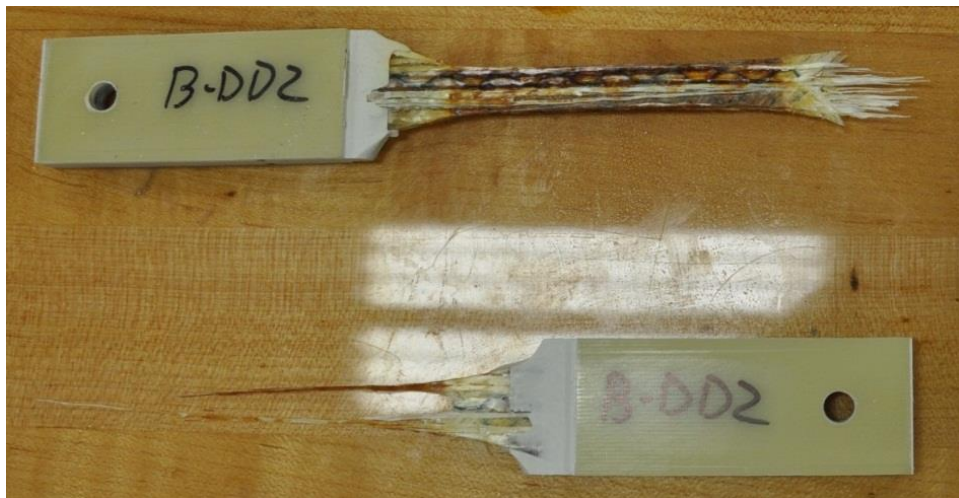
Figure 7: System F creep-rupture – post-failure
