IPC2016-64082

REINFORCEMENT OF PLANAR DEFECTS IN LOW-FREQUENCY ERW LONG SEAMS USING COMPOSITE REINFORCING MATERIALS

Stress Engineering Services, Inc.
Houston, Texas

Boardwalk Pipeline Partners, LP
Houston, Texas

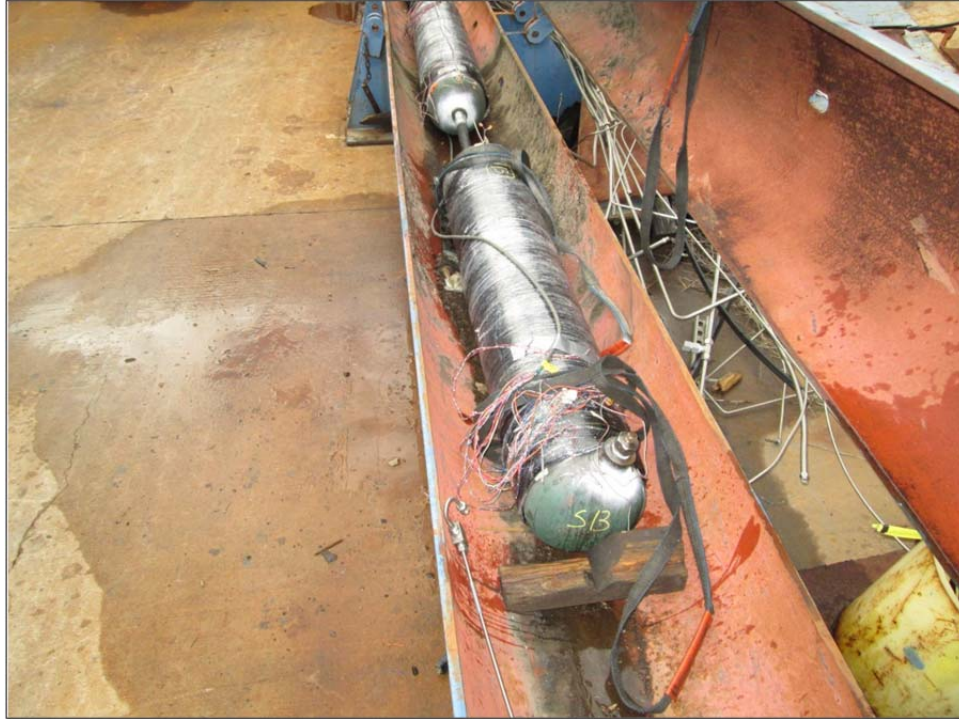
Figure 4: Milliken-Pipe Wrap Atlas System – as Repaired and Set up for Testing

The repair systems were installed at Stress Engineering Services Inc.'s (SES) test facility located in Houston, Texas. The composite repair installations were performed by each respective manufacturer. Prior to installation of the repair systems, the pipe samples were sandblasted to a near-white metal (NACE 2). A photograph of the Atlas system prior to testing is shown in Figure 4. The Atlas system uses a carbon-fiber fabric with a field-impregnated epoxy resin matrix. Photographs showing installation of the ComposiSleeve system are given in Figure 5 and Figure 6. This particular system employs two half-shells that are adhered to the pipe using a high-strength acrylic and overwrapped with a water-activated pre-impregnated E-glass/urethane composite system.

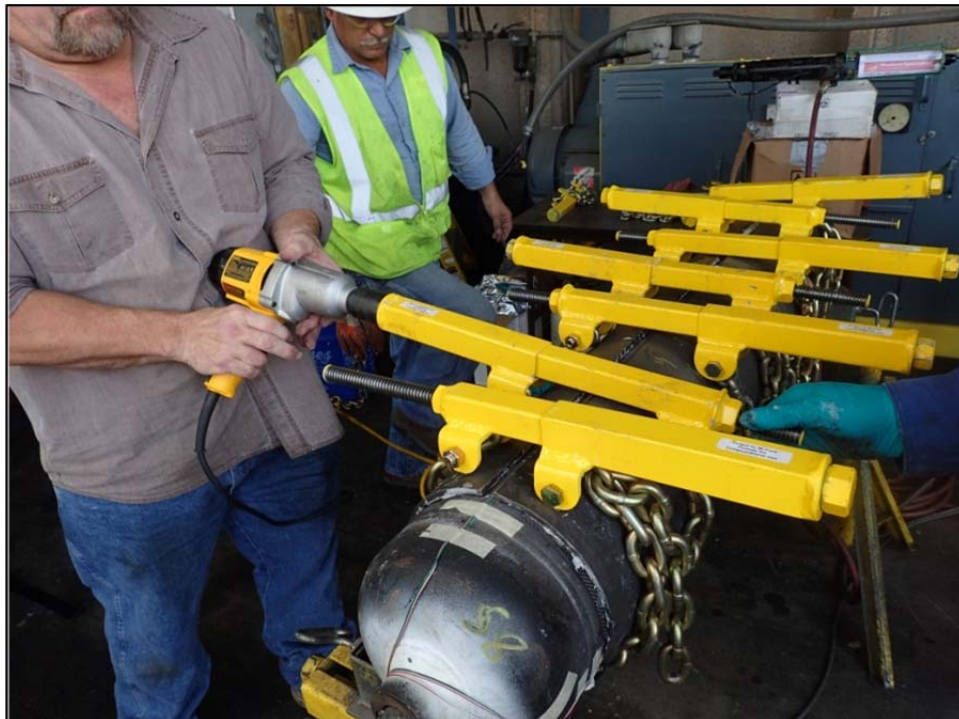
Figure 5: Installation of the Western Specialties ComposiSleeve

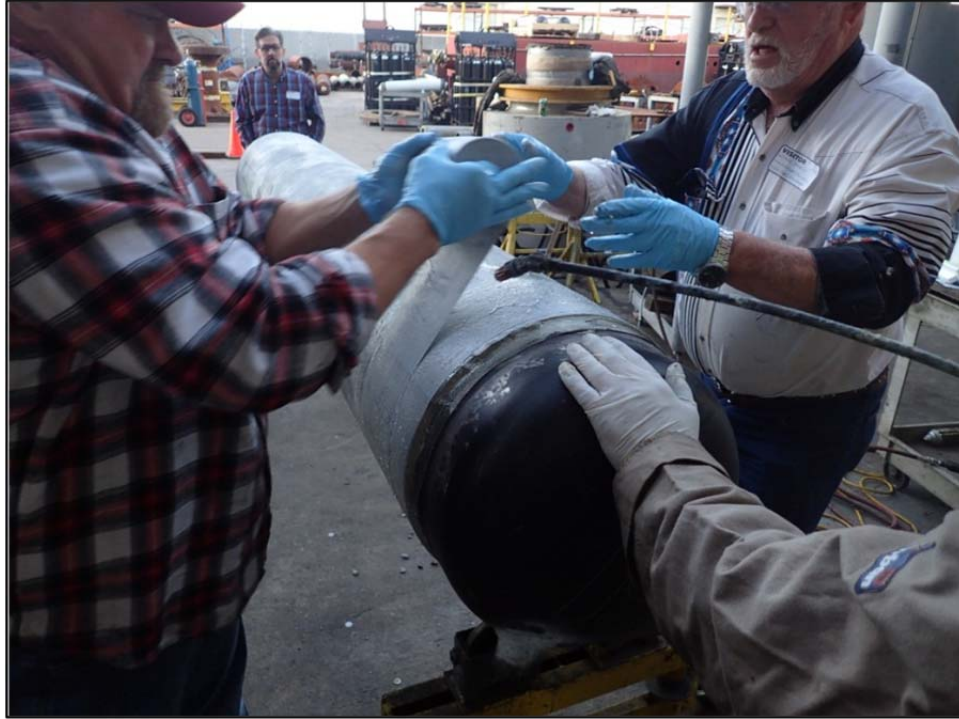
Figure 6: Installation of the Western Specialties ComposiSleeve System

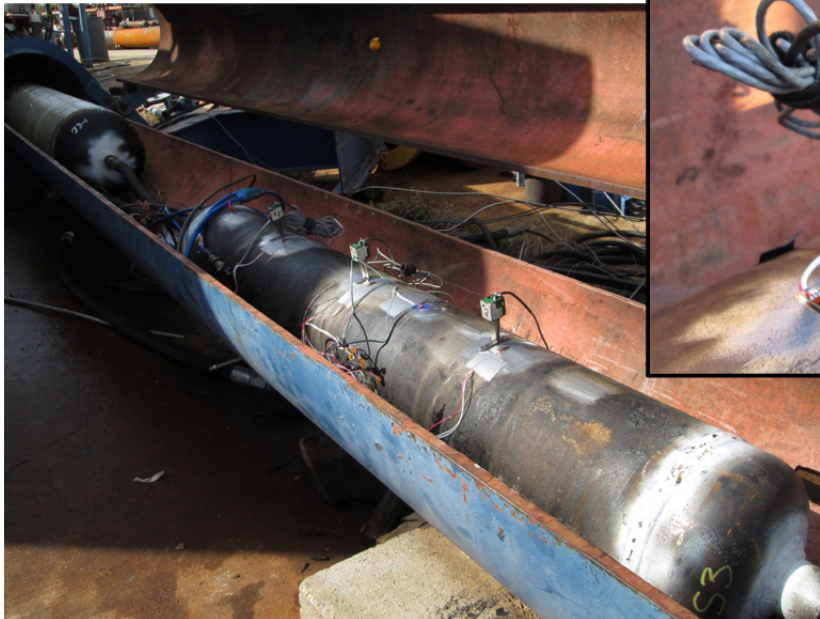
Figure 7: Photograph of Clip Gages on Unreinforced Samples

During pressure testing, strain gages and clip gages were used to monitor stresses in the pipes and crack growth in the EDM notches, respectively. Clip gages specifically measured notch growth during cycling and were only installed on the unreinforced samples. Strain gages were able to be installed both on unreinforced and reinforced samples (i.e., the strain gages could be installed beneath some of the repairs). Photographs showing clip gages installed on an unrepaired sample are given in Figure 7. A strain gage installed over an EDM notch is shown in Figure 8; the gage is shown as installed with the ComposiSleeve repair where washers were installed to prevent the gages from being crushed during installation of the steel half-shells. It should be noted that the wire mesh shown in Figure 8 is specific to ComposiSleeve repairs.

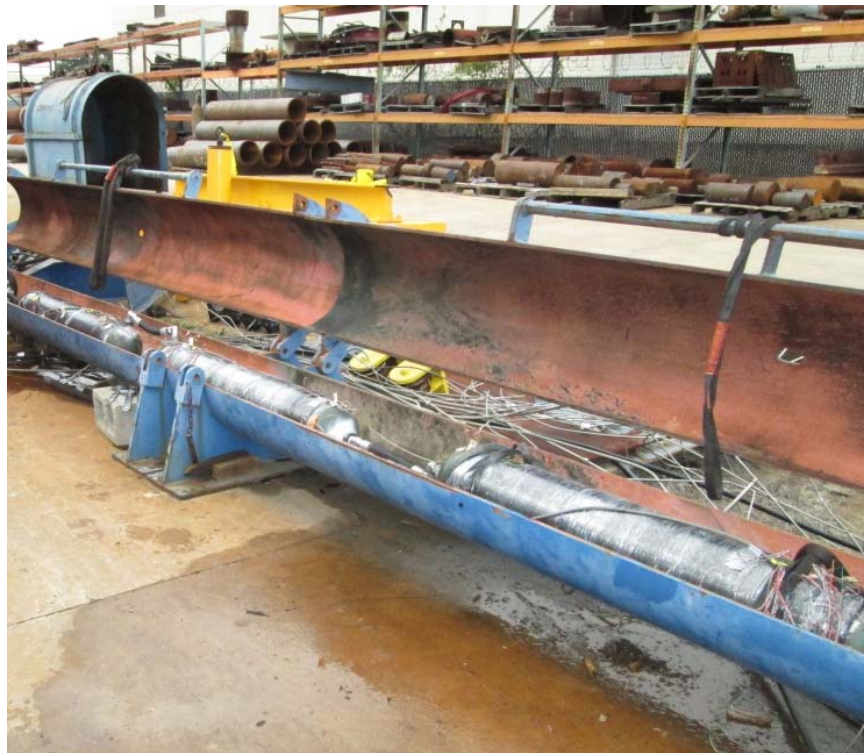
Figure 9: Photograph of Pipe Samples Installed for Pressure Cycling

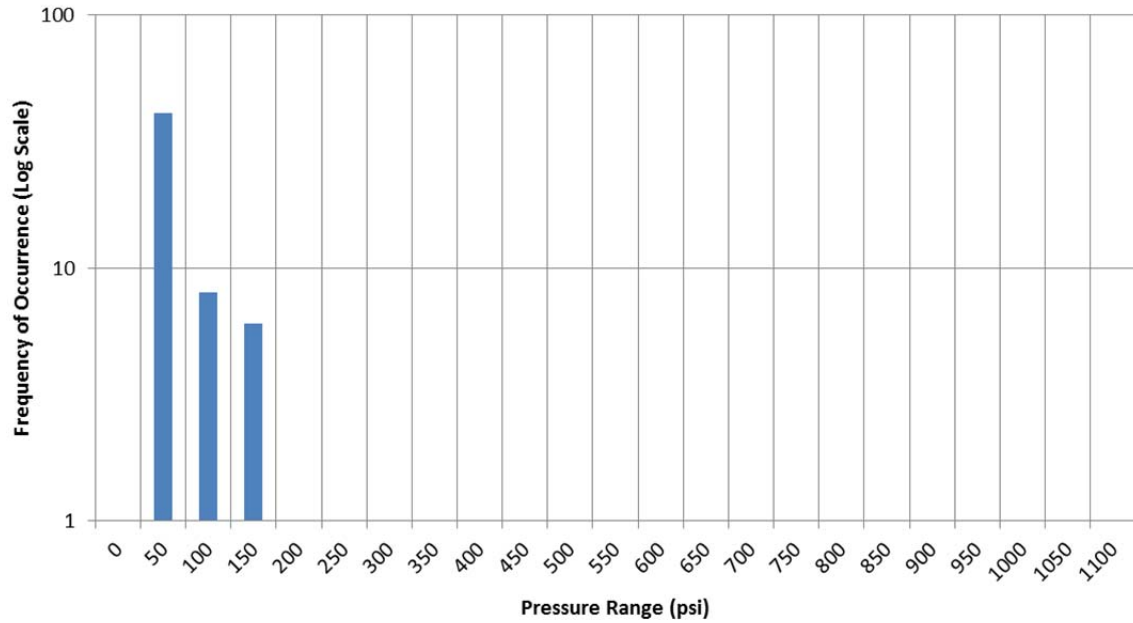
Figure 10: Histogram of Pressure Cycle Data (390 days of data collected)

Pressure data were provided for the pipeline for approximately 390 days. A rainflow count of the data was completed to assess the number of cycles experienced by this particular pipeline. Plotted in Figure 10 is a histogram showing the results for the pressure data. As observed, this particular pipeline experiences minimal pressure cycling. Using Miner's Rule to develop a single equivalent cycle number for a pressure range of 202–1,460 psi (1.39 MPa to 10.07 MPa) (10% to 72% SMYS) for the given data, the result is 0.52 cycles per year. Using this relation, the 3,500 cycles applied to the 16-inch (400-mm) test samples corresponds to 6,736 years of service (i.e. 3,500 cycles / 0.52 cycles per year). From these data one can conclude that this particular pipeline system experiences minimal pressure cycling.

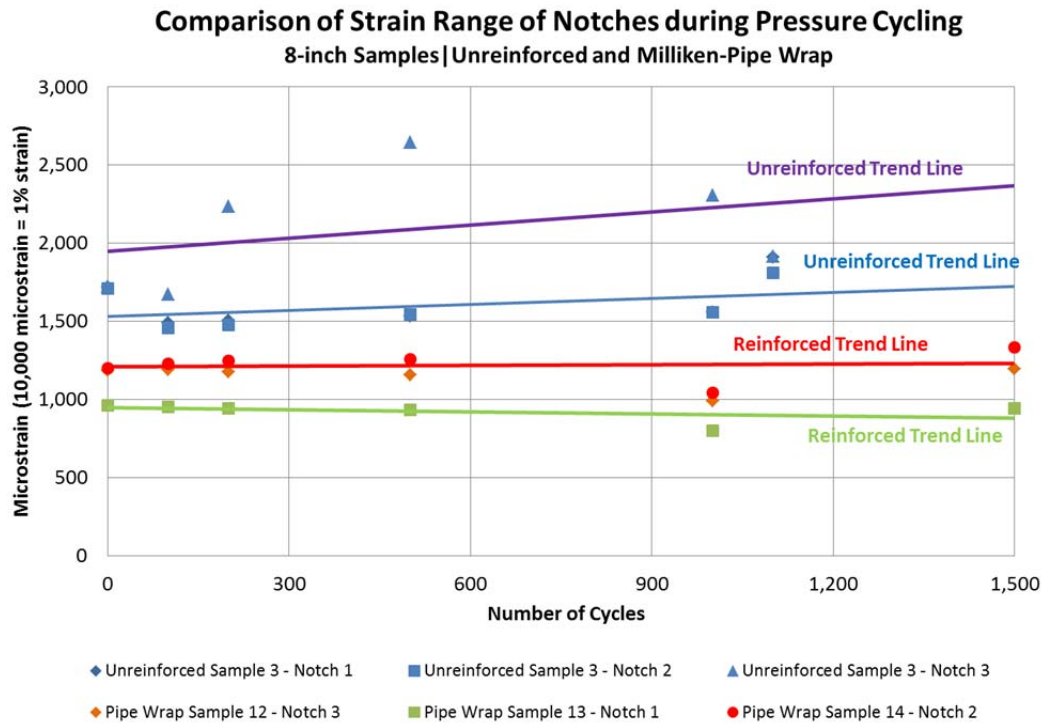
Figure 11: Notch Strain Range vs. Number of Cycles (selected 8-inch diameter samples)

Cyclic pressure testing resulted in all repaired samples achieving the designated 1,500 cycles and 3,500 cycles for 8-inch (200-mm) and 16-inch (400-mm) samples, respectively. Two (2) of the five (5) unreinforced test samples did not reach the target number of cycles during pressure cycling. Failure of these samples occurred during the initial pressure increase of the first cycle. Strain results for several of the samples that did reach the target number of cycles are provided in Figure 11. The strain ranges in these plots were taken from strain gages that were installed across EDM notches. Linear trend lines were added to this plot showing a general strain range increase with the unreinforced samples, while there appear to be minimal strain range changes on the composite material is installed.

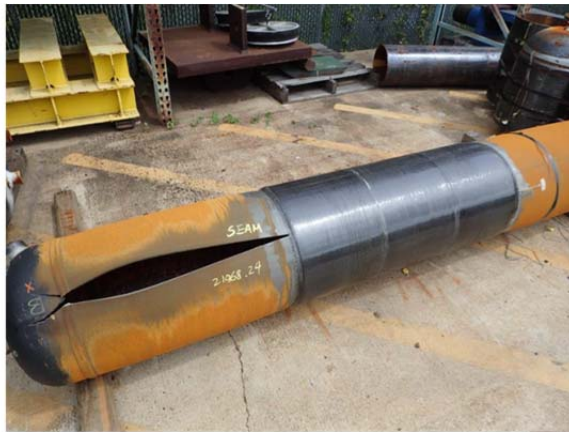
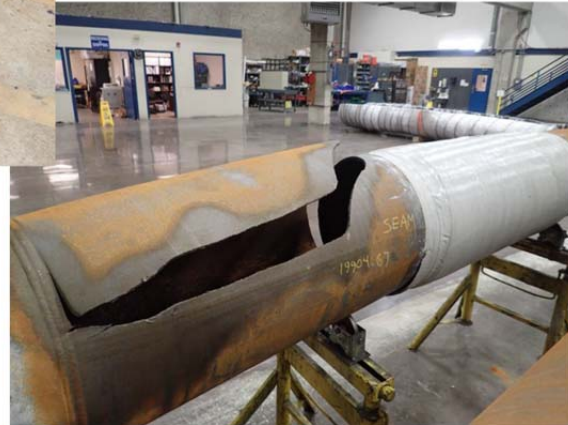
Called 56% deep, 3.33" long seam anomaly
 Burst pressure = 2,787 psi – 2.1xMOP -
 138% SMYS

Called 55% deep, 2.63" long seam anomaly
 Burst pressure = 3,350 psi – 2.5xMOP -
 165% SMYS

Figure 14: Photos Showing Burst Tests of Actual Reinforced Seam Planar Defects

In addition to testing the anomalies associated with the EDM notches, planar defects removed from the actual pipeline were tested. The defects were identified via an in-line combination magnetic flux leakage tool; the two most significant anomalies found were selected for further composite reinforcement validation testing. Figure 14 includes two photographs showing these two anomalies after burst testing. As noted, both failed at pressures in excess of two times the Maximum Operating Pressure (MOP) of the line and the failure occurred outside the repairs. Shown in Figure 15 is a post flaw inspection of one of the reinforced samples where there appears to be no growth in the flaw during the pressure test.
