# **Recent Advances in Evaluating Composite Repair Technology Used to Repair Transmission Pipelines**

**Dr. Chris Alexander**  
Stress Engineering Services, Inc.

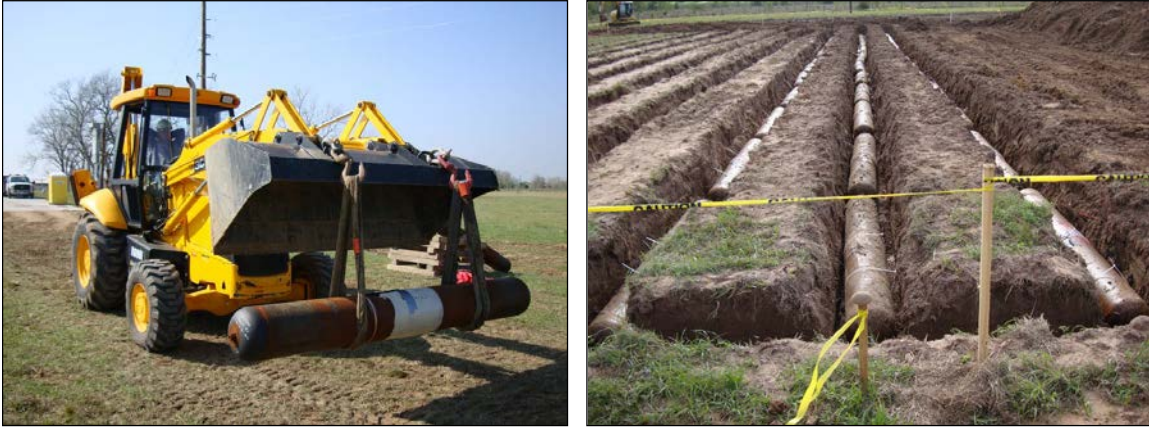
Figure 3 – Photographs from PRCI long-term study

This particular program is the first of its kind and involves 144 12.75-inch x 0.375-inch, Grade X42 test samples with machined corrosion (depths of 40, 60, and 75% of the pipe's nominal wall thickness). The samples are held at a constant pressure of 36% SMYS and cycled periodically from 36% to 72% SMYS (e.g. 900 annual cycles plus 4 blowdowns to 0 psi). At designated periods of time (1, 2, and 3 years) test samples will be removed from the ground and burst tested. Tests were also conducted on a set of 36 samples prior to burial to serve as a baseline data set. Four manufacturers (refer to list above) have also elected to leave test samples in the ground for 10 years and additional burst testing will be conducted at 5, 7.5, and 10 years. Additionally, strain gages were installed in the corroded regions beneath the repairs and are used to quantify the level of reinforcement provided by each composite repair system during the designated pressure cycle periods. The Year 0 burst tests were completed in December 2008 and the test samples that have been buried are currently under pressure during the first year of the study. Interested readers are encouraged to find additional details on the program's website at [www.compositerepairstudy.com](http://www.compositerepairstudy.com). Figure 1 is a schematic showing the machining required for the test samples, while Figure 2 shows the location of strain gages installed in the corroded region of each test sample. Several photographs showing the burial of the test sample are provided in Figure 3.

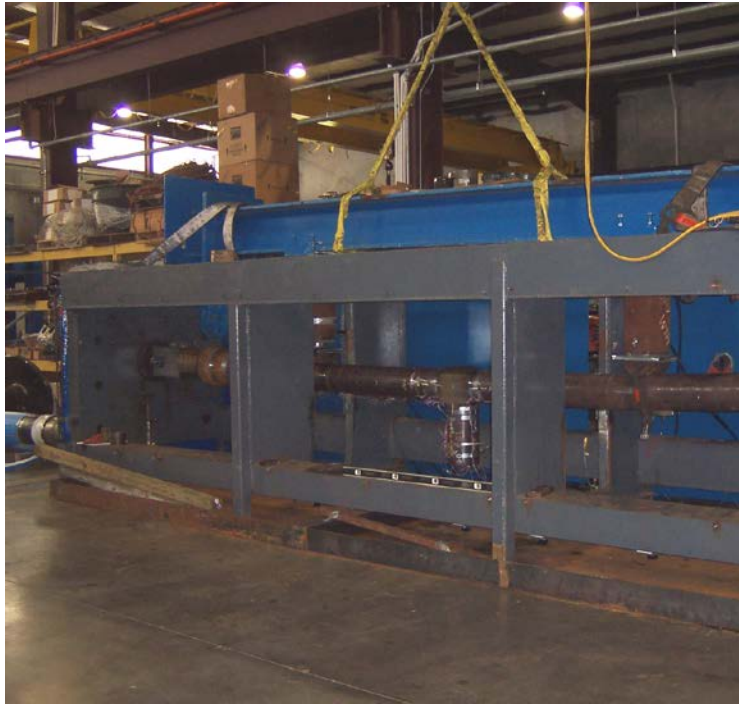
**Figure 9 – Load frame used for pressure-tension-bend testing**

Figure 9 is a photograph of the Product C repair in the load frame prior to bend testing. Table 1 includes the failure results for all three tests and all three composite repair systems. Included in this table are the design loads. The design margin for each respective system is the ratio between failure load and design load. As an example, consider the pressure-tension-bending loads for System C (carbon epoxy system). The failure bending load is listed as 204.2 kip-ft and the design load is 51 kip-ft. The ratio between these bending moments is 4.0, which certainly exceeds acceptable margins for strain-based design methods that range between 1.5 and 2.

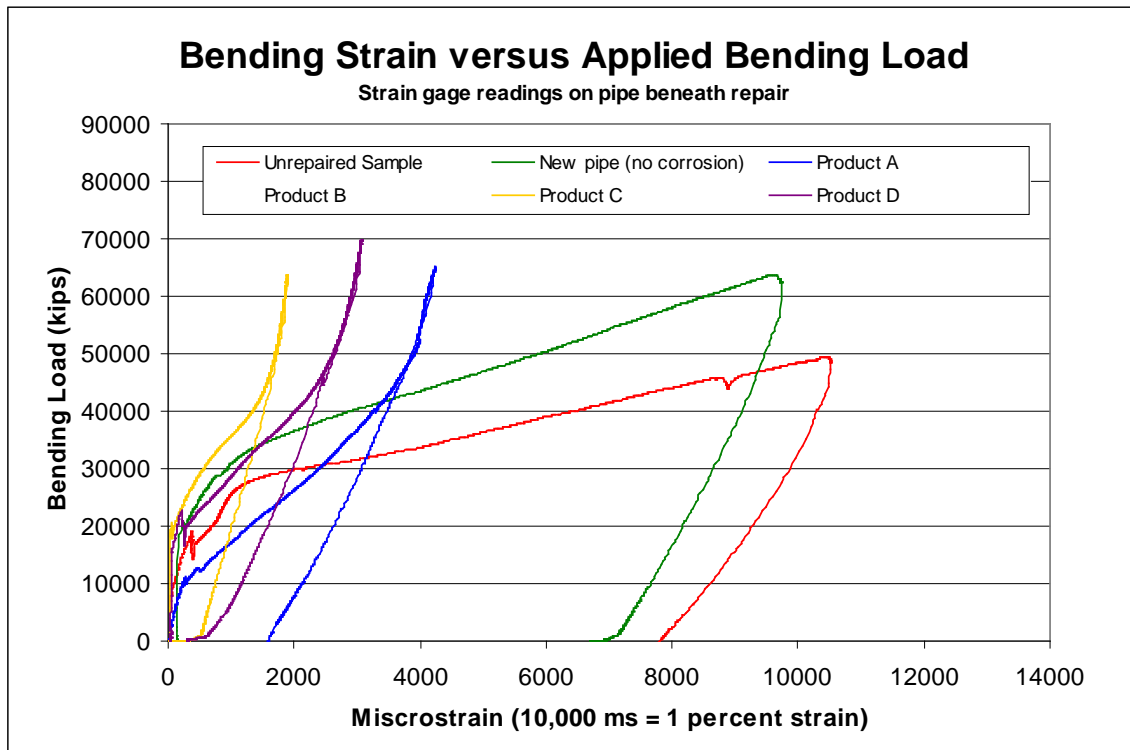
**Figure 10 – Test results from pressure-tension-bending testing**

Results for the pressure-tension-bending test are provided in Figure 10. There are several noteworthy observations in reviewing the plotted data.

- Unlike the other tests, there is a unique pattern observed for the level of reinforcement provided by each of the respective repair systems. As expected, the carbon in Product C provides the greatest level of reinforcement because for any given bending load it had the lowest measured strain. For comparison purposes, consider the strain in the steel at a bending load of 40 kips (bending moment of 116.7 ft-lbs) for each of the repair systems:

- Product A – 4,130 microstrain
  - Product B – data not reported
  - Product C – 2,150 microstrain
  - Product D – 3,022 microstrain
- In assessing the relative performance of the composite systems, the objective of the repair is to reduce the strain in the corroded steel during bend testing, as well as provide reinforcement in the circumferential and axial directions due to internal pressure and axial tension loads, respectively. As noted in Figure 10, at some point the strain gage results appear to stop changing with increasing load (where plotted lines trend vertical). It is at this point that gross plastic deformation, as recorded by the strain gages, occurs outside of the reinforced region and that deflection is occurring primarily in areas outside the composite reinforcement. The sooner this transformation takes place, the more effective the repair is in reinforcing the corroded region.

- Another option for assessing the relative performance of the composite repair systems is to determine the applied bending moment at a specified strain value. If the strain limit is designated as 0.20 percent, the following bending forces and moments are extracted. This method is a better assessment of the relative performance of the repair systems. It should be noted that the unreinforced sample did not include internal pressure during bend testing as failure would have occurred at a lower bending load. The values in parentheses correspond to bending moments in kip-ft.
