ASSESSING THE EFFECTS OF VIBRATORY LOADING ON PIPELINES USING ANALYSIS AND MONITORING TECHNIQUES

ABSTRACT

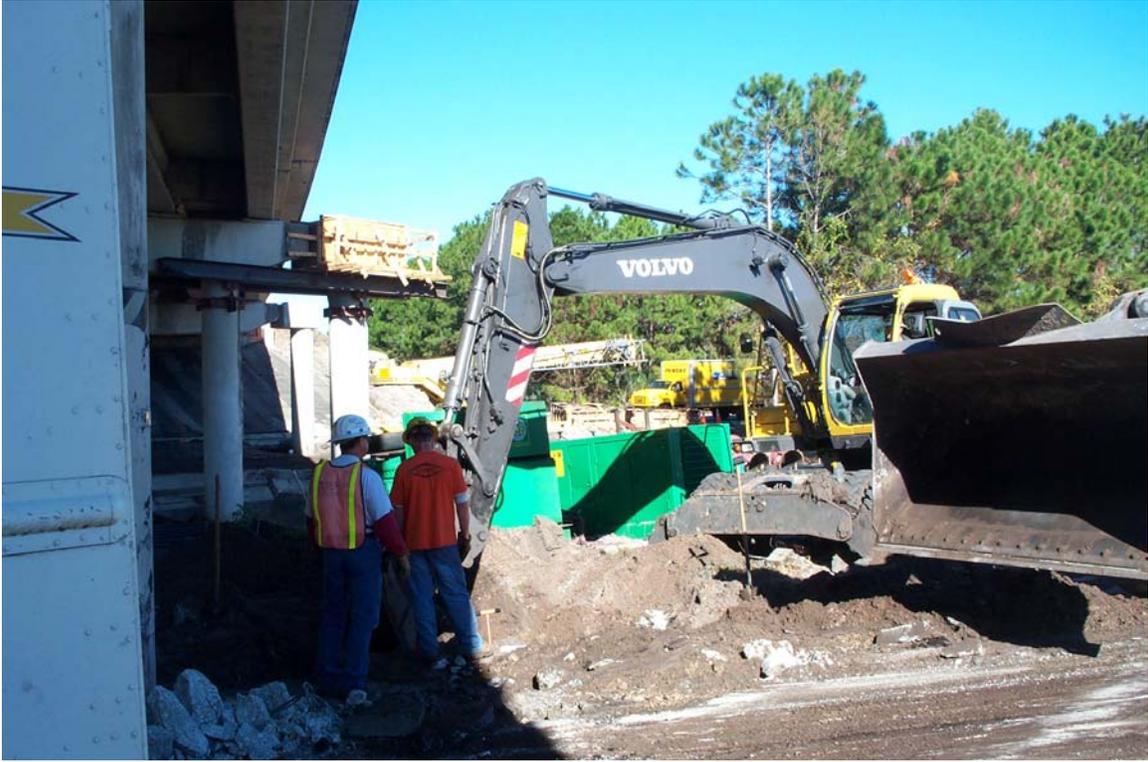
Figure 1 - Excavating pipe adjacent to highway

Figures 1 through **Figure 4** are photographs from the site of the pile driving. The steps involved in the installation of the electronic equipment included:

- Excavating around the pipe to ensure adequate clearance for installing the equipment
- Removing the coating by scraping and polishing the surfaces of the steel pipe in areas where strain gages were installed
- Installing weldable strain gages to the pipe at four (4) locations around the pipe. Two gages (one axial and one hoop) were installed at positions 90 degrees apart.
- Wiring up the strain gages to the cables for connection to the data acquisition system (DAQ)
- Connecting accelerometers using the mounting blocks and brackets. Two accelerometers were used, one vertical and the other horizontal
- Enclose all connections and equipment to prevent moisture penetration
- Completing the connection of cables and running out of the excavation hole up to the computers in the back rented-vehicle
- Check out no-load measurements and make sure all components of the system work properly.

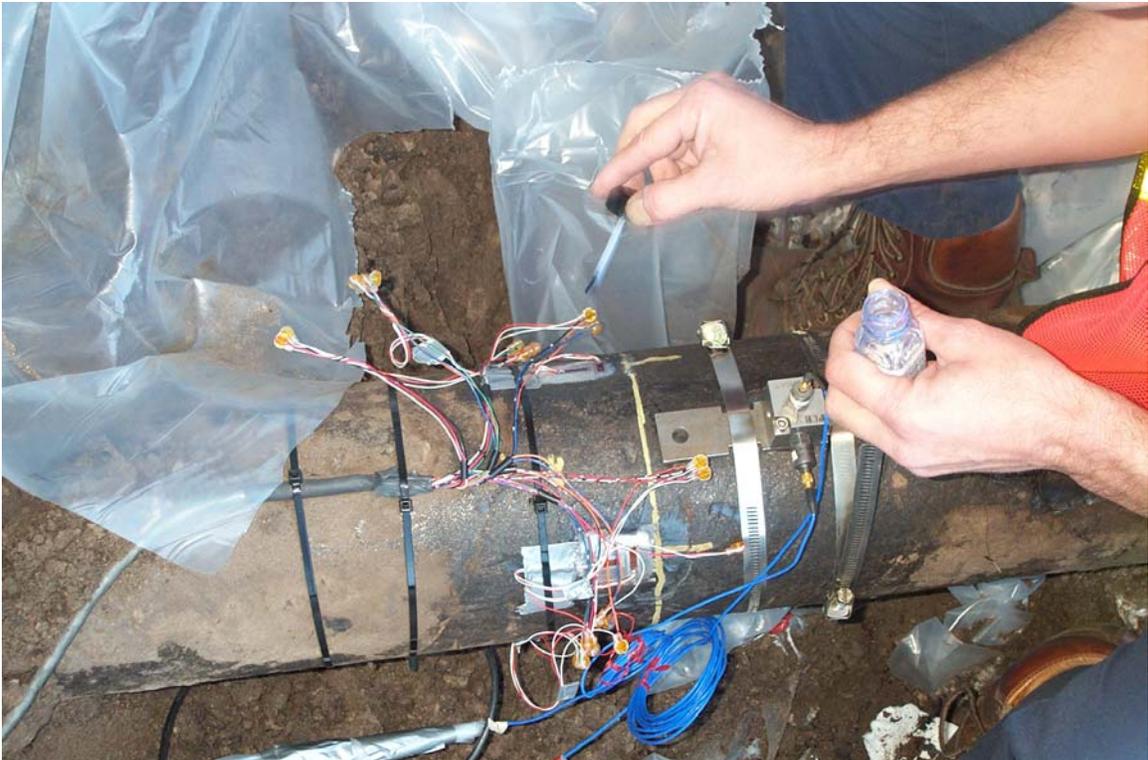
Figure 2 - Installing strain gages on pipe

Strain Gages. Weldable strain gages were used to measure strain in the pipe, both axially and circumferentially. The weldable gage types have a thin gage steel backing that permits their attachment directly to the pipe. The welding used in this context involves nothing more than a series of extremely small spot welds around the outer perimeter of the gage.

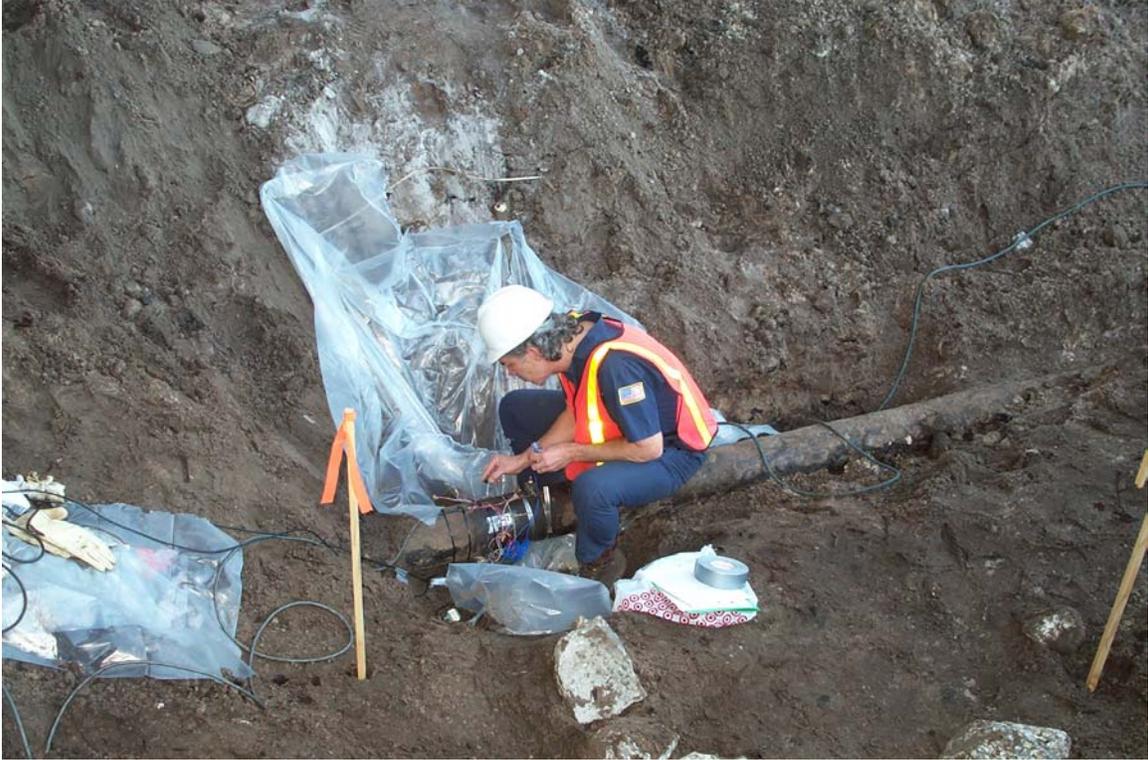
Figure 3 - Location of gages on pipe in exposed ditch

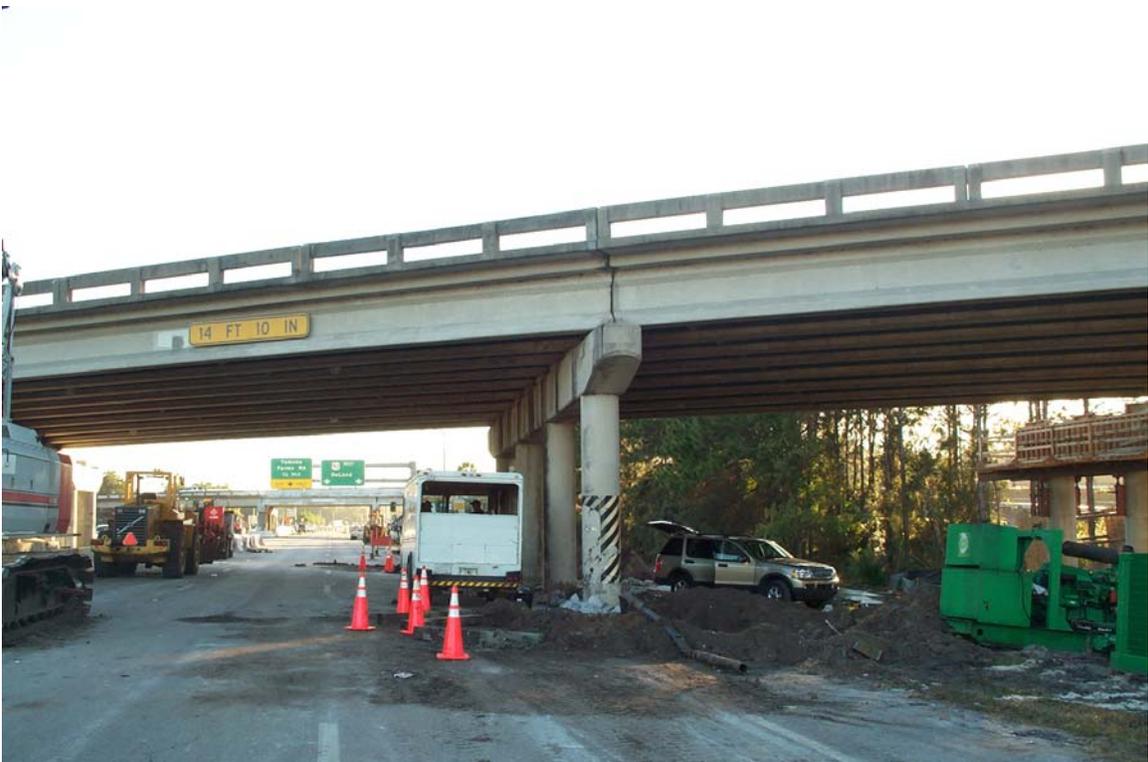
Figure 4 - Location of exposed pipe relative to I-95 overpass

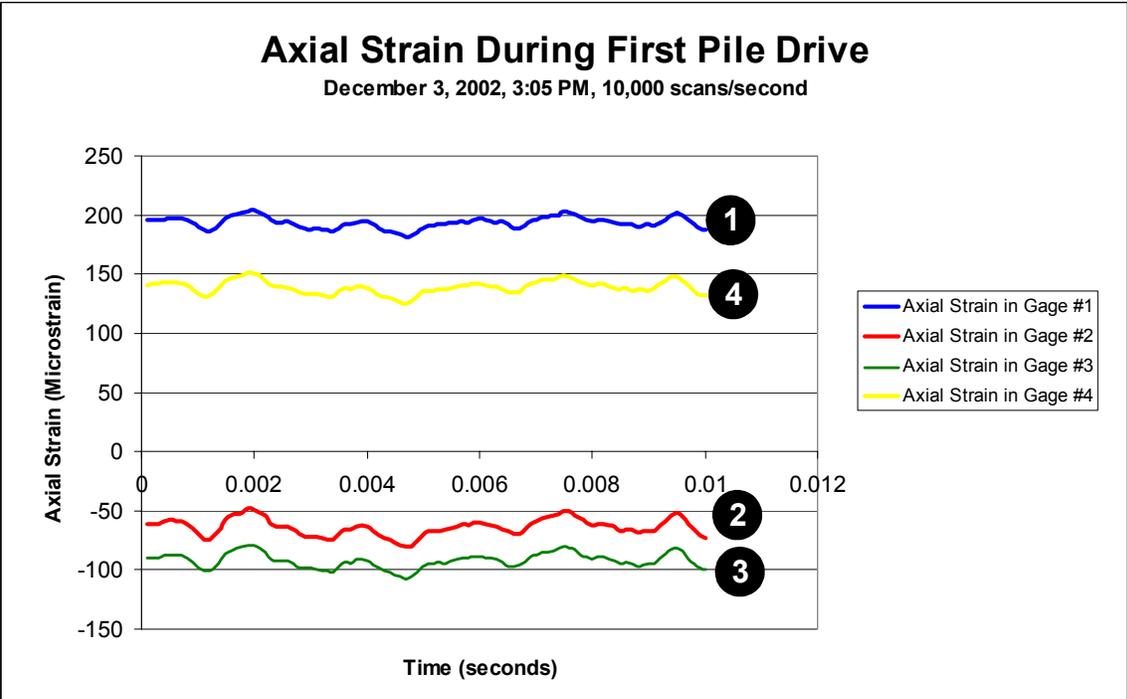
Figure 5 – Strain gage measurements recorded during first pile drive

Figure 5, 6, and 7 are plots showing the strain gage readings. Results for one test showing the accelerometer readings are shown in **Figure 8**. The total cycle time appears to be approximately 0.002 seconds per cycle. With the scan rate of 10,000 scans per second, 20 data points were collected for each measurement device (e.g. strain gages and accelerometers) during each cycle.

Strain Magnitude. During testing, the strain and accelerometer results were displayed on a computer screen. The apparent peak-to-peak magnitude of the strain appeared to be on the order of 30 microstrain, which was well below the pre-calculated allowable axial strain for the pressurized gas pipeline. When converting strains to stresses, the strain is multiplied by the modulus of elasticity for the pipe material. The carbon steel pipe has an approximate modulus of 30 million. Consequently, 30 microstrain multiplied by a modulus of 30 million psi (206.4 GPa) results in a calculated stress of 900 psi (6.2 MPa). As shown in the following section, the calculated axial stress limit for the pipeline was 8,400 psi (57.8 MPa). The peak-to-peak stresses generated by the pile driving process were approximately one-tenth of the allowable value.

Increasing Strain During Initial Stages of Driving. After the first pile had been driven, a trend was observed in the strain gage results that was concerning. Prior to starting the pile driving, the strain gages were zeroed and no strain was measured in the pipe. Once the first pile started moving into the ground, the strain gage readings clearly indicated that the pipe was being moved away from the pile. With Gages #1 and #4 indicating tension and Gages #2 and #3

showing compression, it was clear that the pipe was being subjected to a bending load. Although not completely obvious in the plotted data, the results for all three pile drives show that in Gage #1 a maximum nominal strain on the order of 250 microstrain (stress of 7,500 psi (51.6 MPa)) was reached. Fortunately, even this value was less than the calculated allowable axial stress of 8,400 psi (57.8 MPa). However, it was noted that each time the pile driving process was completed the strains returned to approximately zero microstrain.

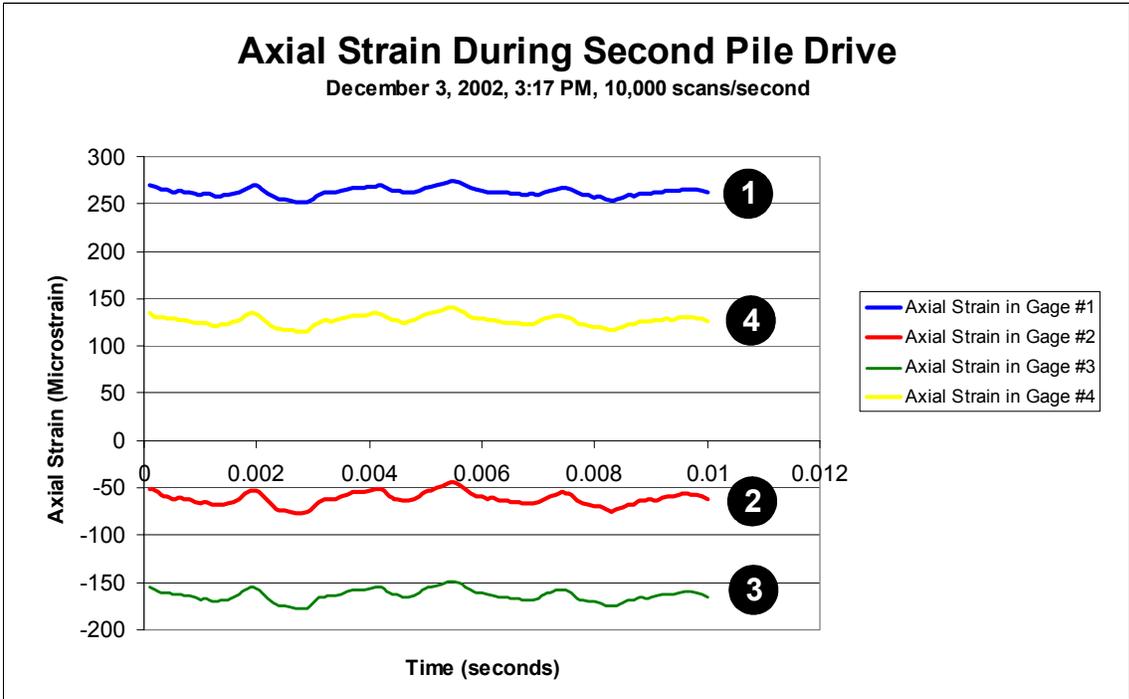
Figure 6 – Strain gage measurements recorded during second pile drive

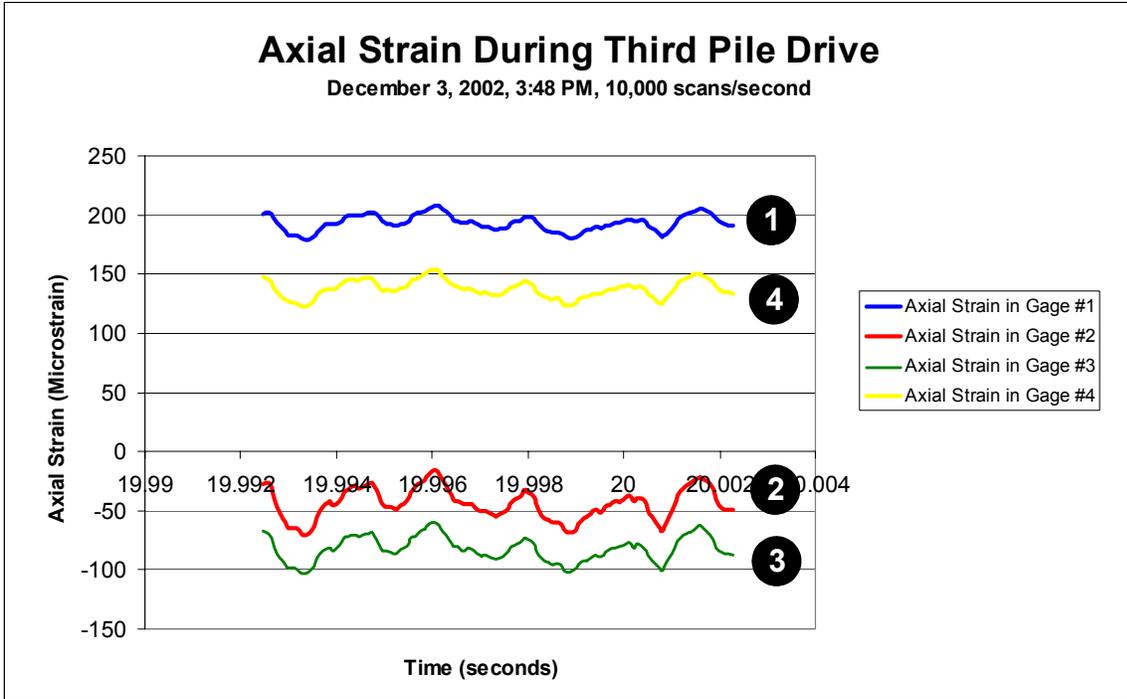
Figure 7 – Strain gage measurements recorded during third pile drive

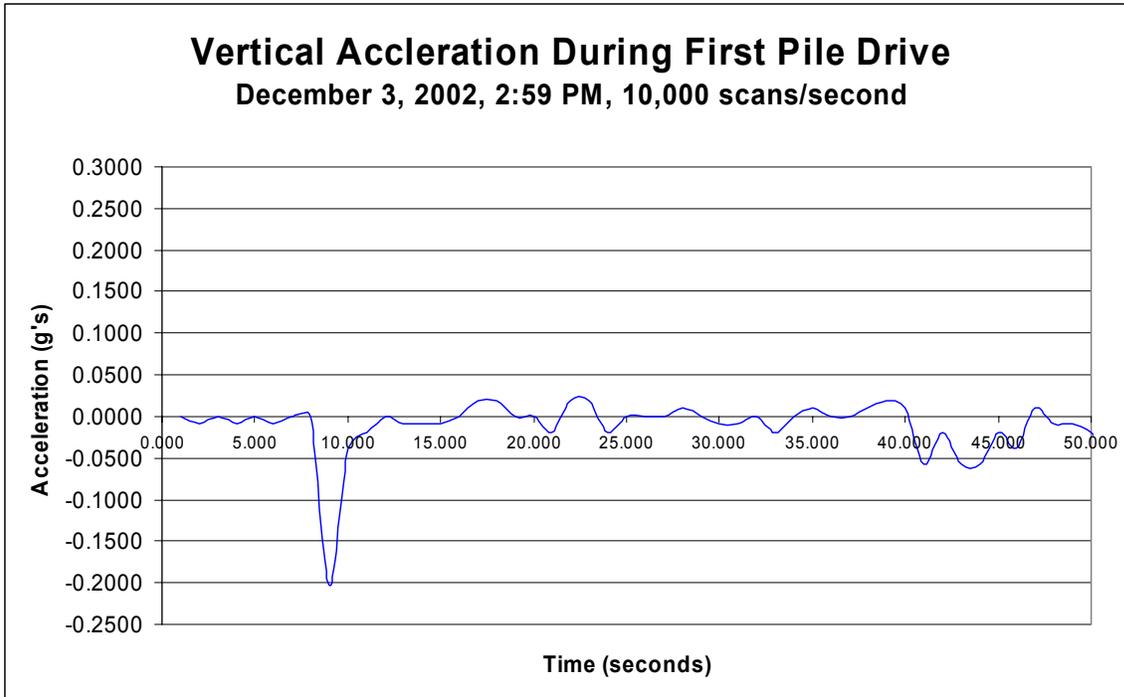
Figure 8 – Strain gage measurements recorded during first pile drive

Acceleration Readings. The primary reason that the accelerometers were installed was to determine the maximum acceleration levels that were imparted to the pipeline during the pile driving process. As shown in **Figure 8**, the maximum acceleration level was less than 0.5 g. This measured value is well below the 1.0 g value that was assumed in the analysis work.

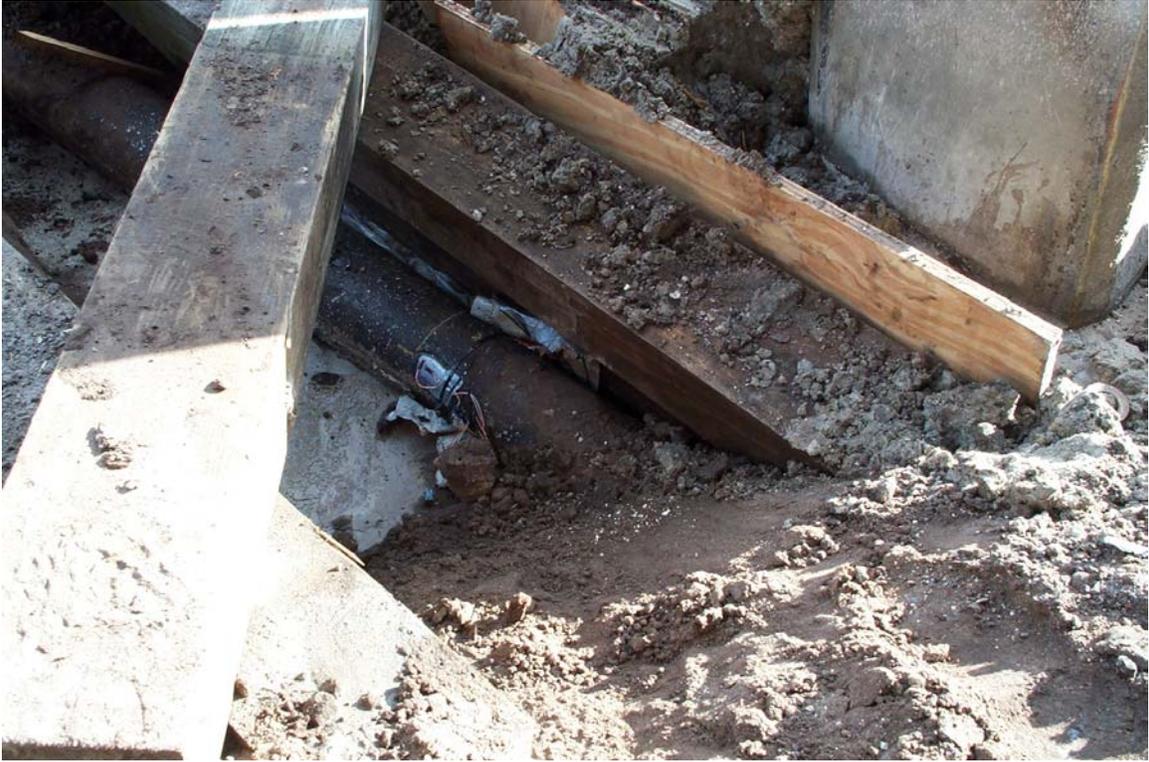
After all three piles were driven, the pipeline was visually inspected. **Figure 9** is a photograph showing what was discovered. As shown in this figure, a wood beam and a piece of plywood were installed to protect the pipe from outside forces. Due to the relative rigidity of these members, as the piles were driven the displaced soil in conjunction with the position of the timber forced the pipeline upward. The fact that Gages #1 and #4 (located on top of the pipe) are in tension throughout the recording process indicates the upward direction of loading.

Figure 9 - Position of wood beam adjacent to pipe

It was recommended that future pile driving efforts create a space barrier between protection members and the pipeline. Having a buffer zone between the pipe and timber will prevent loads from being transferred to the pipe during the pile driving process and permit the soil to be displaced more freely and not load the pipeline.
