## AN UPDATED PERSPECTIVE ON USING COMPOSITE MATERIALS TO REINFORCE OFFSHORE PIPELINES AND RISERS

**Chris Alexander**  
Stress Engineering Services, Inc.  
Houston, Texas  
[chris.alexander@stress.com](mailto:chris.alexander@stress.com)

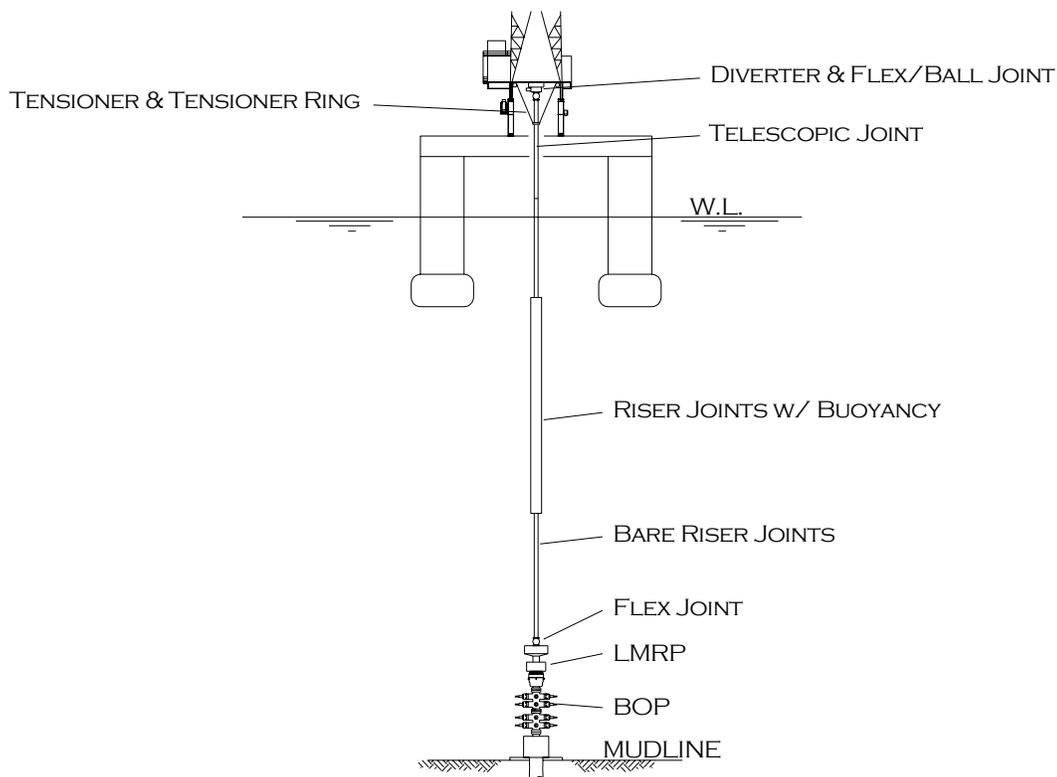
**Figure 1 – Layout for a semisubmersible rig showing position of the riser**

Risers are critical components in offshore operations as they extend the wellhead at the mudline to the surface as shown in Figure 1. During operation risers are subject to degradation mechanisms including external corrosion and mechanical damage due to contact with outside forces. To permit risers to operate safely it is sometimes necessary to perform repairs. Conventional repair techniques incorporate external steel clamps that are either welded or bolted to the outside surface of the riser. Challenges exist with installing steel clamps that include issues such as mobilizing the heavy clamp, welding to an operating riser pipe (including safety issues), and installation expenses. For these reasons, alternative solutions such as composite repair sleeves provide an attractive option as they are relatively inexpensive, lightweight, do not require welding, and are relatively simple to install.

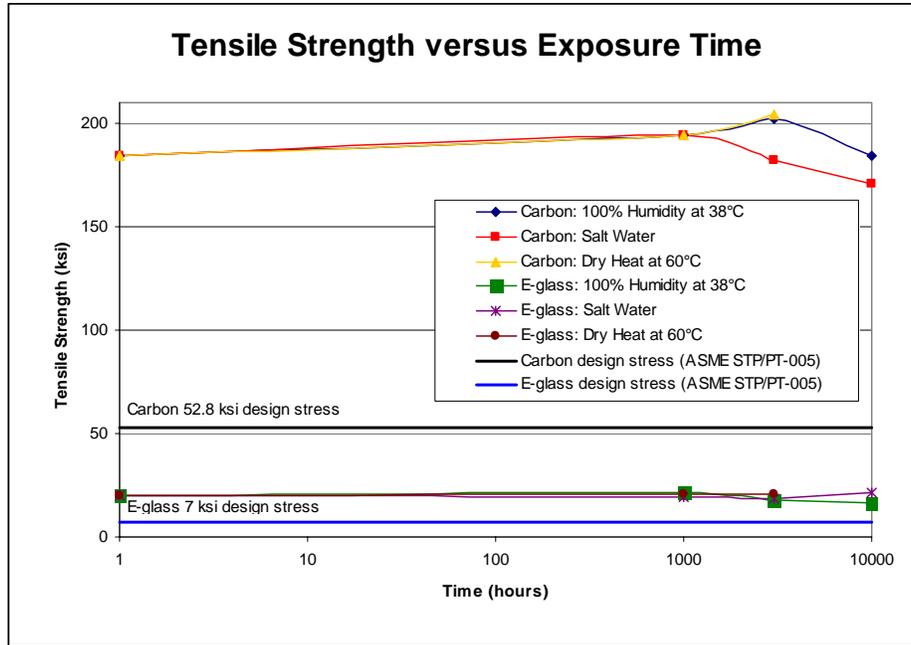
Figure 2 – Tensile strength data from the CALTRANS research program

One of the general concerns across industry regarding the use of composite materials is their long-term performance and the potential for degradation in strength. In the absence of long-term data, designs using composite materials have been the use of large safety factors. One of the more significant bodies of research conducted to date on the long-term performance of composite materials was performed for the State of California Department of Transportation (CALTRANS) by Steckel and Hawkins of the Space Materials Laboratory in assessing the use of composite materials for infrastructure applications such as highways bridge columns [20]. This ninety plus page document provides extensive data on the long-term performance of selected composite systems including carbon-epoxy and E-glass/epoxy. The effects of environmental exposure on the mechanical and physical properties of these select systems are summarized in **Figure 2** and **Table 1**. The plus/minus values shown in this table correspond to the standard deviations.

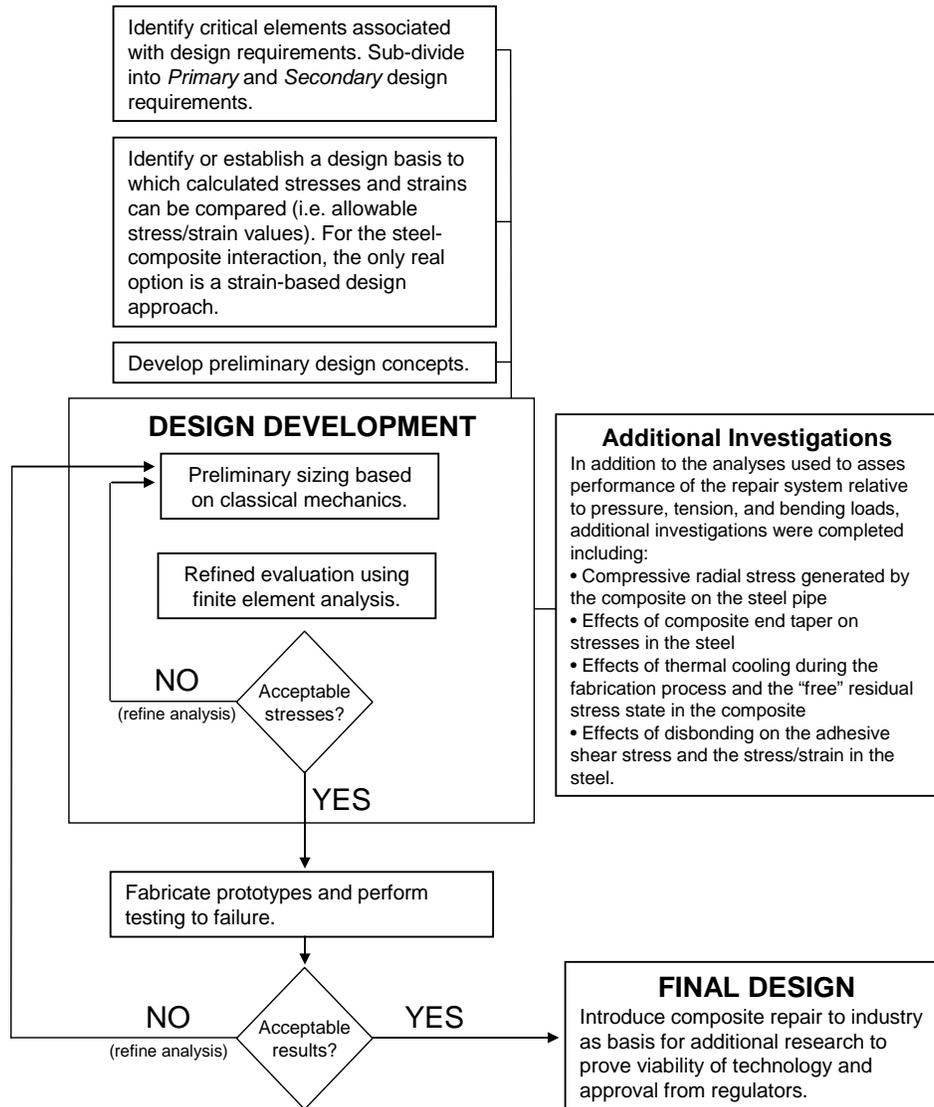
Figure 3 – Steps involved in the optimization process

**Figure 3** presents the steps involved in the design process. Because of the unique nature of this process, no single design document exists that can designate the design requirements for a composite repair in a prescriptive manner. This process involves both design efforts as well as identification of a design limits to which the calculated stresses and strains can be compared. Included in **Figure 3** are details initiating at the preliminary design phase through completion of the final design verified using finite element analysis and prototype testing.

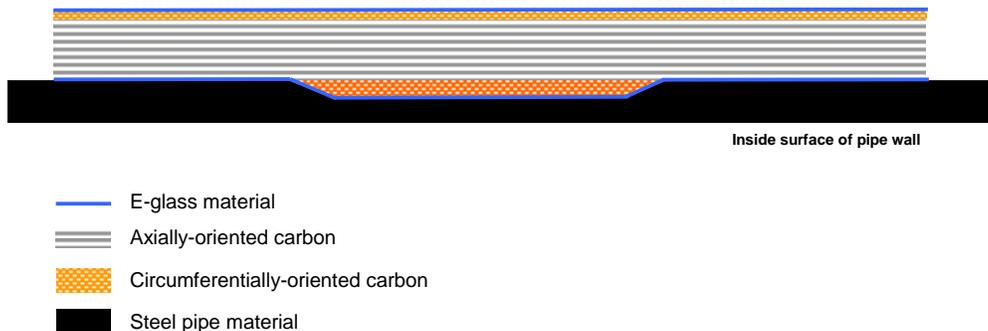
Figure 4 – Generalized layout for optimized E-glass/carbon composite repair

Provided below are elements of the composite repair system design for the specific pipe geometry evaluated in this study. The materials for the optimized design integrated a combination of carbon and E-glass fibers.

2. Circumferentially-oriented carbon fibers placed in the region of corrosion.
3. Outside of the inner circumferential fibers, the majority of the fibers are oriented axially to provide rigidity in bending and tension.

4. The length of the repair should be at least 16 inches on each side of the corroded region. A repair length of 60 inches was selected, providing 18 inches on each side of the 24-inch long corroded region.

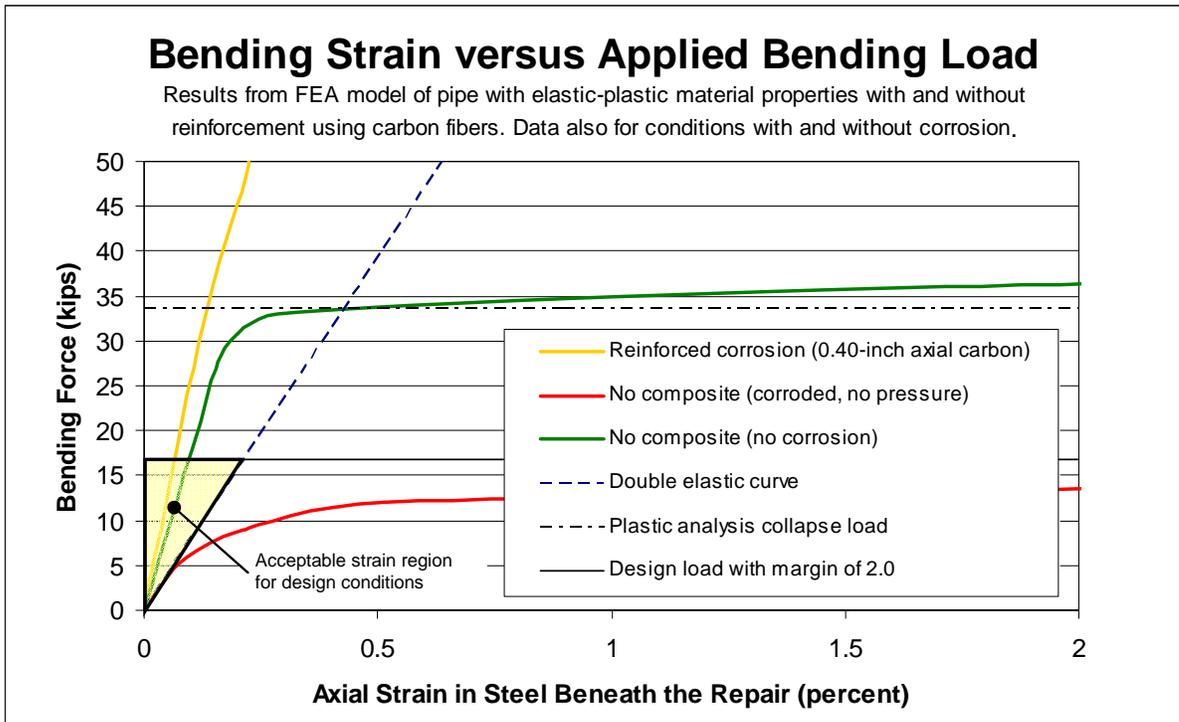
**Figure 5 – Bending force versus axial strain in pipe**  
(carbon repair with 0.200-inch thick hoop | 0.400-inch axial | 0.100-inch layers)

To assess performance of the repair subject to design loads, a finite element model was analyzed for the CRA system that included internal pressure (2,887 psi), axial tension (145,000 lbs), and a range of bending forces. A four point bend configuration was used in the finite element model, so to compute the applied bending moment the applied force is multiplied by 2.92 feet (i.e. 10,000 lbs corresponds to a bending moment of 29,200 ft-lbs). There are several noteworthy observations in reviewing the data plotted in **Figure 5** that are listed below.

- The data corresponding to the unrepaired condition (solid red curve) did not include pressure. This was to mimic the test program that did not include pressure during the bend test for the unrepaired case. If pressure had been applied, an excessively low bending capacity would have resulted for the corroded unrepaired case due to gross plastic yielding in the steel.
- The primary source of the design limits is based on the un corroded base pipe data (green line). From this case the design load is calculated. As noted in the figure, the following data points are determined:
  - Plastic analysis collapse load of 33.6 kips.

- Design load (bending force) of 16.8 kips (design margin of 2.0 on the collapse load) which also corresponds to a bending moment of 49.1 kip-ft.
- At the design condition, the maximum permissible axial strain in the steel beneath the repair is 0.214 percent (corresponds to the intersection of the horizontal line designating the design load and the double elastic curve).

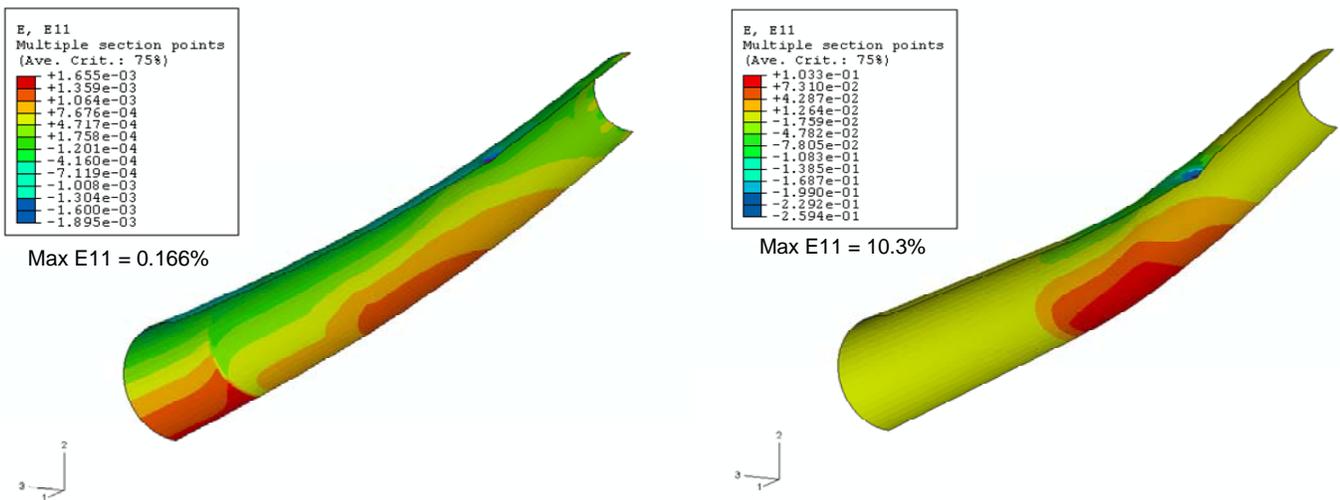
**Figure 6 – Axial strains in steel at design (left) and plastic collapse (right) load conditions**

**Figure 6** shows the maximum principal strain in the steel at loads equal to the design and plastic collapse loading conditions. There are several noteworthy observations in viewing this figure.

- At the design condition, the maximum strain in the steel that is observed beneath the composite repair is 0.17% (based on the plotted contour data). It should be noted that if the composite reinforcement were not present, the deformation in this region would exhibit gross yielding.
- Once the plastic collapse load is reached, the maximum strain occurs outside the corroded and reinforced region. Once this condition is reached, the composite reinforcement carries a significant portion of the bending load and the maximum bending strain in the pipe actually occurs outside the composite reinforced region.

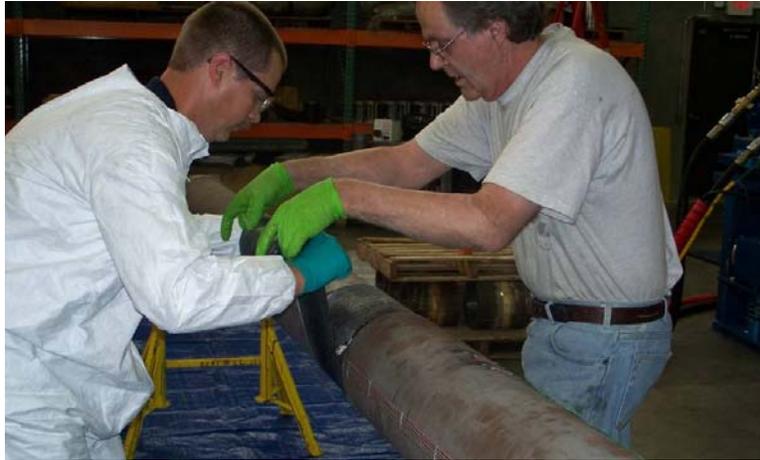
**Figure 7 – Installing the hoop wrapped inner carbon layers**

1. Sandblast the surface of the pipe where the composite repair to be installed.
2. To repair the 24 inch long corroded section of pipe, the uniaxial stitched carbon cloth material was cut to length. Repairs were made by saturating the cloth with two part epoxy and wrapping the cloth around the pipe in the hoop direction. Two rows of material, each totaling 10 layers, were installed in the damaged region as shown in **Figures 7** to produce a total thickness of 0.200 inches.

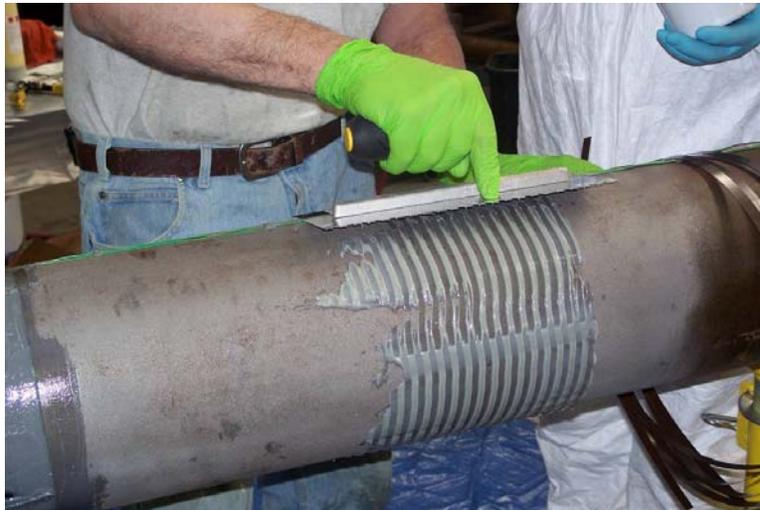
**Figure 8 – Applying the epoxy adhesive using a slotted hand trowel**

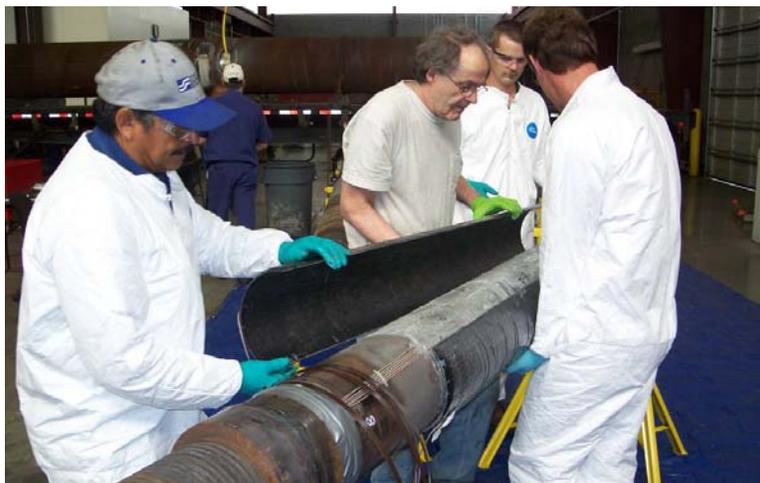
**Figure 9 – Installation of the carbon half shells**

5. The carbon half shells were installed on the outside surface of the pipe. The 60-inch long half shells were centered axially on the corroded region. **Figure 9** shows the carbon half shells being installed on the 8-ft long tension sample.

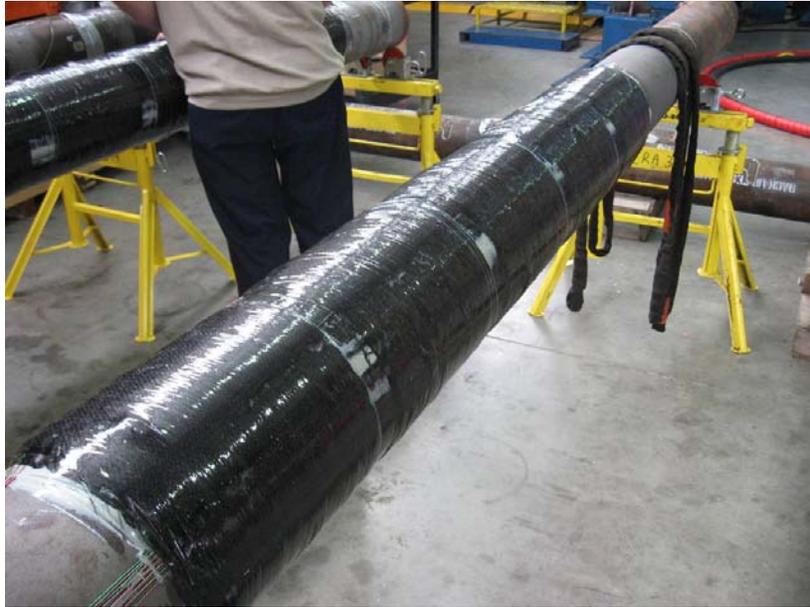
Figure 10 – Final view of cured repair prior to testing

8. The samples were permitted to cure overnight and the stricker wrap was removed the following morning. **Figure 10** shows the final repair including the carbon half shells and outer carbon hoop wrapped material.

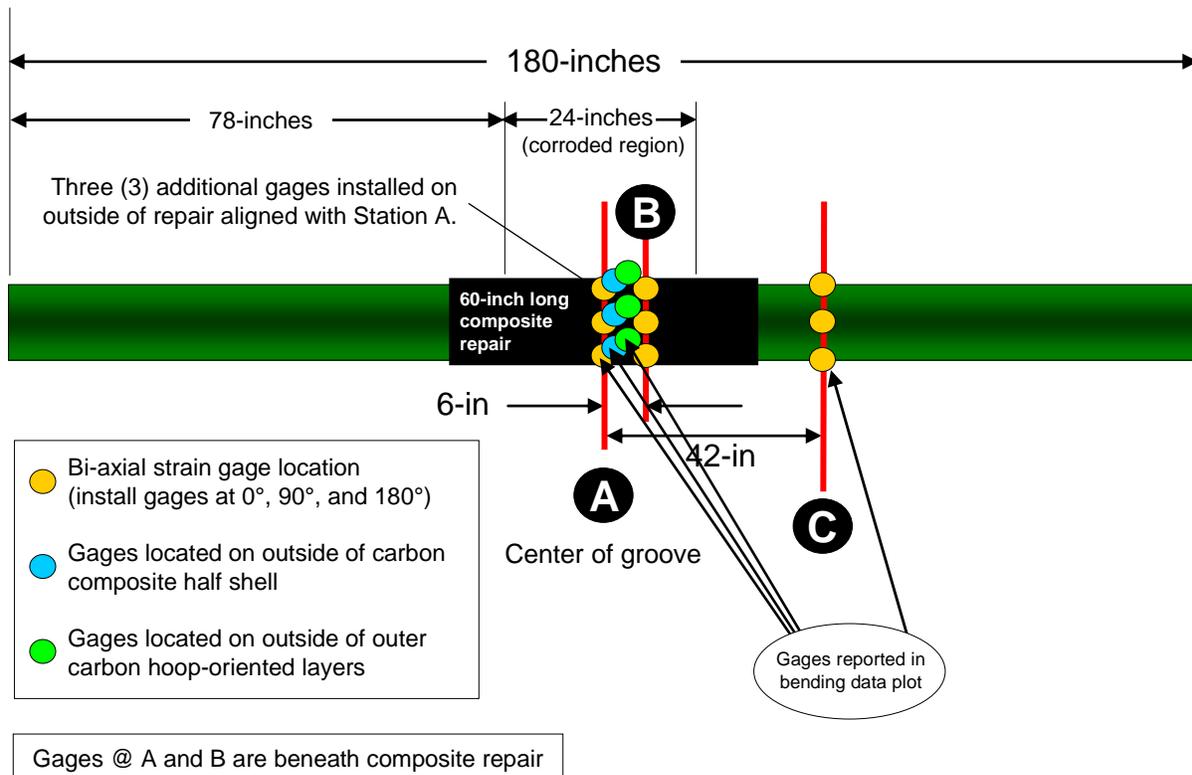
Figure 11 - Locations for strain gages of interest on CRA system samples

**Figure 11** is a schematic showing the location of the strain gages installed on the CRA system test samples. Note that six total gages are located on the outside of the repair. Three of these are on the outside surface of the pre-cured carbon shell, while three are placed on the outside surface of the carbon hoop material (this composite material placed over the carbon half shells to restrain them).

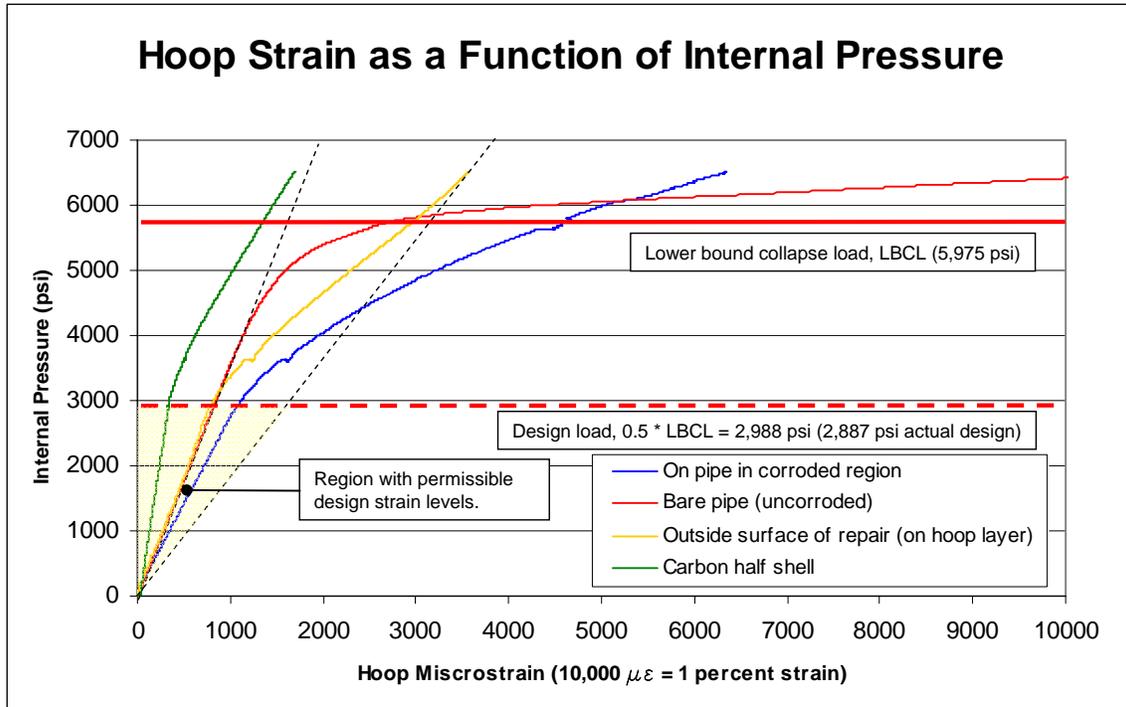
Figure 12 – Annotated pressure test plot showing limit state design parameters

**Figure 12** plots hoop strain measured in the steel on various sections in the CRA composite repair system during the burst pressure test. The measurements associated with the following hoop strain gages are included in this plot.

- On steel beneath the repair in the corroded region of the pipe
- On the bare pipe outside of the repair (represents results for an undamaged pipe)
- Outside surface of the repair on the outer carbon hoop wrap (axial center)
- On the carbon half shell beneath the outer carbon hoop wrap (axial center) – noted as the *carbon half shell* in the figure legend

- The ideal level of reinforcement is one that parallels the initial response of the uncorroded bare pipe (**RED** curve). The plotted data for the strain gage results in the corroded region (**BLUE** curve) show the level of reinforcement that is provided by the repair system.

- Results are presented for the strain gage placed on the carbon half shell (**GREEN** curve). It is observed that the hoop strain in this component of the repair with axial carbon fibers does not measure the same level of strain observed in the other layers dominated by hoop-oriented fibers. This is to be expected as the intent in the design is for the inner hoop layers to provide reinforcement to reduce bulging the corroded region of the pipe.

Also provided in the figure is a highlighted region showing the acceptable design pressure and strain levels. It is important to note that the strain in the corroded region of the test sample exists within this region, demonstrating that adequate reinforcement is provided by the composite repair system.

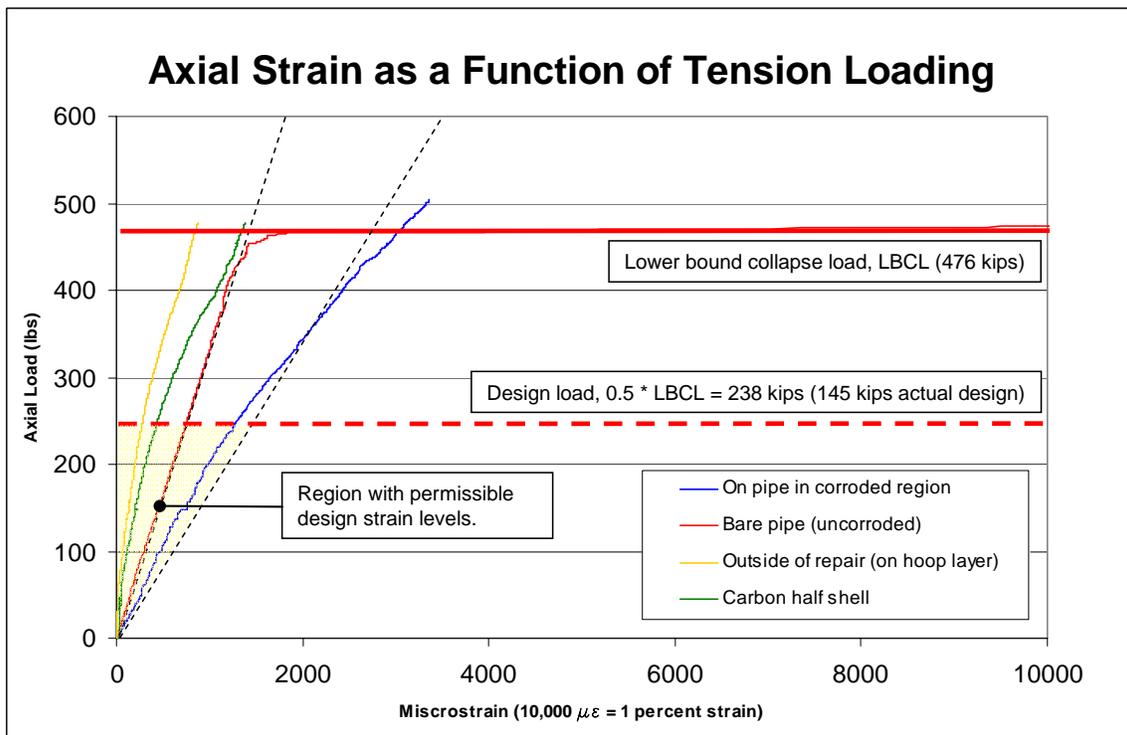
Figure 13 – Annotated tension test plot showing limit state design parameters

3. Axial strains measured in the outer hoop wrapped carbon are less than those measured in both the pipe (corroded and uncorroded) and the carbon half shells. This is to be expected as this region is the last to be loaded during the process of applying the axial tensions loads.

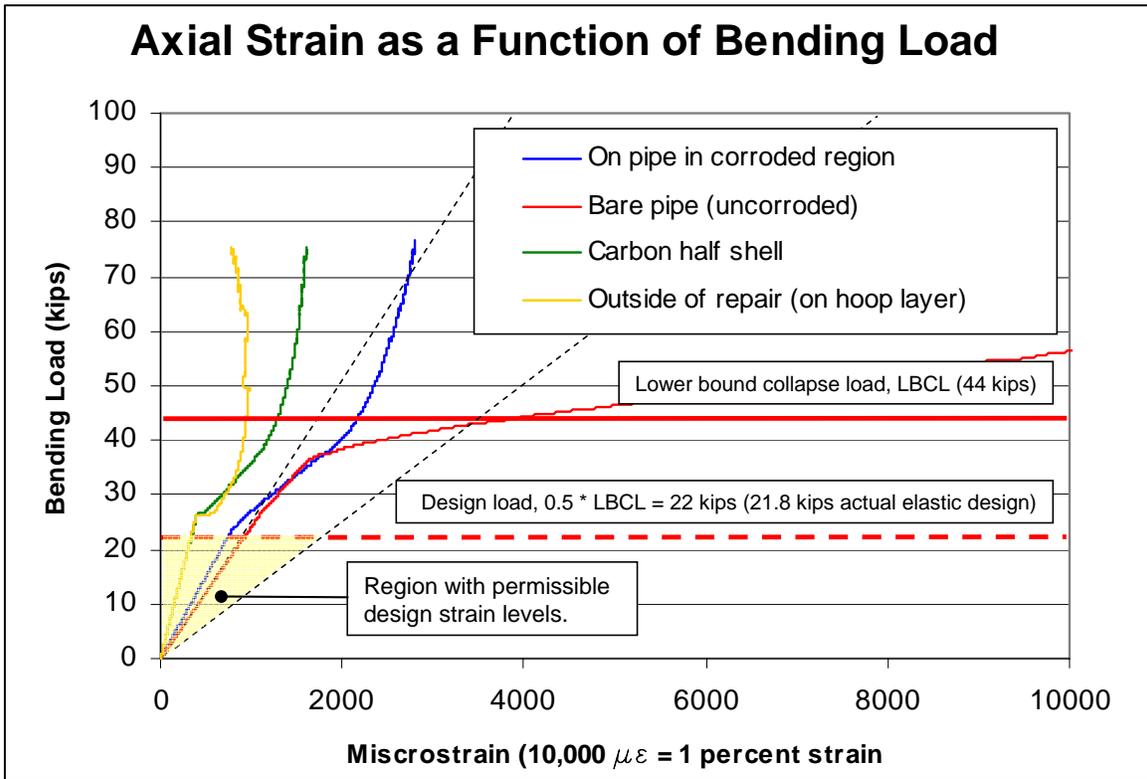
Figure 14 – Annotated bending test plot showing limit state design parameters

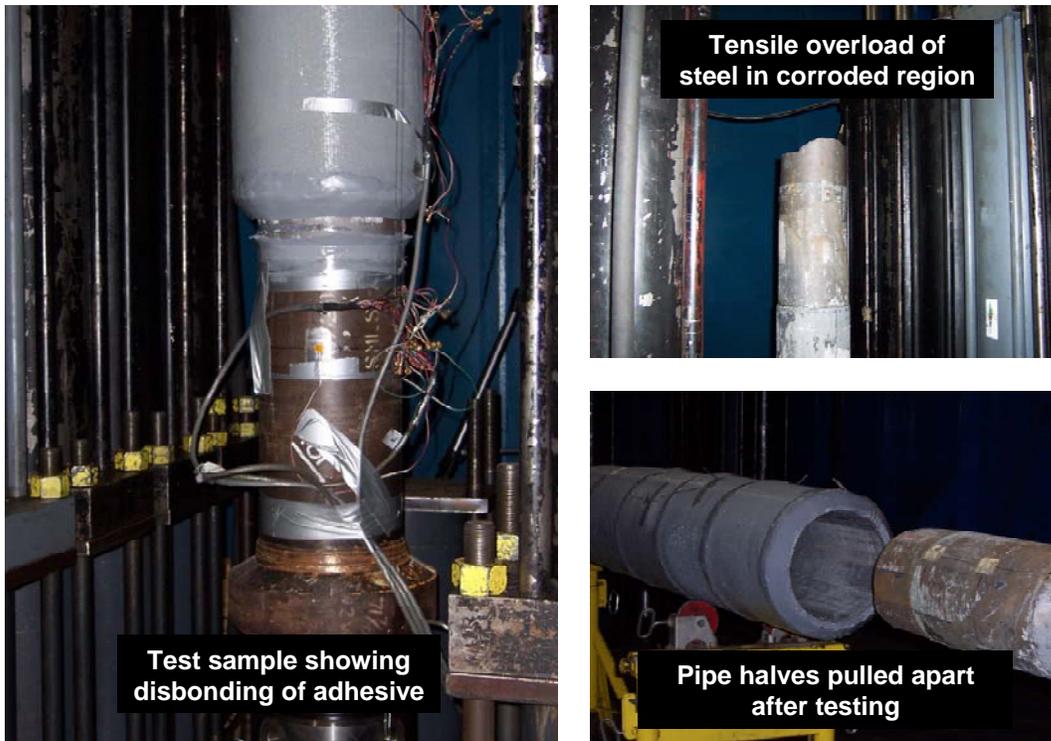
Tension Test Sample (failure in corroded region of repair)

Figure 15 – Photographs from axial tension sample in MMS study

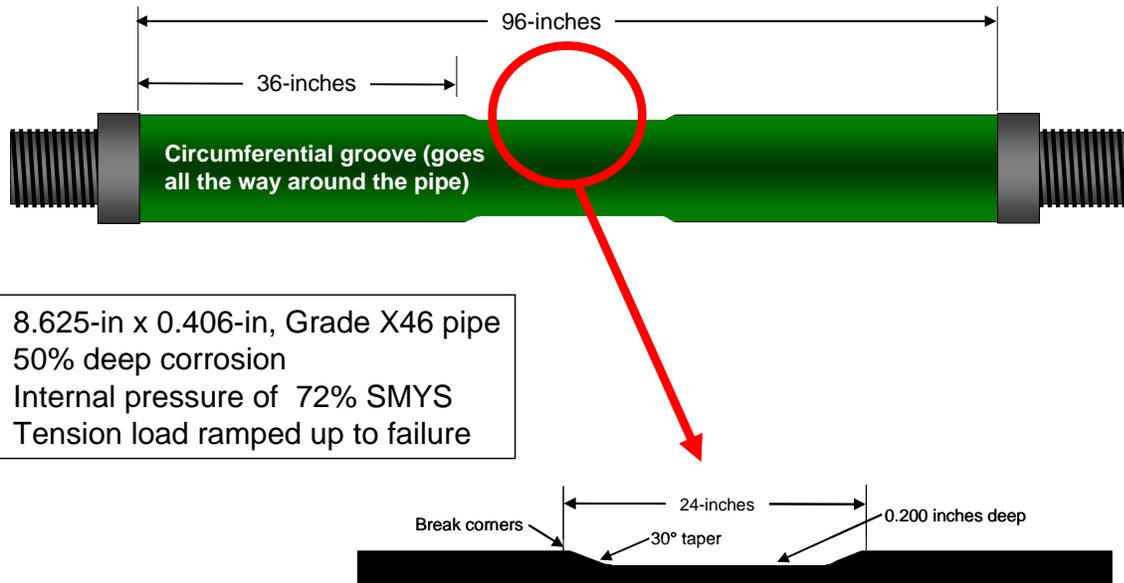
Figure 16 – Axial tension sample from prior MMS study

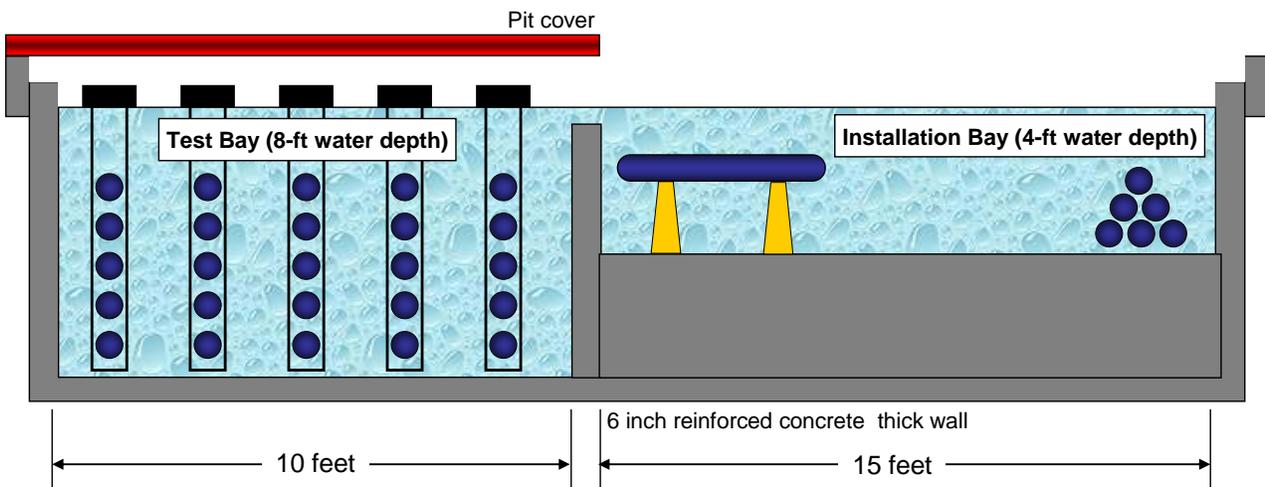
Figure 17 – Proposed saltwater test facility for 10,000 hour long-term study

Also included in this paper is information on an upcoming program involving PRCI and composite manufacturers where test samples will be subjected to operating conditions in a saltwater environment for 10,000 hours. This program will contribute significantly to the future of offshore riser repairs and foster future applications and investigations involving operators by integrating their insights regarding the need for composite repair based on emerging technology.
