PIPELINE REPAIR OF CORROSION AND DENTS: A COMPARISON OF COMPOSITE REPAIRS AND STEEL SLEEVES

Chris Alexander

Stress Engineering Services, Inc.
Houston, Texas
chris.alexander@stress.com

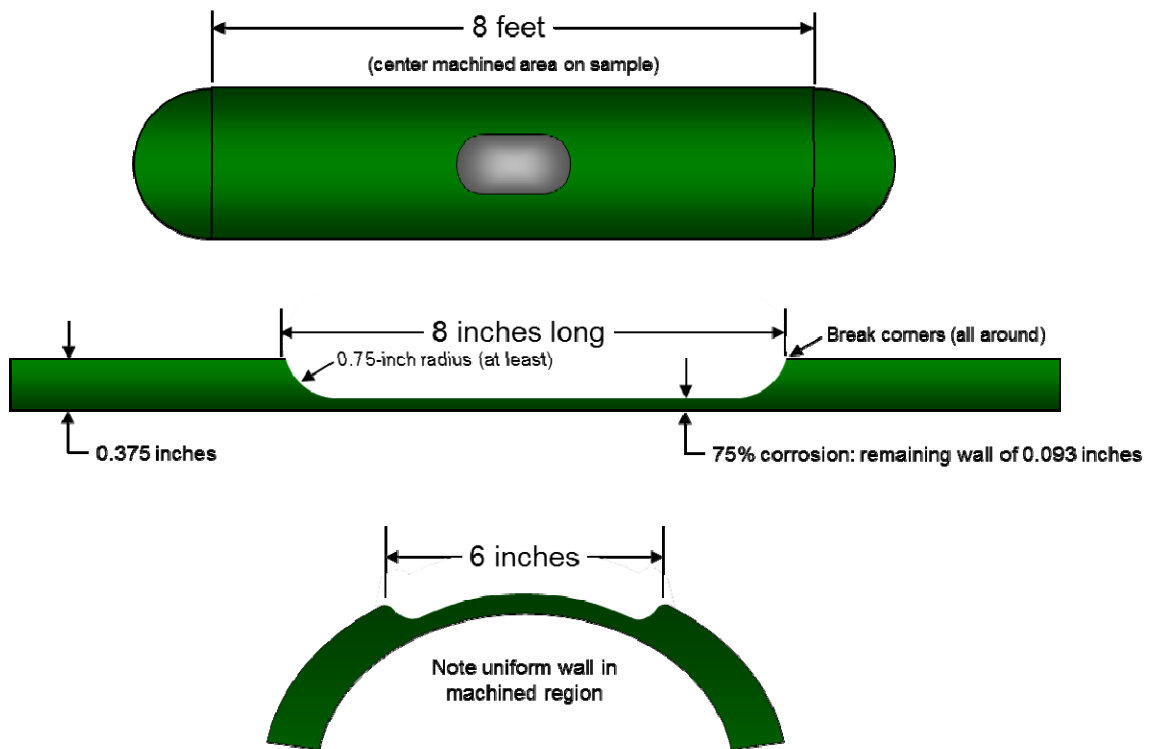
Figure 1: Simulated corrosion details

Details on machining
(machined area is 8 inches long by 6 inches wide)

1. Weld end caps to samples.
2. Machine simulated corrosion area in pipe as shown in Figure 1.
3. Install strain gages as shown in Figure 2.
4. Sandblast samples.
5. Install composite repair, Type A sleeve, and Type B sleeve. The thickness of the composite was 0.625 inches (10 layers) based on design calculations performed prior to making the repair.

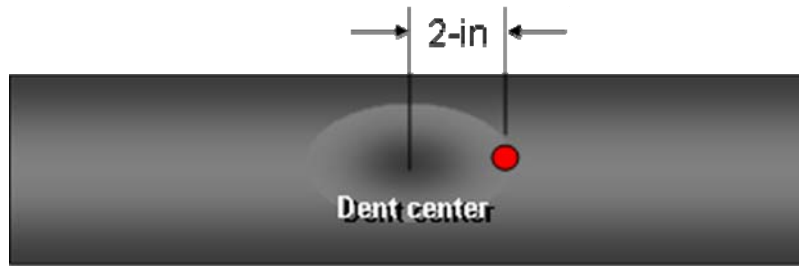
Figure 3: Dent configuration with strain gage locations

Close-up View of Dented Region

3. Sandblast pipes where the composite repair material will be installed.
4. Install strain gages near dents in transition area on “halo” region of dent. Refer to details shown in Figure 2.3 for strain gage locations

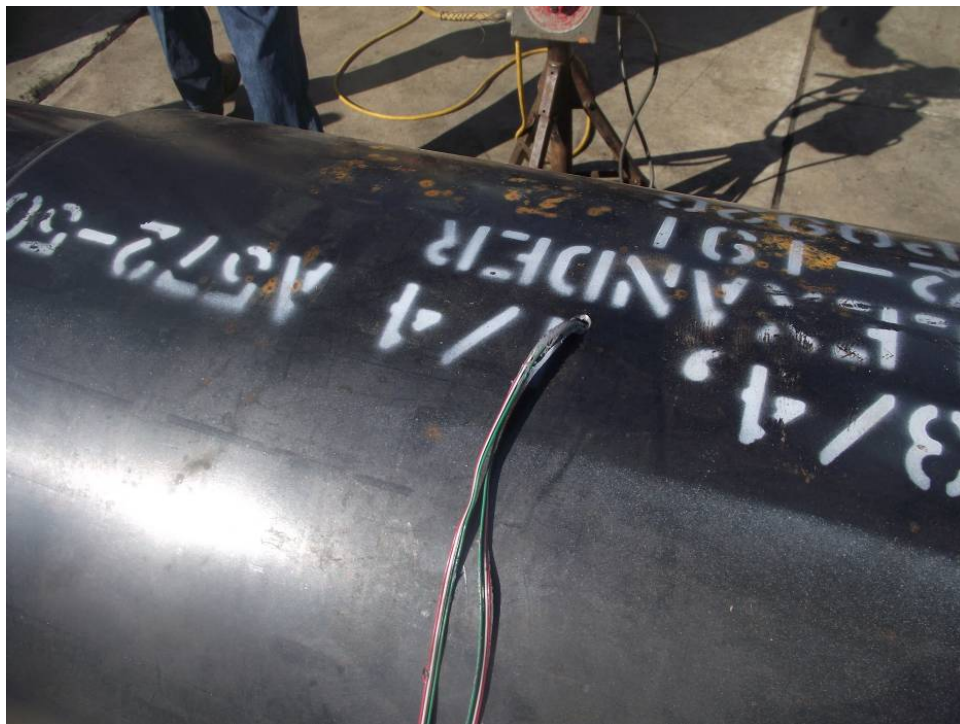
Figure 6: Photograph of hole in sleeve for strain gage wires

- Figure 5: Photograph of the composite installation.
- Figure 6: Photograph of hole in sleeve for strain gage wires
- Figure 7: Photograph of metal backing strip between sleeves chained to pipe
- Figure 8: Photograph of Type B steel sleeve

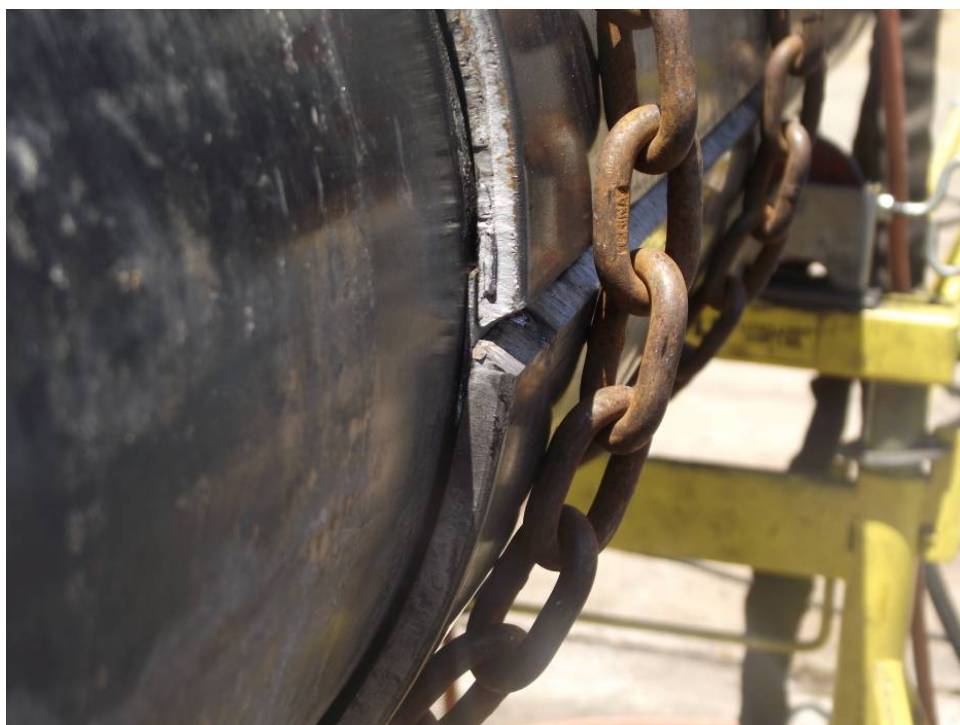
Figure 7: Photograph of metal backing strip between sleeves chained to pipe

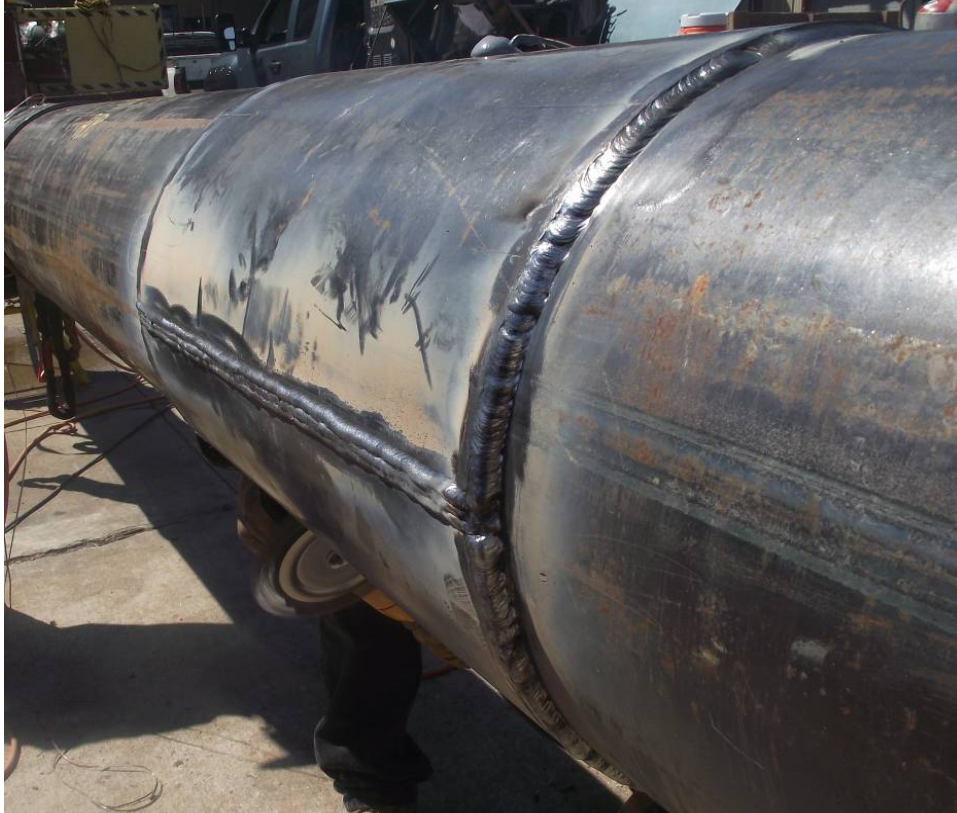
Figure 8: Photograph of Type B steel sleeve

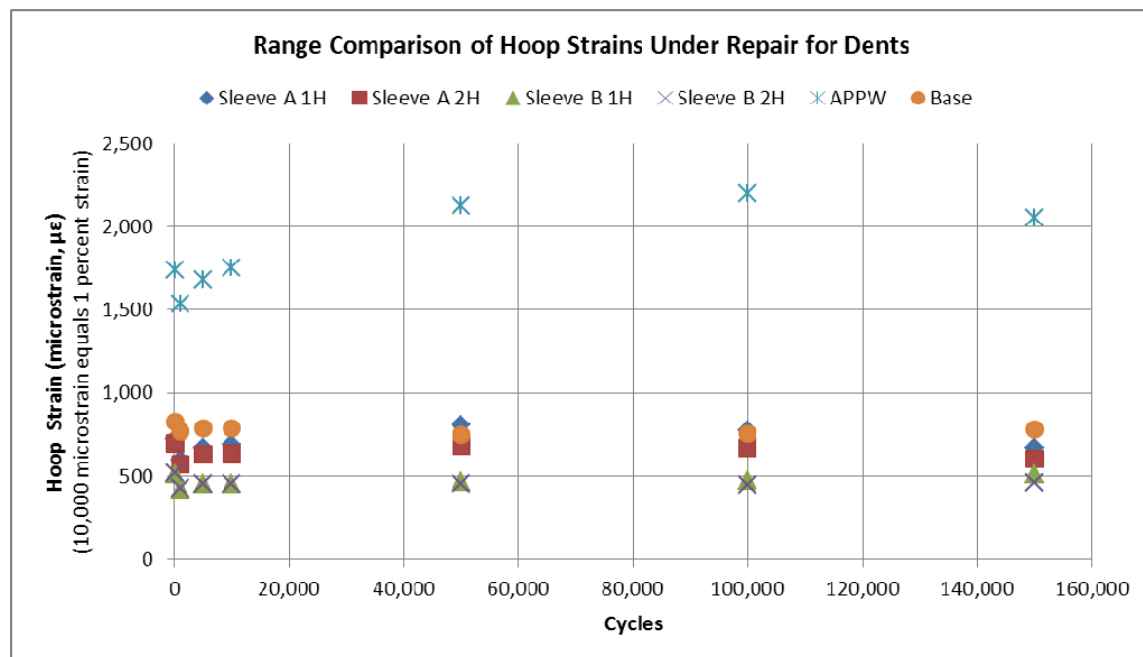
Figure 10: Strain measurements made during fatigue testing of the dent samples

The maximum hoop strains and ranges for the fatigue dent samples at 1,000 cycles are listed in Table 3. The composite repair sample failed in the dent after 149,913 cycles. The steel sleeves reached 239,897 cycles before cycling was stopped after the samples had exceeded the run-out condition. Figure 10 plots hoop strain measurements made during fatigue testing of the dent samples. As observed, data for the strain gages was recorded up to 150,000 cycles.
