USE OF FIBER OPTIC TECHNOLOGY IN MONITORING STEEL SLEEVES AND COMPOSITE WRAP REINFORCEMENTS

ADV Integrity, Inc.
Magnolia, Texas

Western Specialties, LLC
Houston, Texas

Lloyd's Register
Houston, Texas

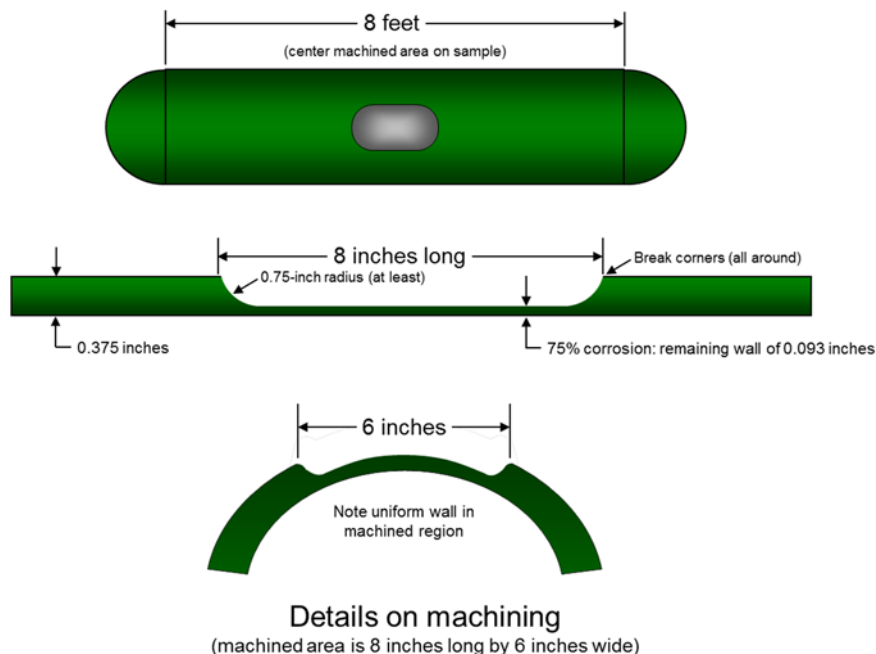
Figure 1: Simulated corrosion details

1. Welded end caps to samples and 1-inch NPT bosssets.
2. Machined simulated corrosion area in pipe as shown in Figure 1.
3. Sandblasted samples.
4. Installed strain gages as shown in Figure 2 and Figure 3; fiber optic sensor installed near Gage #3.
5. Installed Ultra-Wrap and ComposiSleeve™ repairs (completed by Western Specialties).

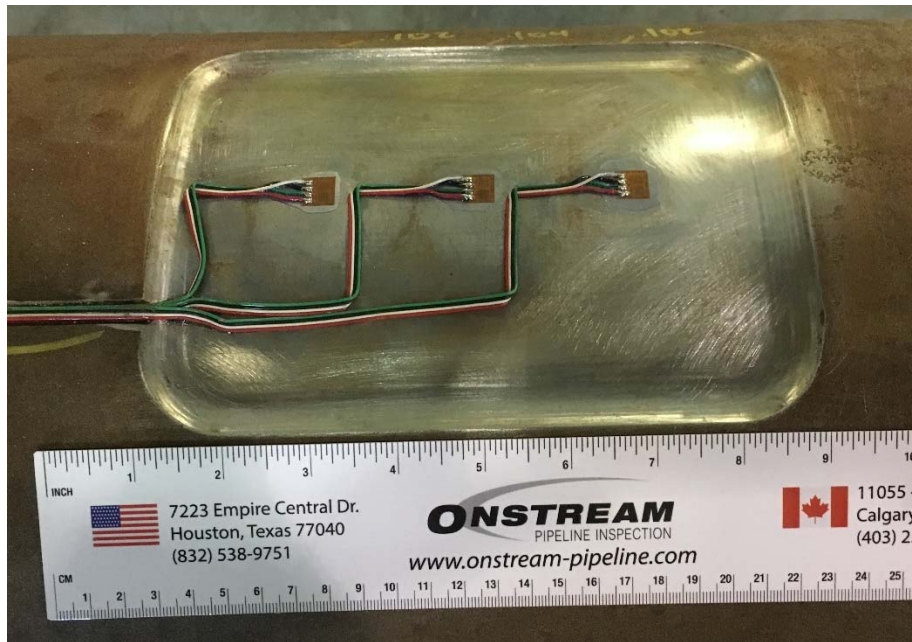
Figure 2: Simulated corrosion strain gage locations

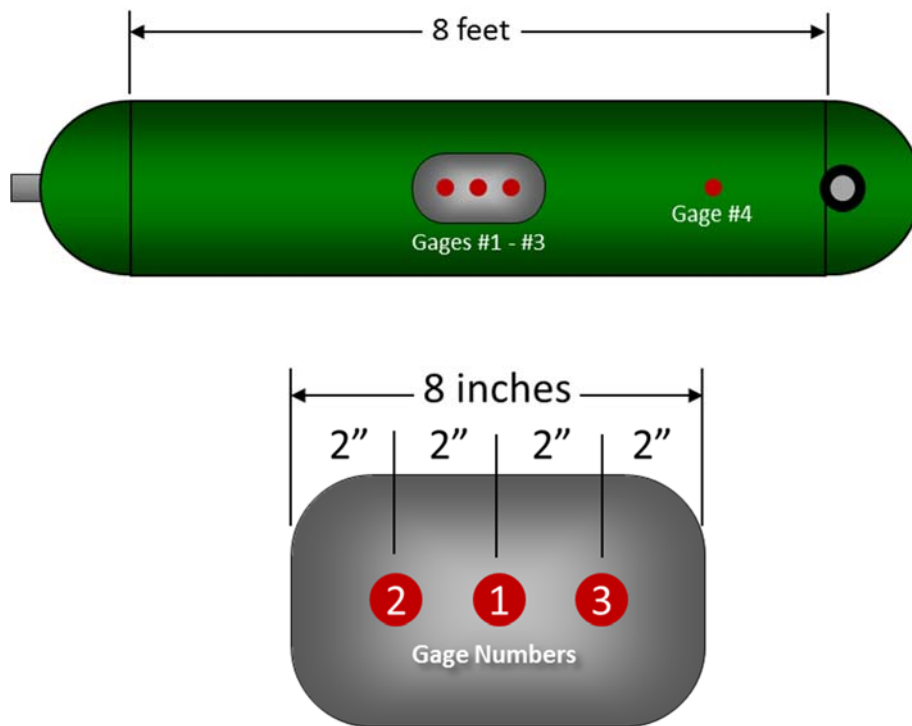
Machined region details

Figure 3: Strain gage locations and numbering

- d. Gage #4 ComposiSleeve™ sample: 0.362 inches Ultra-Wrap sample: 0.365 inches
3. Took photos during various stages of testing.
4. Installed strain gages as shown in Figure 3

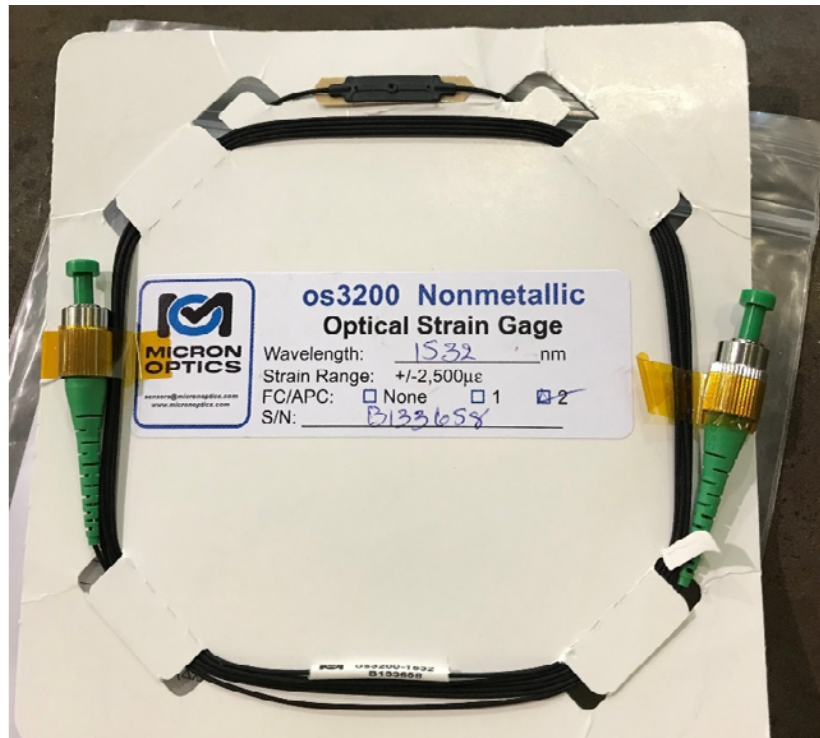
Figure 4: Fiber optic packaging

- Figure 4: Fiber optic packaging
- Figure 5: Close-up view of fiber optic sensor in simulated corrosion region (near Gage #3)
- Figure 6: Photograph showing installation of fiber optic sensor in steel sleeve
- Figure 7: Photograph showing installation of filler material
- Figure 8: Make-up of ComposiSleeve™ to specified torque value

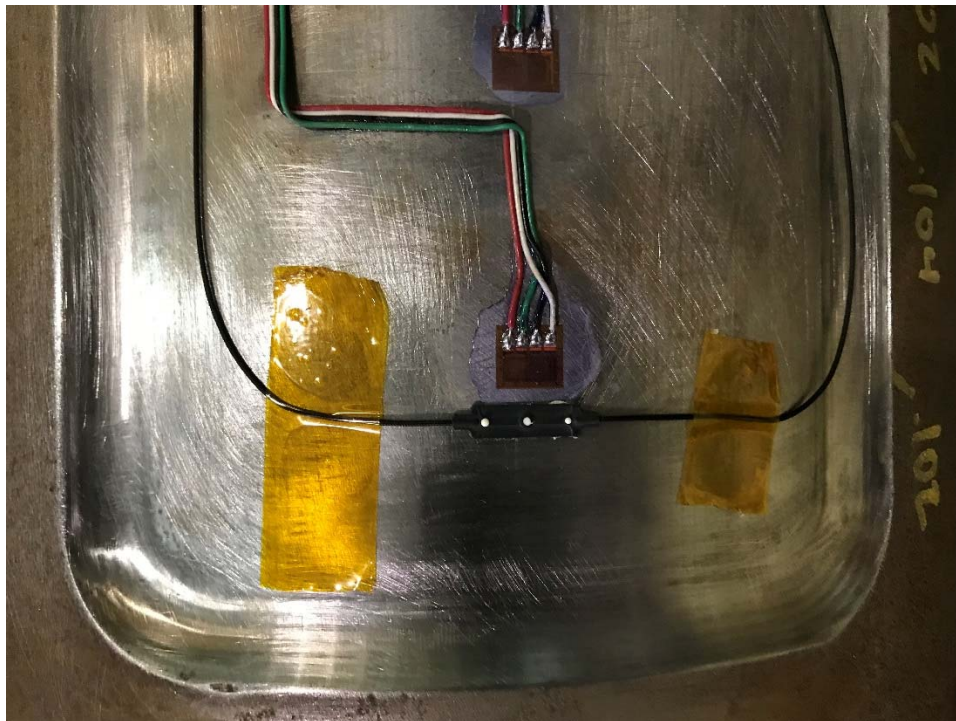
Figure 5: Close-up view of fiber optic sensor in simulated corrosion region

- 45° sensor located in top half shell
- 135° sensor located in bottom half shell
- 225° sensor located in bottom half shell
- 315° sensor located in top half shell
- 0° sensor located in corrosion feature near Gage #3 (as shown in Figure 5)

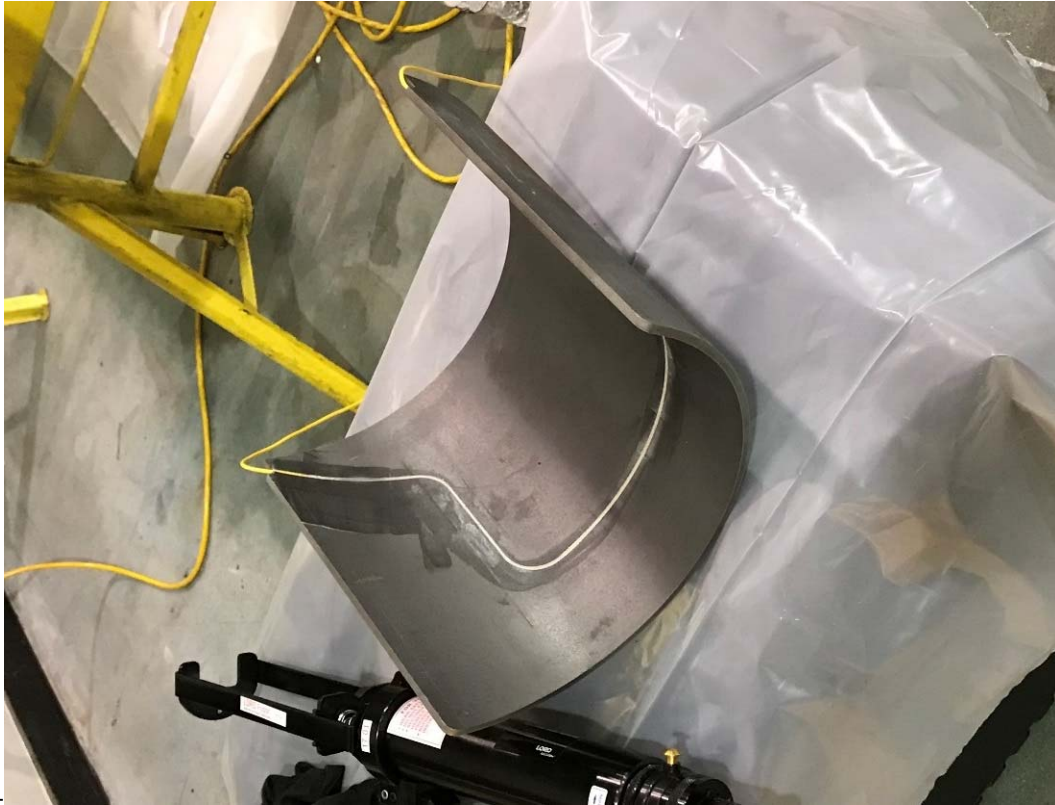
Figure 6: Photograph showing installation of fiber optic sensor in steel sleeve

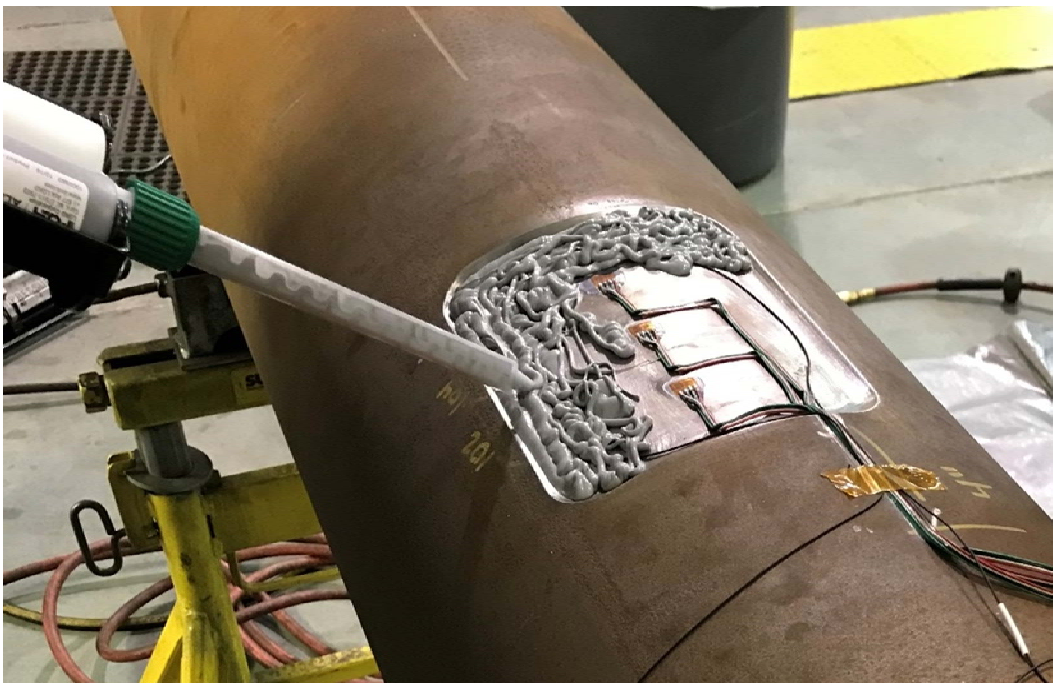
Figure 7: Photograph showing installation of filler material

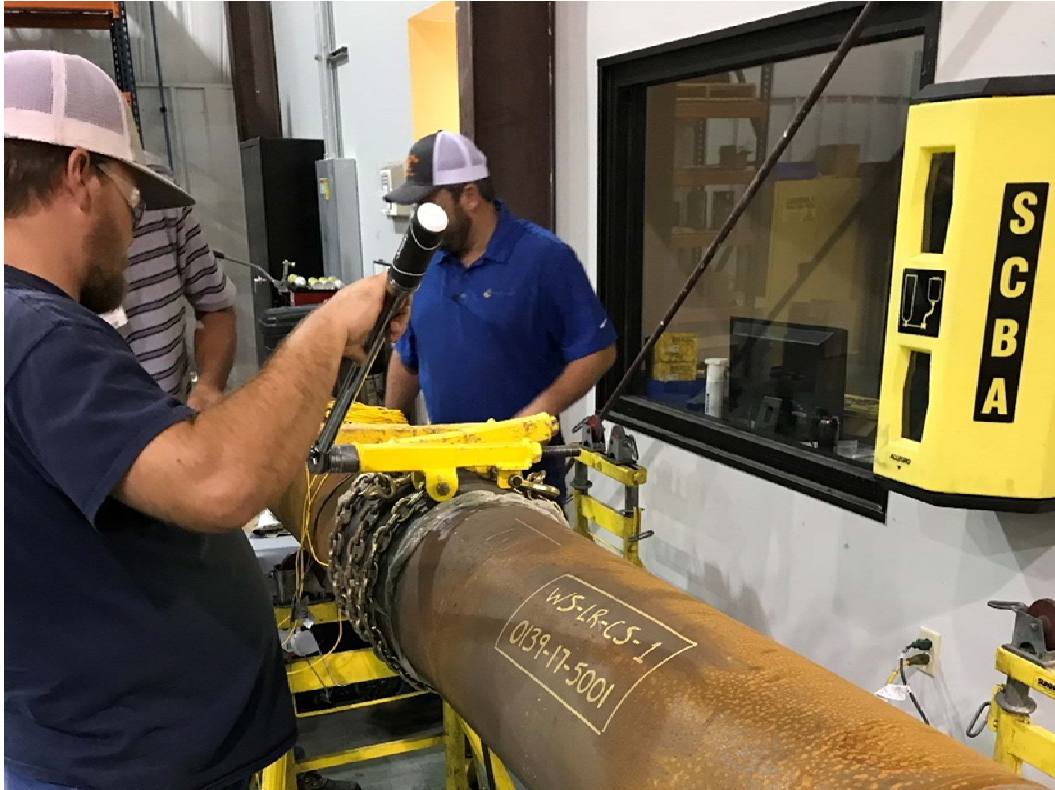
Figure 8: Make-up of ComposiSleeve™ to specified torque value

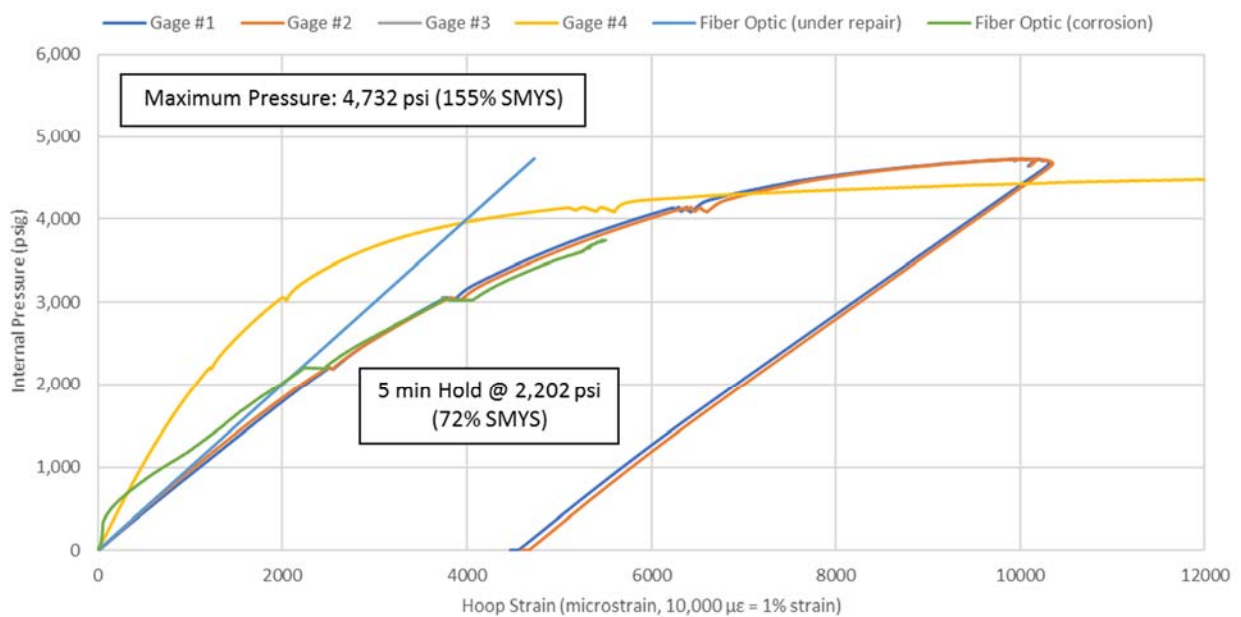
12.75-inch x 0.375-inch, Grade X52 pipe with 75% corrosion defect | $P_{failure} = 4,732$ psig

Figure 9: Hoop strain versus internal pressure for Ultra-Wrap Sample

The Ultra-Wrap sample was pressurized to the designated 5-minute holds at 72% SMYS, 100% SMYS, and 100% AYS pressure levels. The sample was then pressurized to failure. Figure 9 plots hoop strain as a function of internal pressure for the Ultra-Wrap sample; included in this plot are results for the four strain gages, as well as results for the fiber optic sensor located in the simulated corrosion region adjacent to Gage #3 (refer to the photograph in Figure 5) and the sensor located 180° from the corrosion feature on pristine (un corroded) pipe beneath the composite repair. Note that Gage #4 is located on the base pipe away from the corrosion feature and repair zone.

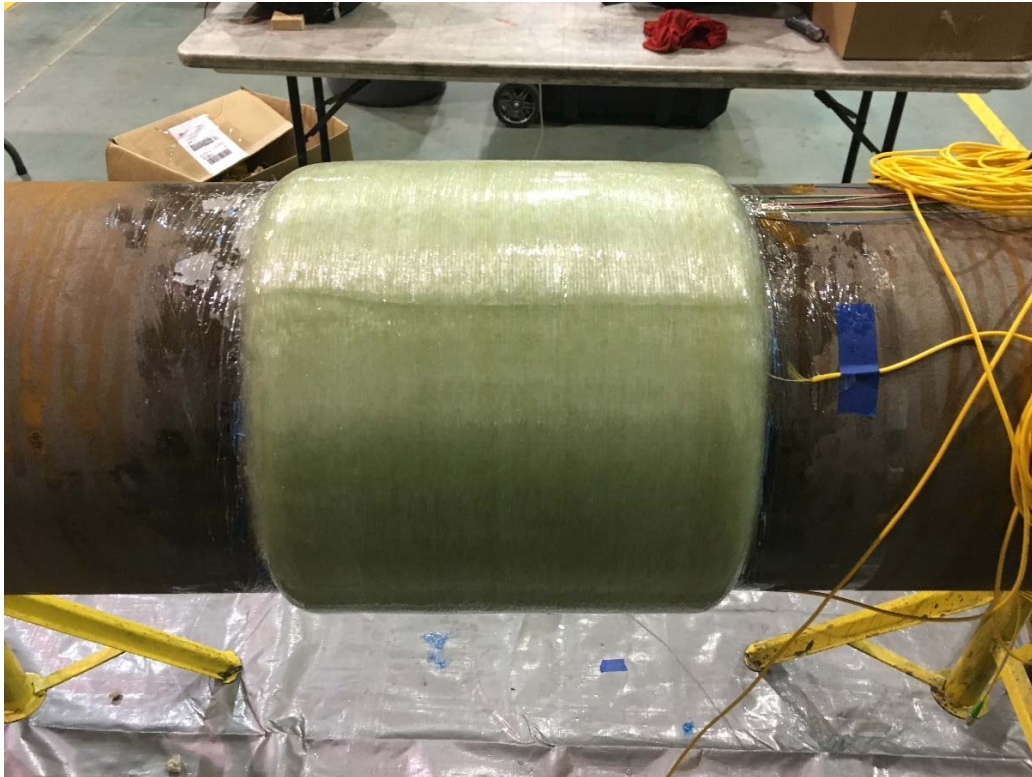
Figure 10: Photograph of Ultra-Wrap sample before pressure testing

Figure 10 and Figure 11 are photographs of the Ultra-Wrap sample before and after testing, respectively. The maximum pressure this sample reached before failure was 4,732 psi (155%) and failed outside the repair as shown in Figure 11.

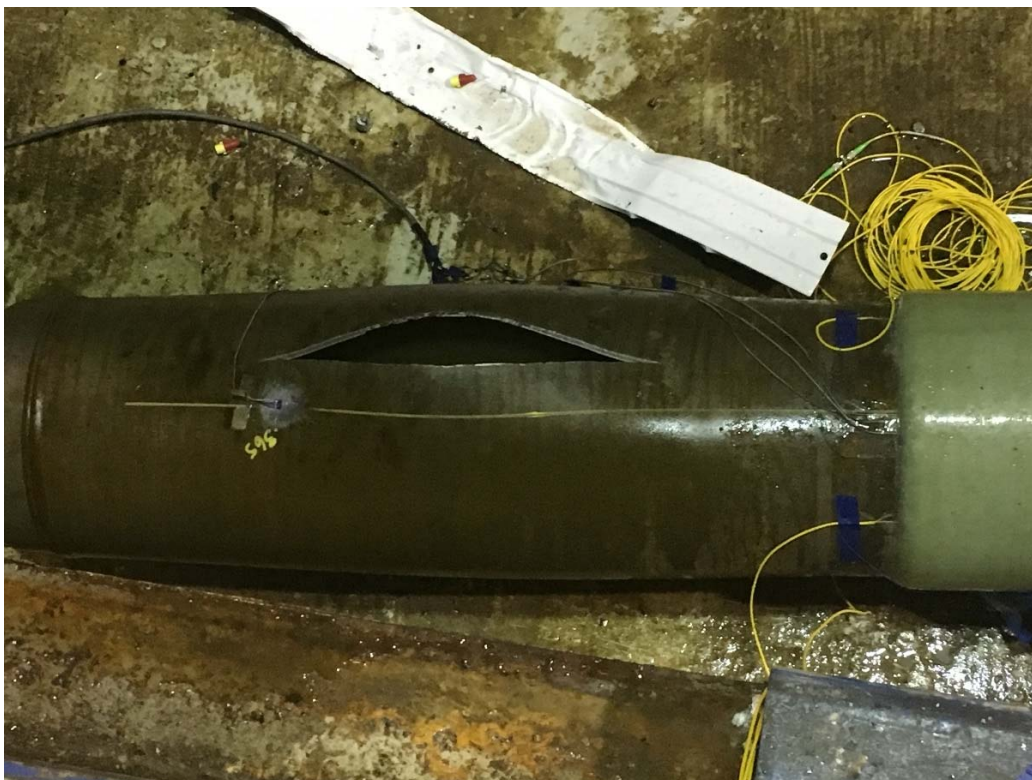
Figure 11: Photograph of Ultra-Wrap sample after pressure testing

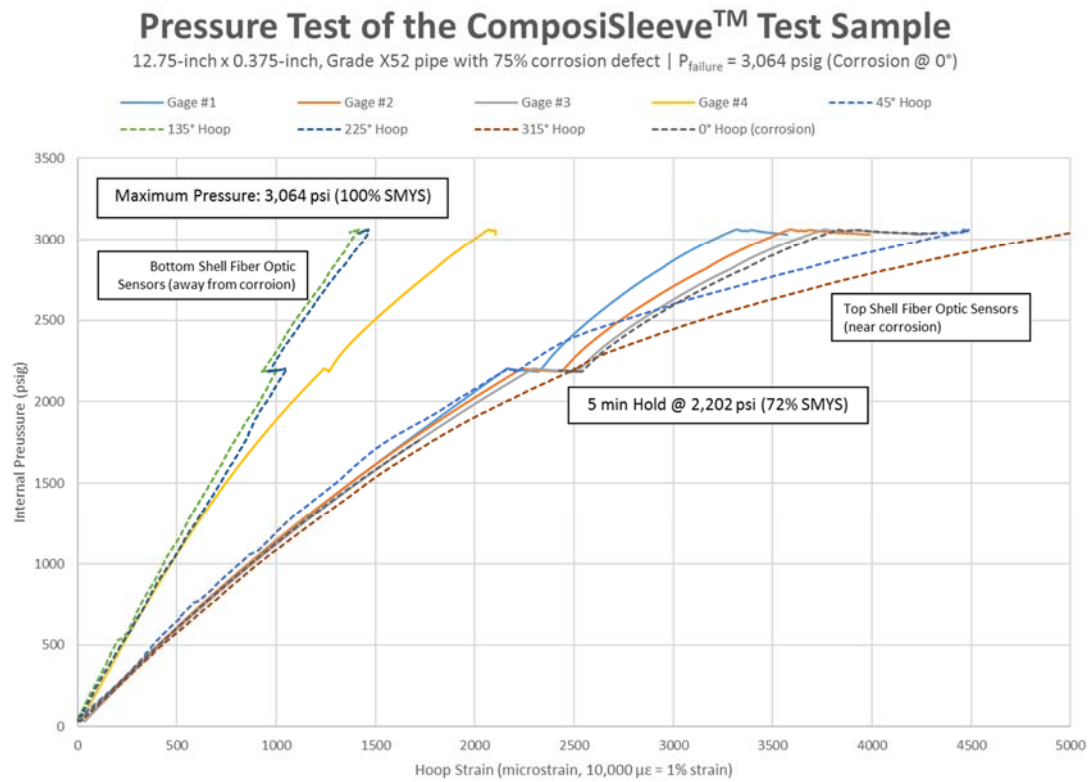
Figure 12: Hoop strain versus internal pressure for ComposiSleeve™ Sample

The ComposiSleeve™ sample was pressurized to the designated 5-minute holds at 72% SMYS and 100% SMYS pressure levels. Figure 12 plots hoop strain as a function of internal pressure for the ComposiSleeve™ sample; included in this plot are results for the four strain gages, as well as results for the fiber optic sensor including those embedded in the steel half shells and simulated corrosion region. Unlike the Ultra-Wrap sample that only employed one fiber optic sensor, the ComposiSleeve™ sample integrated five fiber optic sensors as noted below (all measurements relative to 12 o'clock position, or 0° where corrosion feature installed):

Annotations are made in Figure 12 to assist the reader in identifying results for the top side (45° and 315° sensors) and the bottom side (135° and 225° sensors) half shells. In general, the measurements made by the fiber optic sensors embedded in the top side half shell track closely with strain gage measurements made in the corrosion region, while the bottom side sensors generally track with measurements made on the base pipe.

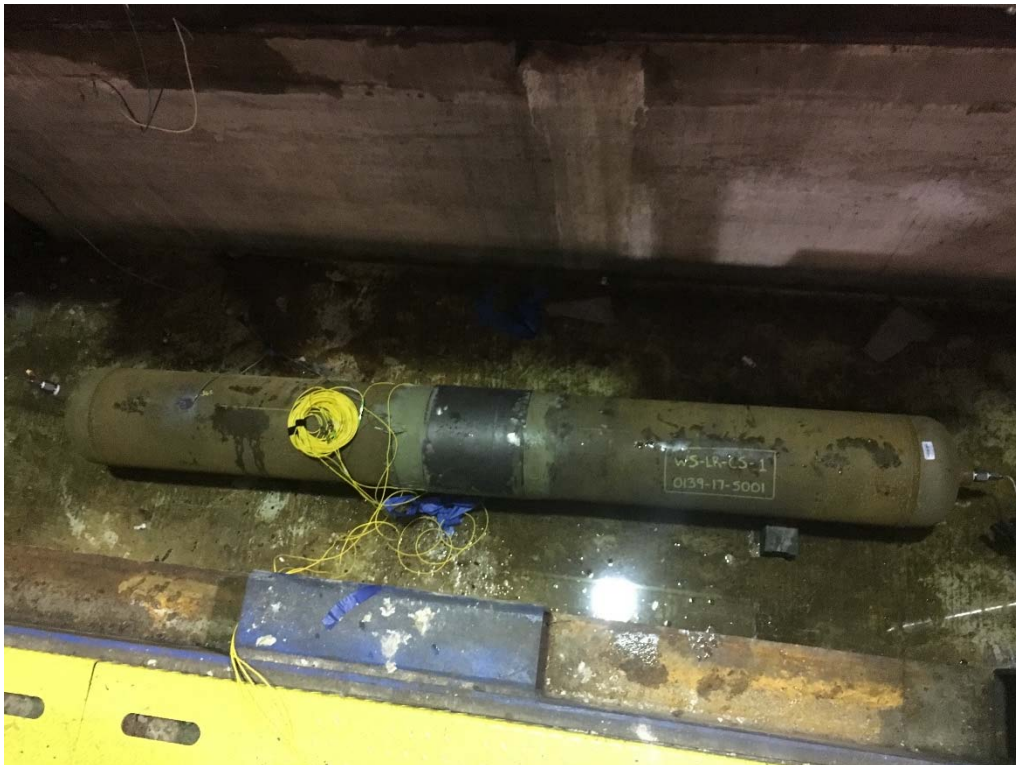
Figure 13: Photograph of ComposiSleeve™ sample before pressure testing

- Figure 13: Photograph of ComposiSleeve™ sample before pressure testing
- Figure 14: Photograph of ComposiSleeve™ sample after pressure testing

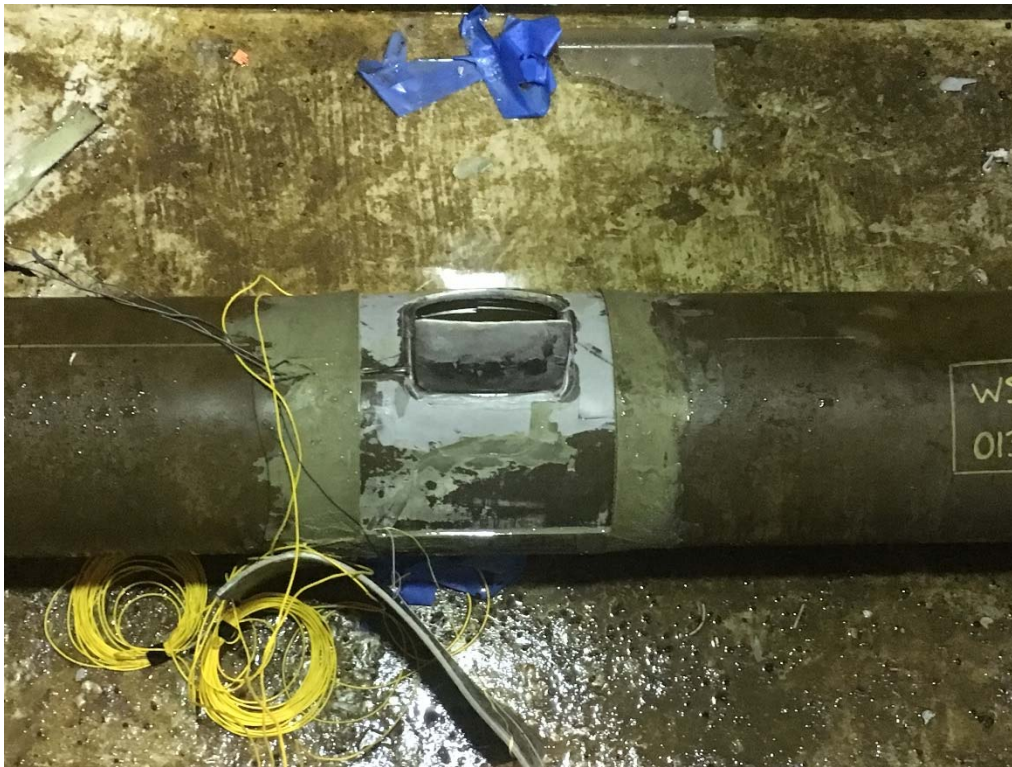
Figure 14: Photograph of ComposiSleeve™ sample after pressure testing

As shown in Figure 14, failure of the ComposiSleeve™ sample occurred in the repaired region. However, this result was not unexpected as a composite overwrap was not installed over the steel half shells. Had the Ultra-Wrap system been installed over the steel half shells as is typically done for this system, the failure would have

occurred outside the reinforcement. The composite overwrap was not included in this particular test to maximize strain in the steel half shells and ensure that appreciable strain levels would be imparted to the steel half shells during pressure testing, especially in the vicinity of the simulated corrosion feature.

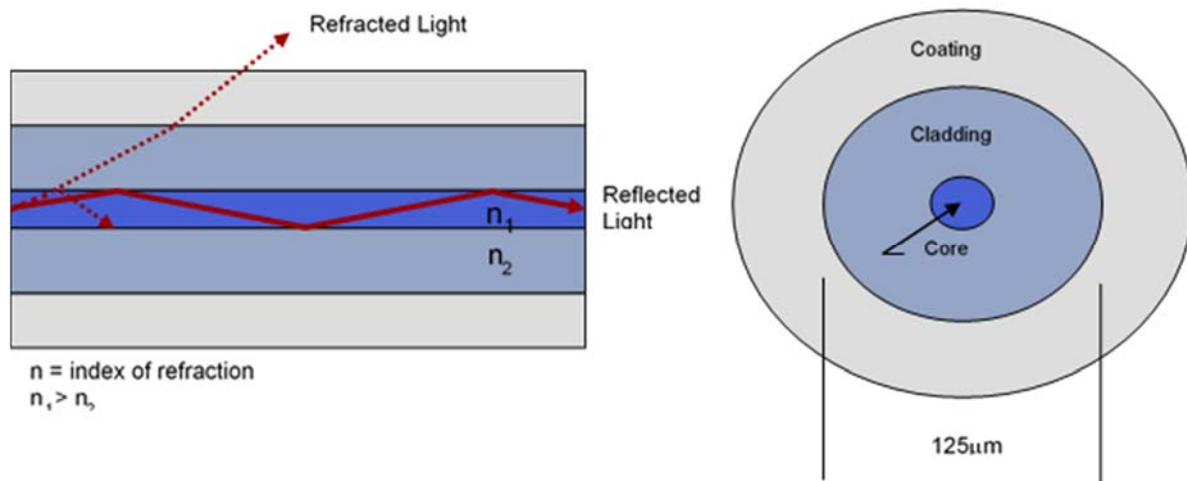
Figure 15: Schematic of a Single Mode Optical Fiber
(125 micrometers, approximately 0.005 inches)

Fiber optic sensing technology and associated data analytics have evolved to a point where industry can derive an accurate understanding of what is happening inside a repair or the health of the repair, the condition of the anomaly on the pipe and the condition of the pipeline itself by integrating the sensors into the repair. Using two Fiber Bragg Grating (FBGs) arrays with a total of six sensors each allows measurements at each 90-degree location. There is a hoop sensor (mounted circumferentially), and axial sensor (mounted longitudinally) and a temperature compensation gage. Once a base measurement is established with strain and temperature then the sensors can then be calibrated/converted to monitor strain, pressure, bending and temperature. The main advantage of FBGs for mechanical sensing is that these devices perform a direct transformation of the sensed parameter to an optical wavelength, independent of light levels, connector or fiber losses, or other FBGs at different wavelengths. A typical fiber structure is depicted in Figure 15 and an example of the FBGs used in this study shown in Figure 16.

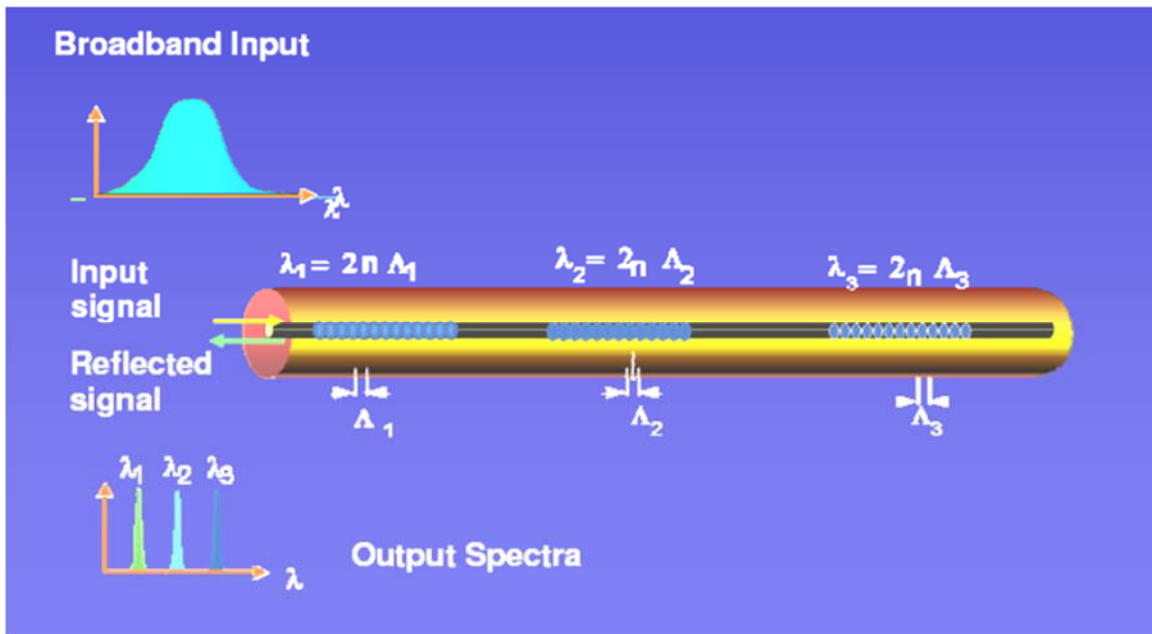
Figure 16: Fiber Bragg Grating with 3 separate and unique sensor locations
