Steel Sleeves: A New Look at a Widely-Used Repair Method

Pipeline Pigging and Integrity Management Conference

ABSTRACT

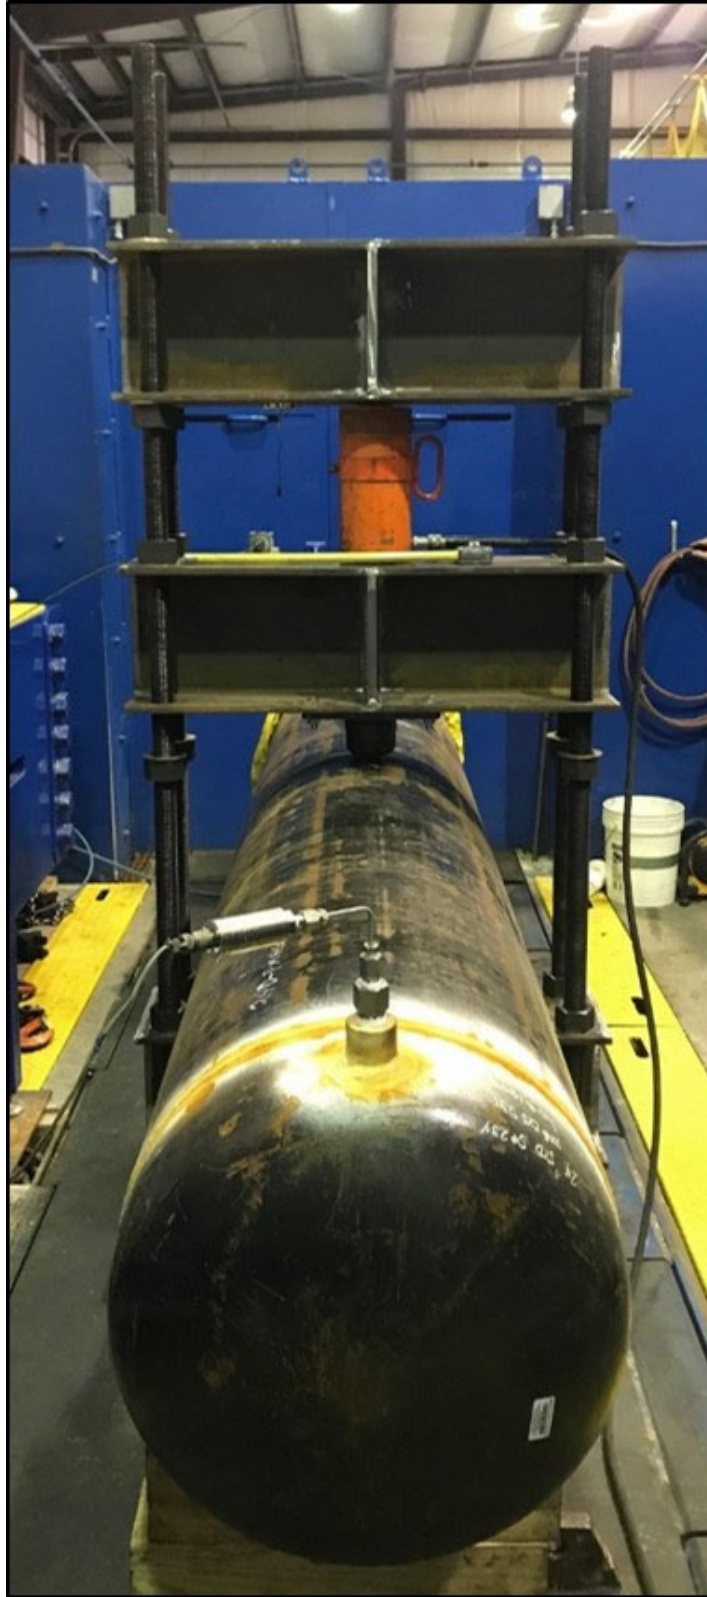
Figure 1: End view of indentation frame with 24-inch pipe

Several photos are included from the Steel Sleeve Qualification Study showing various stages of the testing process:

- Figure 1: End view of indentation frame with 24-inch pipe
- Figure 2: View of simulated dent
- Figure 3: Strain gage locations for the dented samples

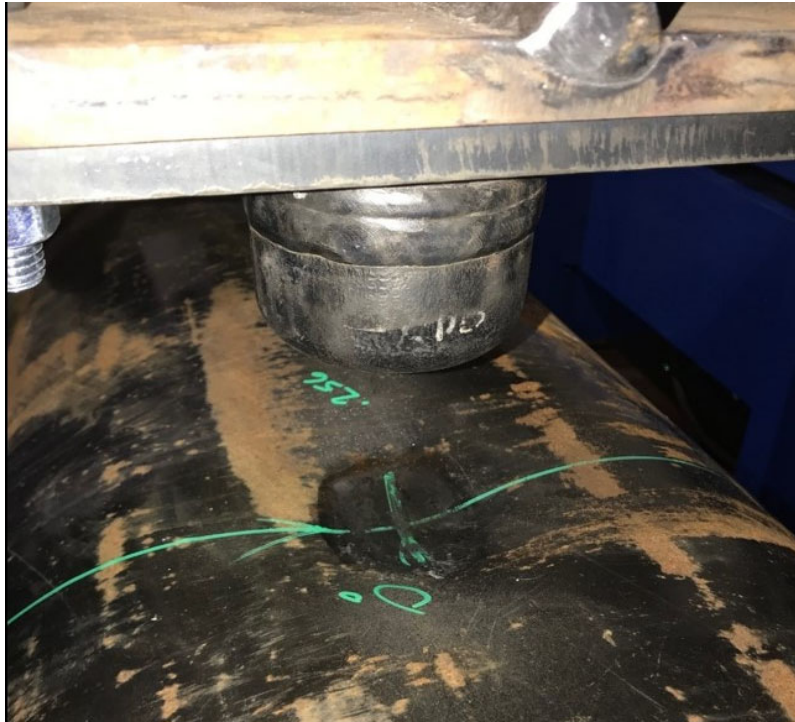
Figure 2: View of simulated dent after indenter removal

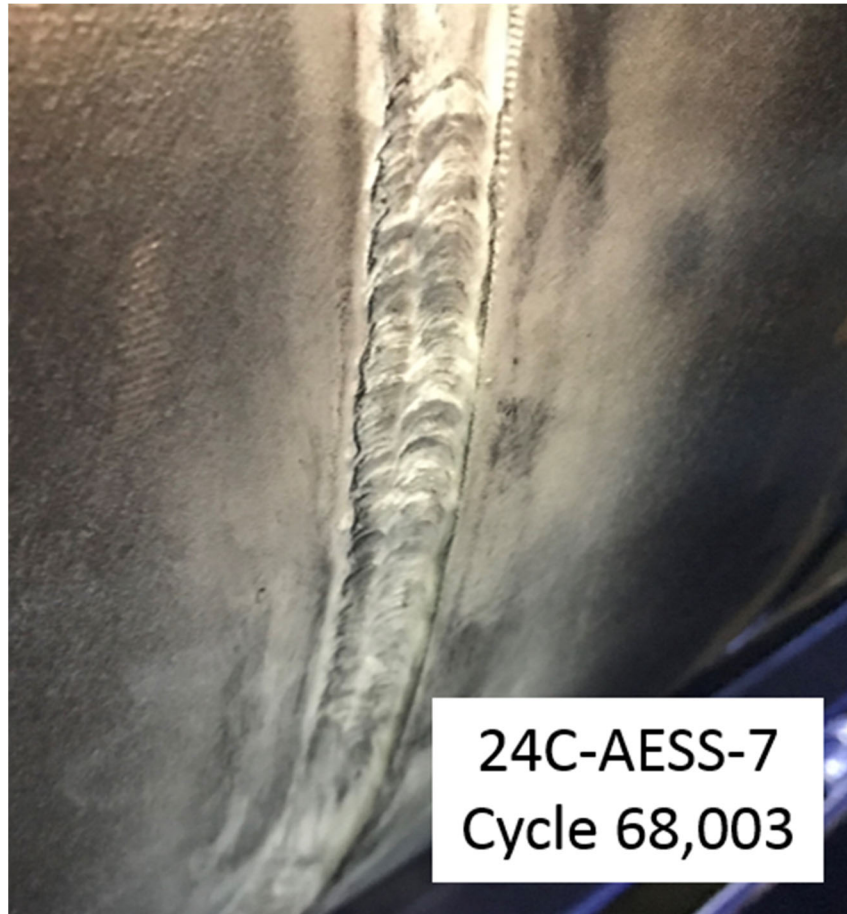
Figure 6 – View of Failure 24C-AESS-7

A longitudinally-oriented crack developed in the unreinforced sample after 32,579 cycles, as shown in Figure 4. In a similar manner the two Allan Edwards samples, 24C-AESS-3 and 24C-AESS-7, increased the fatigue lives of the unreinforced corrosion defect to be 53,665 and 68,003 cycles, respectively. As shown in Figure 5 a leak developed in the long seam weld of 24C-AESS-3; however, in sample 24C-AESS-7 a leak developed in the girth weld of the sleeve as shown in Figure 6.
