Paper 36

INSIGHTS GAINED THROUGH THE DEVELOPMENT OF A ROADMAP FOR COMPOSITE REPAIR SYSTEMS

Chris Alexander *

Stress Engineering Services Inc., Houston, Texas USA

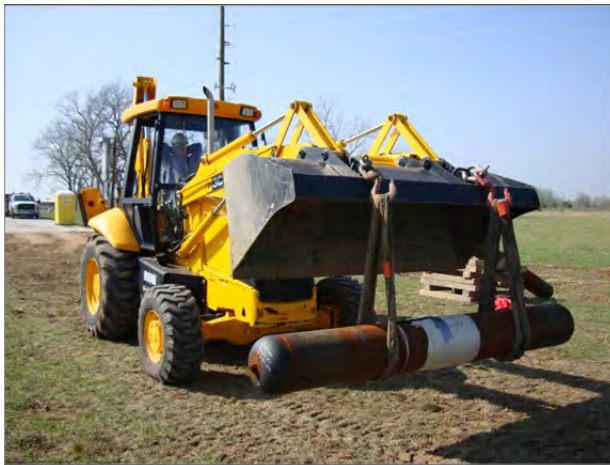
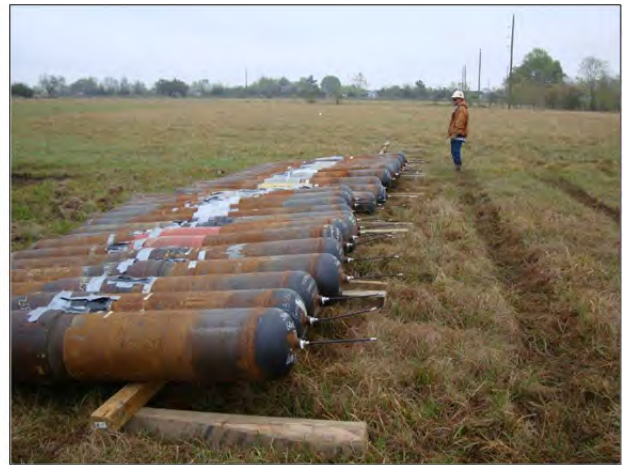
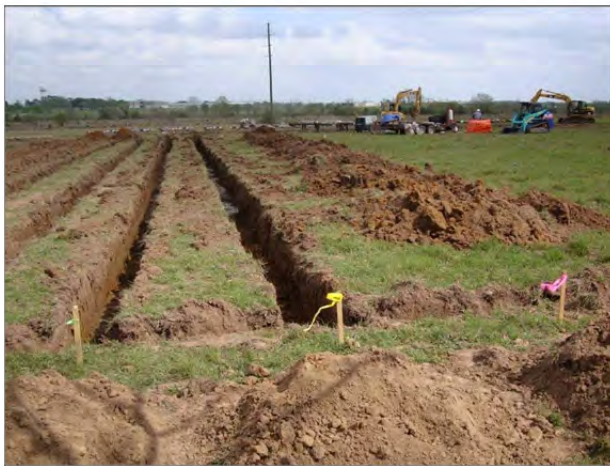
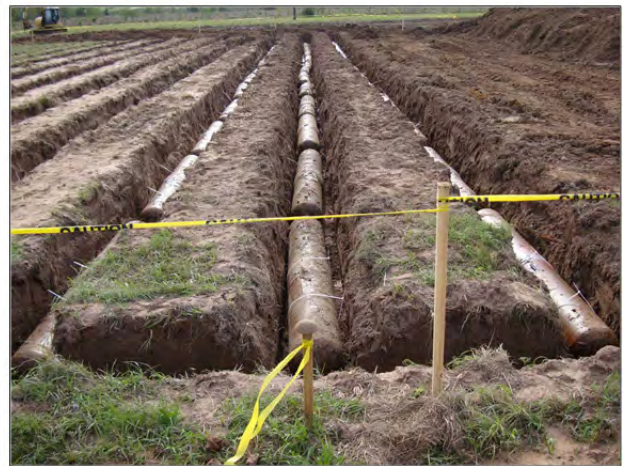
Figure 4: Photographs of the MATR-3-4 buried pipeline test facility

A second benefit, and the primary focus of this study, is to evaluate the long-term performance of the composite repair systems. If one considers the 3 and 10 years test periods, the time during which the samples are loaded is approximately 26,300 hours and 87,600 hours, respectively. The 75% corrosion samples represent a relatively severe condition, especially when one considers that 900 cycles at a stress range of 36% SMYS and 4 cycles at 72% SMYS were applied annually to all buried samples.

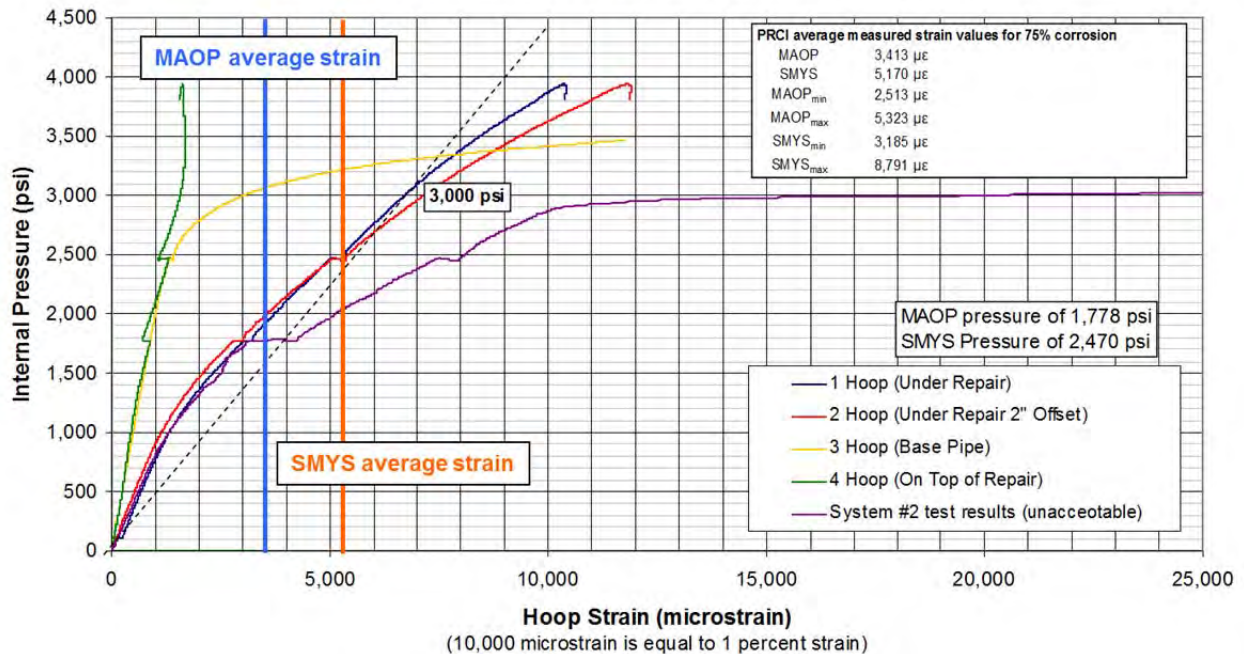
Hoop Strain Versus Pressure for Two Repair Systems

Burst test of 12.75-inch x 0.375-inch, Grade X42 pipe with 75 % Corrosion with Gages #1 and #2 beneath compositerepair on steel. MAOP of 1,778 psi (72% SMYS) and SMYS of 2,470 psi.

Figure 6: Strain gage measurements from Year 0 burst tests for two competing systems

As mentioned previously, the Year 0 served as the baseline data set for the test program. It was recognized that the due to varying degrees of composite material degradation, these results would be the best that could be expected of all test results. **Figure 5** provides the average hoop strain measurements for the Year 0 75% corrosion samples at the designated pressure levels (72% and 100% SMYS), while **Figure 6** provides actual stress-strain data from two of the burst test samples.

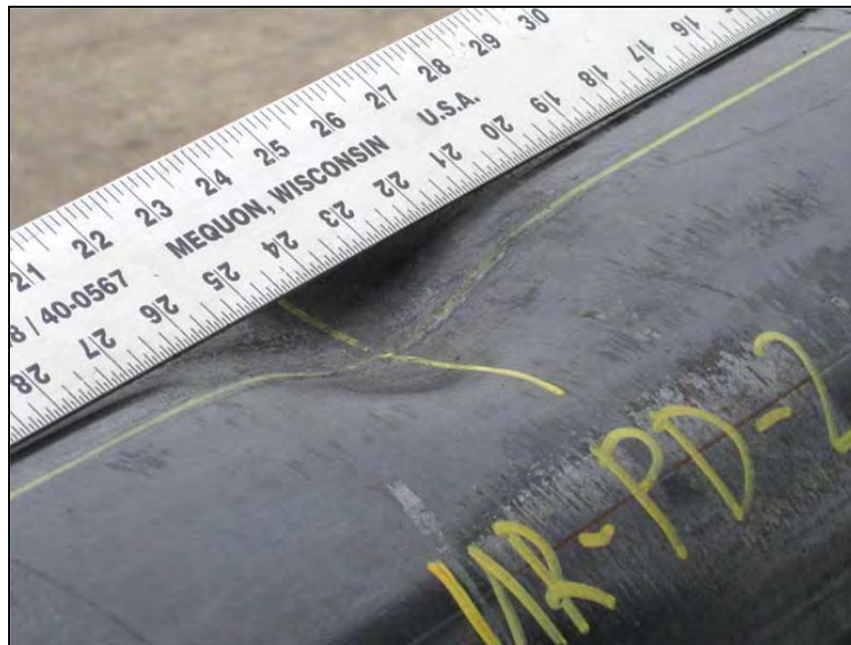
Figure 8: Photograph showing plain dent test sample after indentation

A total of 11 different repair systems were evaluated in this study, coming from eight composite manufacturers and one steel sleeve manufacturer. These repair systems were used to repair specific dent configurations installed in 12.75-inch x 0.188-inch, Grade X42 pipe ERW material. The dent geometries included plain dents, dents in girth welds, and dents in seam welds. The dents were installed to a depth of 15% of the pipe's outer diameter (1.91 inches) using an NPS 4 end cap as an indenter held in place while the pipe sample was pressurized to 72% SMYS, or 892 psi. A schematic diagram of the 28-ft test samples is shown in **Figure 7**. One test sample of this configuration was made for each of the repair systems, as well as the unrepaired condition. **Figure 8** provides a photo showing one of the installed dents.

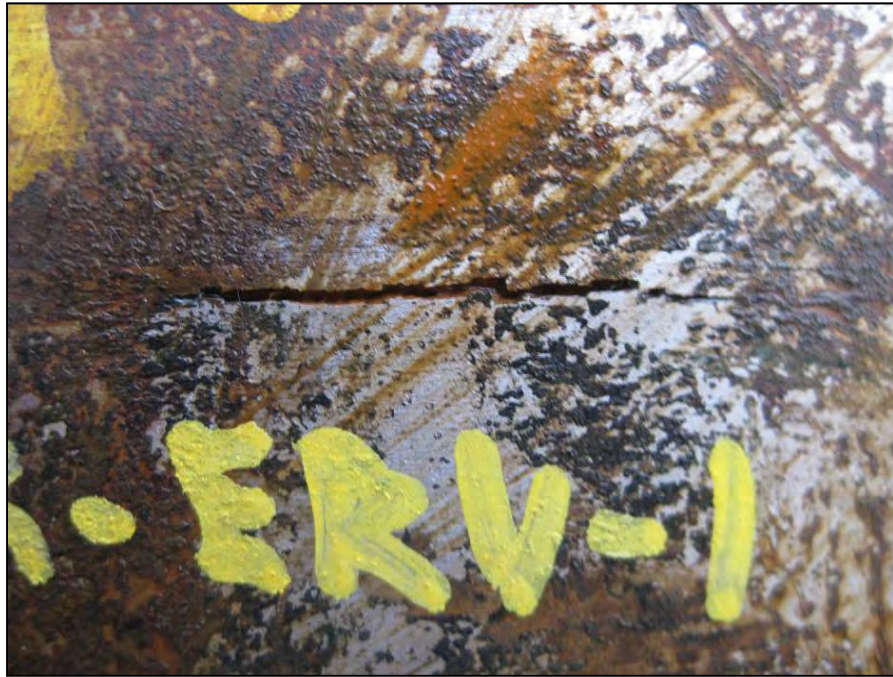
Figure 9: Photograph showing typical fatigue crack in dented test samples

Each composite repair system was evaluated using a total of six dents, except one system that was only used to repair two plain dents (retest to re-qualify a previously tested system). The six dents in each pipe sample were pressure cycled to failure or 250,000 cycles (whichever occurred first) at a pressure range of approximately 100 psi to 992 psi. These pressure values are referred in this report as having a range equal to 72% of the pressure causing the specified minimum yield strength (SMYS) in the hoop direction, varying from 100 psi, or 8% SMYS to 992 psi, or 80% SMYS. **Figure 9** is a photograph showing a fatigue failure in one of the unrepaired test samples.

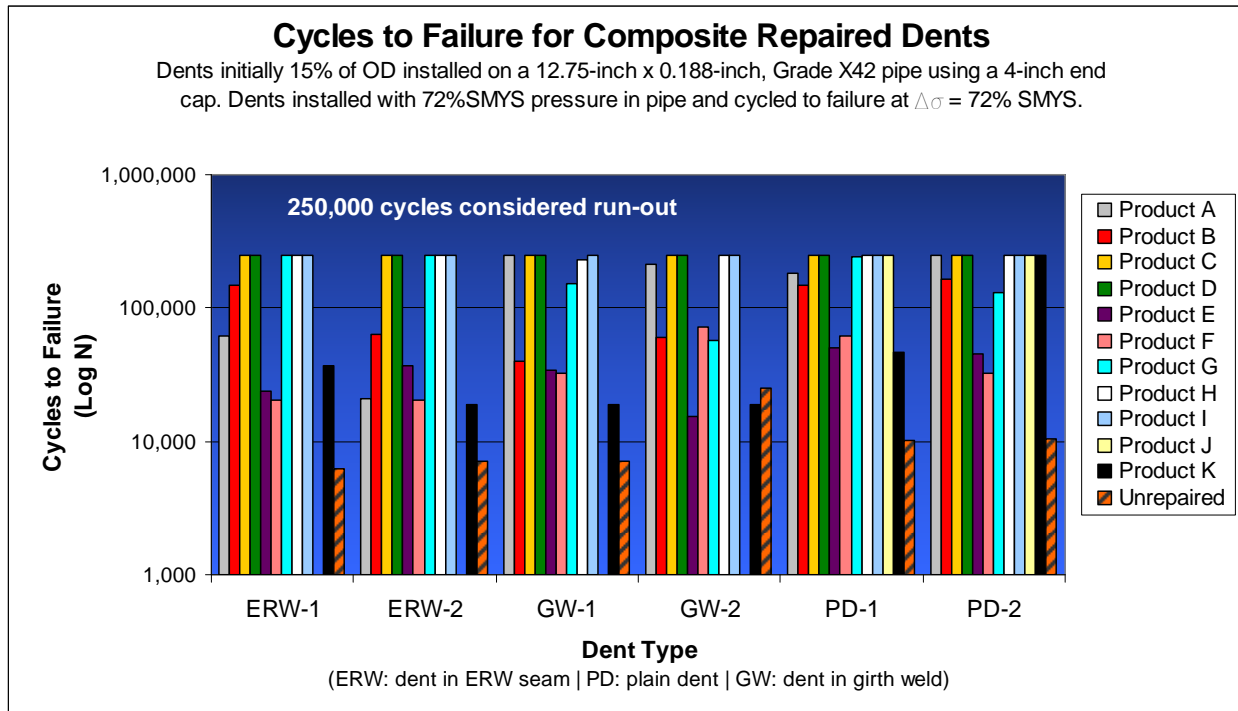
Figure 10: Fatigue test results for composite repaired dent test samples
(Dent configurations: ERW is dent in ERW seam, GW is dent in girth weld, and PD is the plain dent)

Of the 11 tested systems, six products used to repair plain dents were able to achieve the 250,000 cycle run-out condition. The cycles to failure is plotted graphically in **Figure 10**. Some samples ran for more than 250,000 cycles, since the shut-off condition in the cyclic pump was not automated. The results section of this report lists actual cycles accumulated for each sample. One of these systems was cycled beyond the run-out condition to determine the actual limit state of the pipe, which resulted in a fatigue failure of the ERW seam in the base pipe (outside of the repairs) at 358,470 cycles.

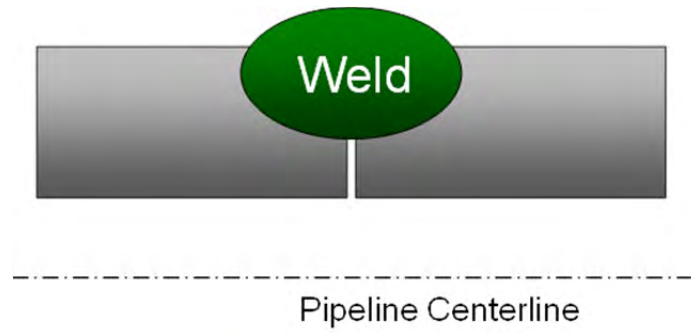
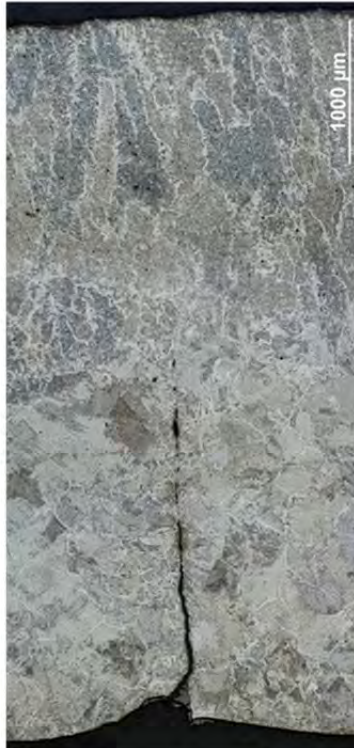
Figure 12: Schematic and photograph showing MATR-3-7 defective girth weld samples

The program involved the reinforcement of 12.75-inch x 0.188-inch, Grade X42 pipe samples that had defective girth welds that did not include a root pass (i.e., simulated lack of penetration weld defects). **Figure 12** provides a schematic of the girth weld configuration, as well as a cross-section showing the lack of penetration in an exemplar weld. **Figure 13** is a schematic diagram showing the MATR-3-7 test sample with strain gage locations.

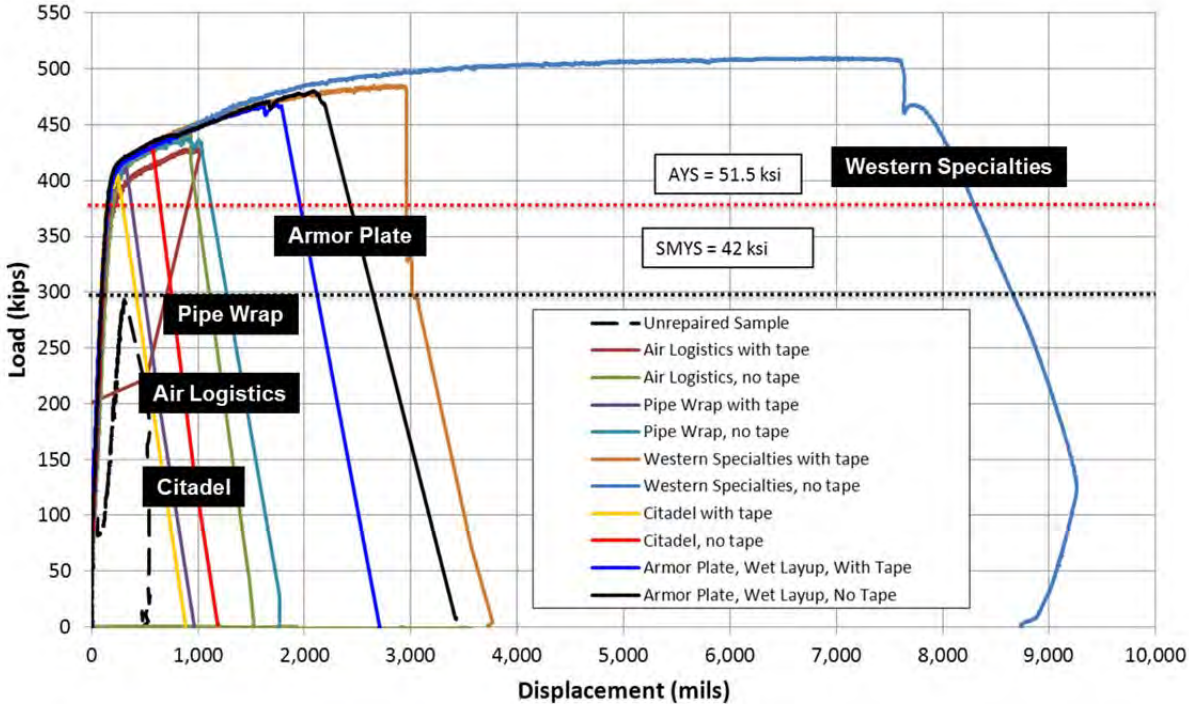
Figure 15: Load-deflection tension test results for the MATR-3-7 girth weld samples

Considering the reinforced tension samples with full bonding areas, products from Air Logistics, Pipe Wrap, LLC, Citadel, and Armor Plate Pipe Wrap had tension-to-failure loads ranging from 433 to 481 kips. However, the Western Specialties LLC repair was able to achieve a maximum tension load of 522 kips, with a failure occurring outside of the repair in the base pipe near a welded boss. The load-deflection tension test results for the reinforced and unreinforced girth weld samples are shown in **Figure 15**.
