## REPAIR OF LEAKS IN THIN WALL HIGH PRESSURE PIPELINES USING COMPOSITE REINFORCING TECHNOLOGIES

### ABSTRACT

A study was conducted to evaluate two composite repair technologies used to reinforce severe corrosion and thru-wall leaking defects in thin-walled pipe materials; conditions where the welding of conventional Type B steel sleeves cannot be conducted. This program involved the reinforcement of simulated 85% corrosion defects in 6.625-inch x 0.157-inch, Grade X52 pipe materials subjected to cyclic pressure and burst testing. The test matrix also included repaired pipe samples with thru-wall defects that were pressurized using nitrogen gas and buried for 90 days. The program was comprehensive in that it evaluated the following elements involving a total of 81 reinforced corrosion defects.

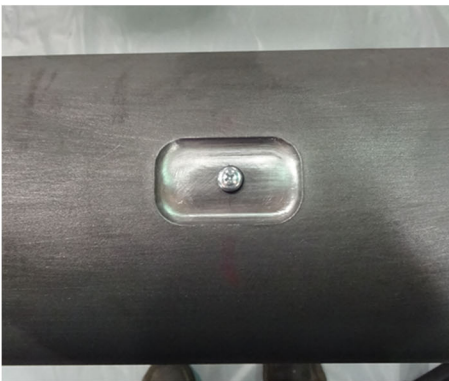
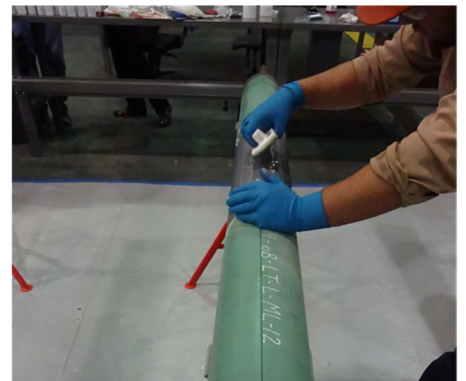
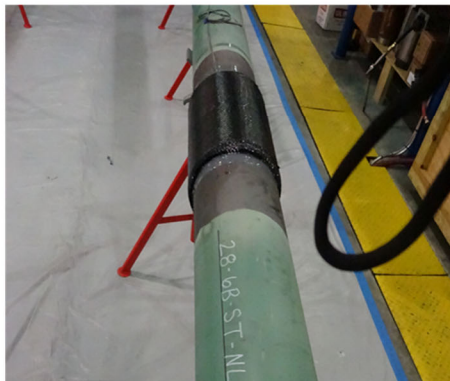
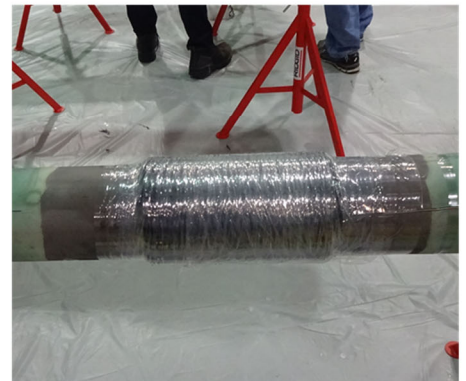
**Figure 2: Milliken Atlas™ Installation (Stage I)**

Testing began in 2018 and was conducted over a two-year period that was divided into two stages of work: Stage I testing included three (3) phases, four (4) repair technologies, 28 pipe samples, for a total of 36 severe-corrosion defects. Figure 2 and Figure 3 show the installation procedures utilized by two of the composite repair companies, Milliken and Western Specialties (results for the other two repair companies are not included in this paper).

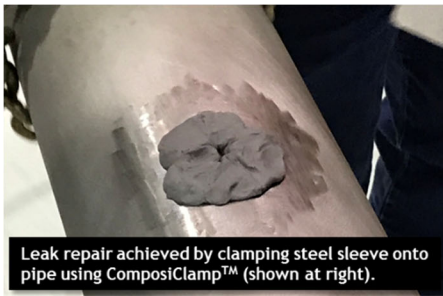
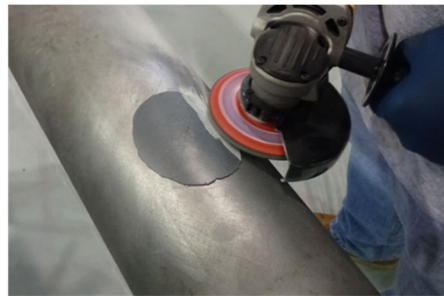
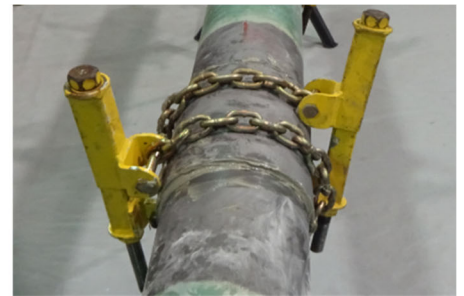
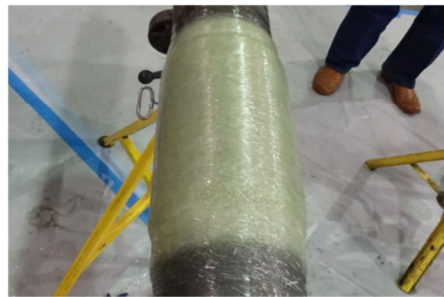
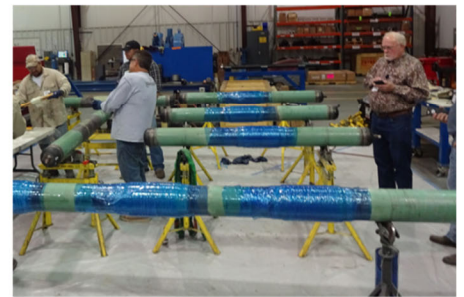
**Figure 3: Western Specialties Installation (Stage I)**

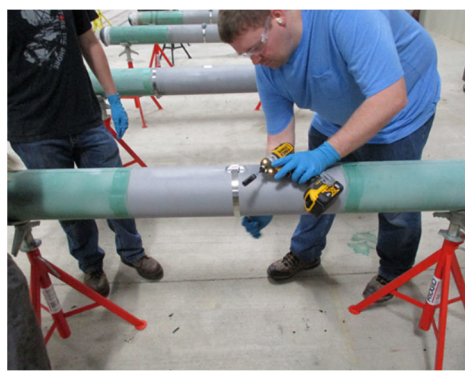
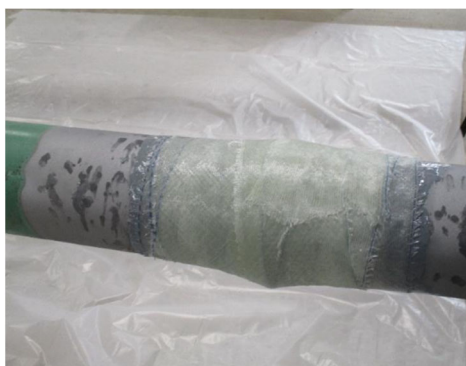
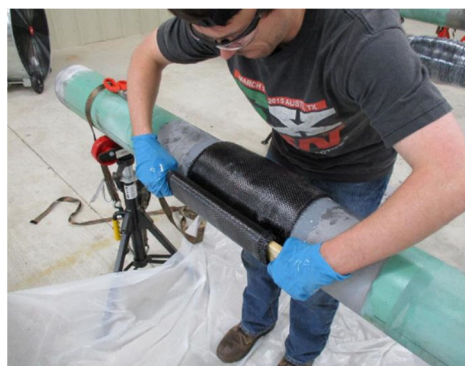
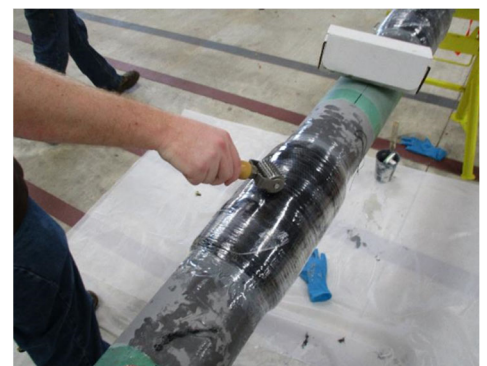
**Figure 4: Milliken Atlas™ Installation (Stage II)**

After Milliken adjusted their installation procedures for the Stage II phases of testing, the performance between the two systems became more comparable. In fact, when comparing the Stage II – Phase 1 burst pressures, the Milliken system performed better at elevated temperatures and the average failure pressure was 3,669 psig [25.30 MPa] for ambient temperature, and 2,800 psig [19.31 MPa] for the 60°C [140°F] elevated temperature. While Western Specialties' average failure pressure was 3,679 psig [25.4 MPa] for ambient temperature, and 1,966 psig [13.6 MPa] for the 60°C [140°F] elevated temperature. Milliken's failure pressures were reduced an average of 869 psig [6.0 MPa] at the 60°C [140°F] elevated temperature, while Western Specialties was reduced by 1,713 psig [11.8 MPa] on average. This advantage is also seen in the Stage II – Phase 2 cycle test results. Milliken's average cycles to failure at the 60°C [140°F] elevated temperature was 2,192 cycles, while Western Specialties was 437 cycles.

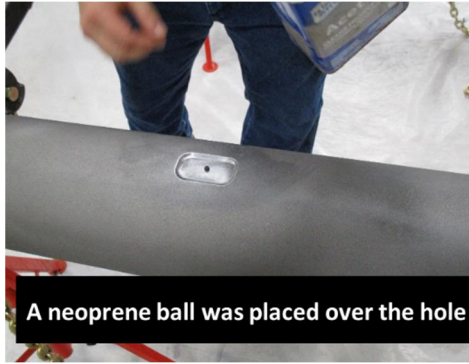
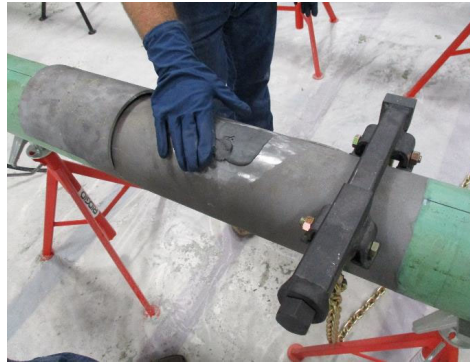
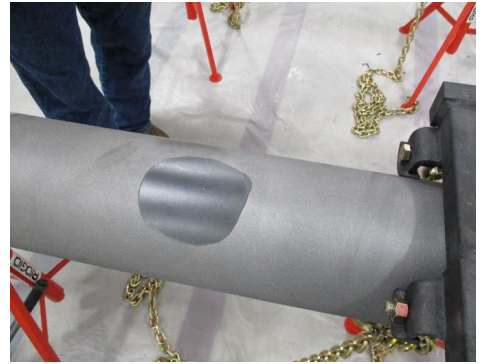
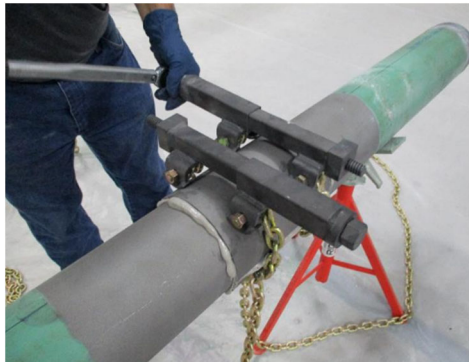
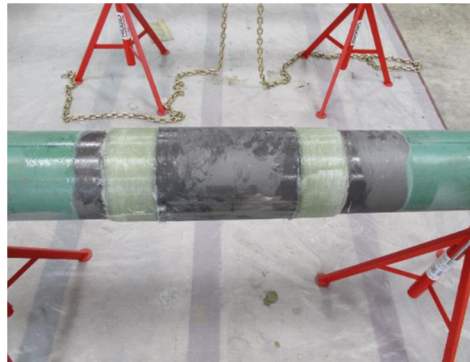
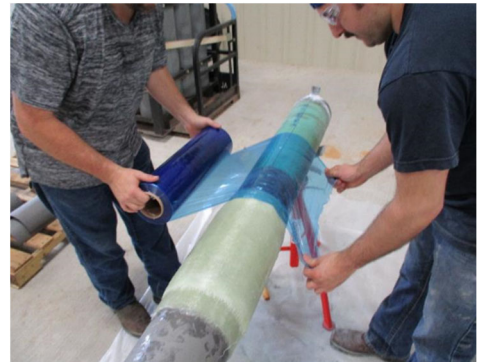
**Figure 5: Western Specialties Installation (Stage II)**
