## GENERATION AND MONITORING OF SYNTHETIC CRACK-LIKE FEATURES IN PIPELINE MATERIALS USING CYCLIC PRESSURE LOADING

Chris Alexander<sup>1</sup>, Jon Rickert<sup>1</sup>  
Rhett Dotson<sup>2</sup>, Felipe Freitas<sup>2</sup>, Simon Slater<sup>2</sup>, Christopher De Leon<sup>2</sup>

<sup>1</sup>ADV Integrity Inc., Waller, Texas

<sup>2</sup>ROSEN, Houston, Texas

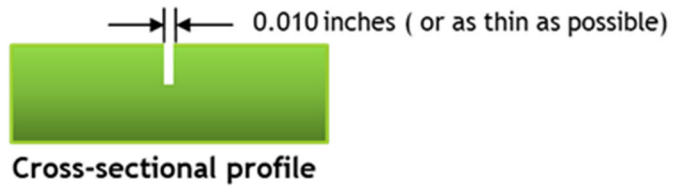
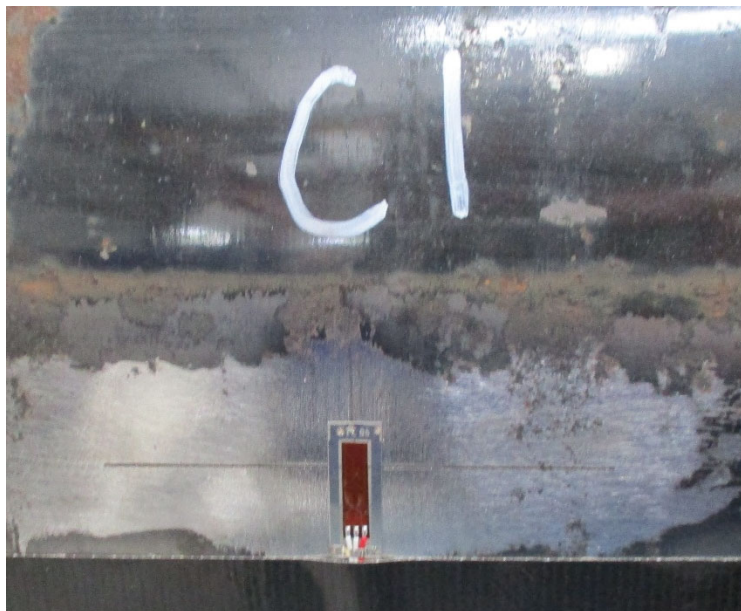
Figure 5: Notch Geometry for Samples 2 through 5 with close-up photo of strain gage

EDM Notch Details

Figure 4 shows cracks initiated from Notches “A2”, “B0”, and “C1”. The notch geometry for Samples 2-5 was chosen based on the crack growth results from the sacrificial sample. As discussed later in the results section, Sample 1 failed at feature type “C” (fastest crack growth rate); therefore, for optimizing testing schedule and to guarantee a crack length within ILI tool detectable tolerance, feature type “C” (3-inch long notch) was the selected candidate to be used in the other samples (Samples 2-5). Figure 5 shows the geometry of the notches and schematics for Samples 2-5.
