Paper No. OMAE2011-49425

ASSESSING THE USE OF COMPOSITE MATERIALS IN REINFORCING OFFSHORE RISERS AND PIPELINES

Chris Alexander
Stress Engineering Services, Inc.
Houston, Texas
chris.alexander@stress.com

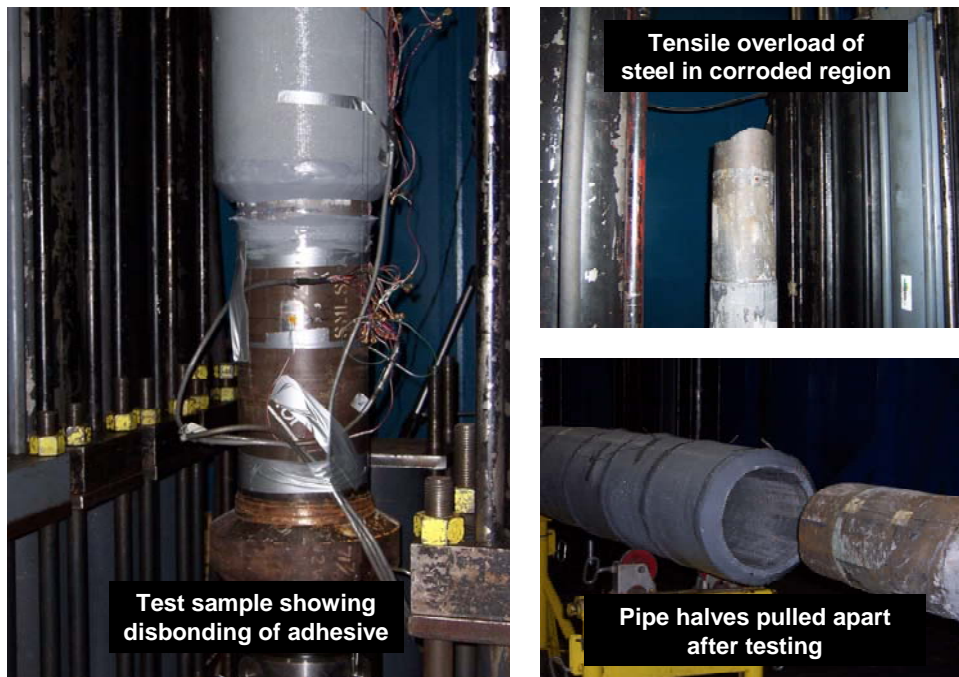
Figure 10 provides several photos showing the post-failure surface of the pressure-tension sample for Product D. As shown, the inner steel in the corroded region failed due to tensile overload. The adhesive at the interface between the composite and steel is used to transfer load into the composite material. At some point during loading, the strength in this bond is exceeded and the composite is no longer able to carry the tensile load. As shown in Figure 10 (lower right hand side photo), the composite material remains intact.

**Figure 10 – Post-failure photos of Product D pressure-tension test**
