ANALYSIS OF COMPOSITE REPAIR METHODS FOR PIPELINE MECHANICAL DAMAGES SUBJECTED TO CYCLIC LOADING

Christopher R. Alexander
Stress Engineering Services, Inc.
13800 Westfair East Drive
Houston, Texas 77041-1101

Keith Leewis
Gas Research Institute
8600 West Bryn Mawr
Chicago, Illinois 60631

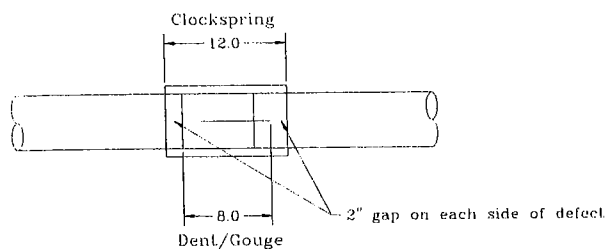
Fig. 3 Location of Clock Spring Relative to Defects

Figure 3 shows how the Clock Spring was positioned on the pipe relative to the dent/gouge regions. The Clock Spring wraps are 12 inches wide and sufficiently cover any dent/gouge combination which is less than 8 inches in length longitudinally (it was recommended that a 2 inch gap exist on each side of the defect). The Clock Spring samples were installed at 0, 50, and 90%

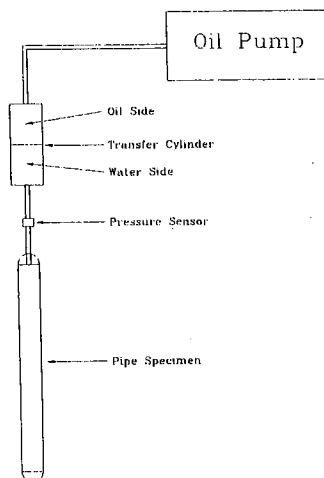
Fig. 4 Layout for Fatigue Testing

Fatigue testing was accomplished using the schematic layout shown in **Fig. 4**. The layout includes a test-specimen and the oil pump which was used to pressurize the system. A water/oil transfer cylinder was used so that water could be used in the pipes as opposed to oil. Oil which came from the pump was injected into the transfer cylinder and would pressurize the other side which was filled with water that would in turn pressurize the pipe. This process was found to be an effective and efficient means for pressure cycling the pipes. A typical complete pressure cycle in a pipe which was 20 feet long would take approximately 12 seconds, and a shorter version (maybe 10 feet) would take about 7 seconds. A shut-down mechanism was installed so that cycling would cease in the event of a specimen failure. A counter was installed in the loop to keep count of the number of cycles.
