OTC 23454

Application of a Grouted Sleeve to Remediate Damaged Subsea Pipeline

Alessandro Vagata and Bill Bath, Saipem America; Chris Alexander, Stress Engineering; Alexander Aalders, Williams Midstream; Danny Seal, GL Nobel Denton

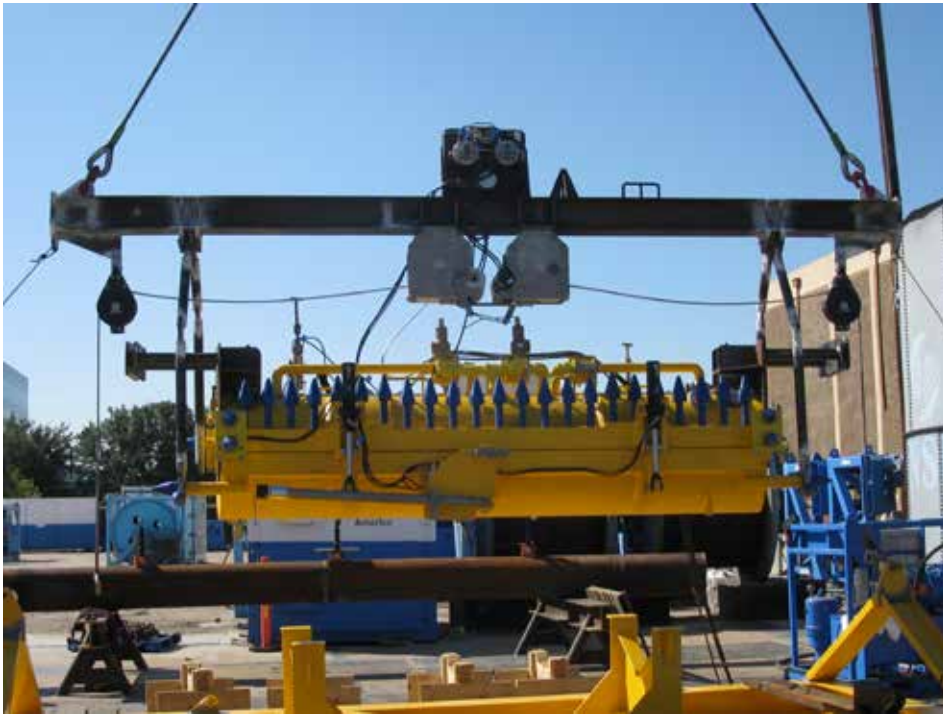
Figure 3 – Grout Sleeve and Spreader Bar during Factory Acceptance Testing

An ROV-installable grout sleeve design was developed that would accept the full range of bend radii of 35 to 80 feet. The 28 inch inside diameter of the sleeve was selected to provide a minimum of 3 inches of grout around the pipeline at the minimum estimated radius. The ends of the sleeve were then cut at an angle to match the likely exit angle of a 45 foot radius. Openings in the end plates were also offset to improve the fit on the pipeline. The sleeve was then split horizontally so that vertically-positioned, cone-head screws would provide an ROV-friendly method of closing the sleeve around the pipeline (Figure 3). It was recognized that the center of gravity of a horizontally split sleeve would change significantly as the sleeve opened and closed. In order to minimize this effect, the spreader bar connecting legs were attached at specific positions with one pair of legs attached to the top half of the sleeve and one pair attached to the bottom half of the sleeve. This articulated arrangement moved the spreader bar horizontally as the sleeve opened and closed.

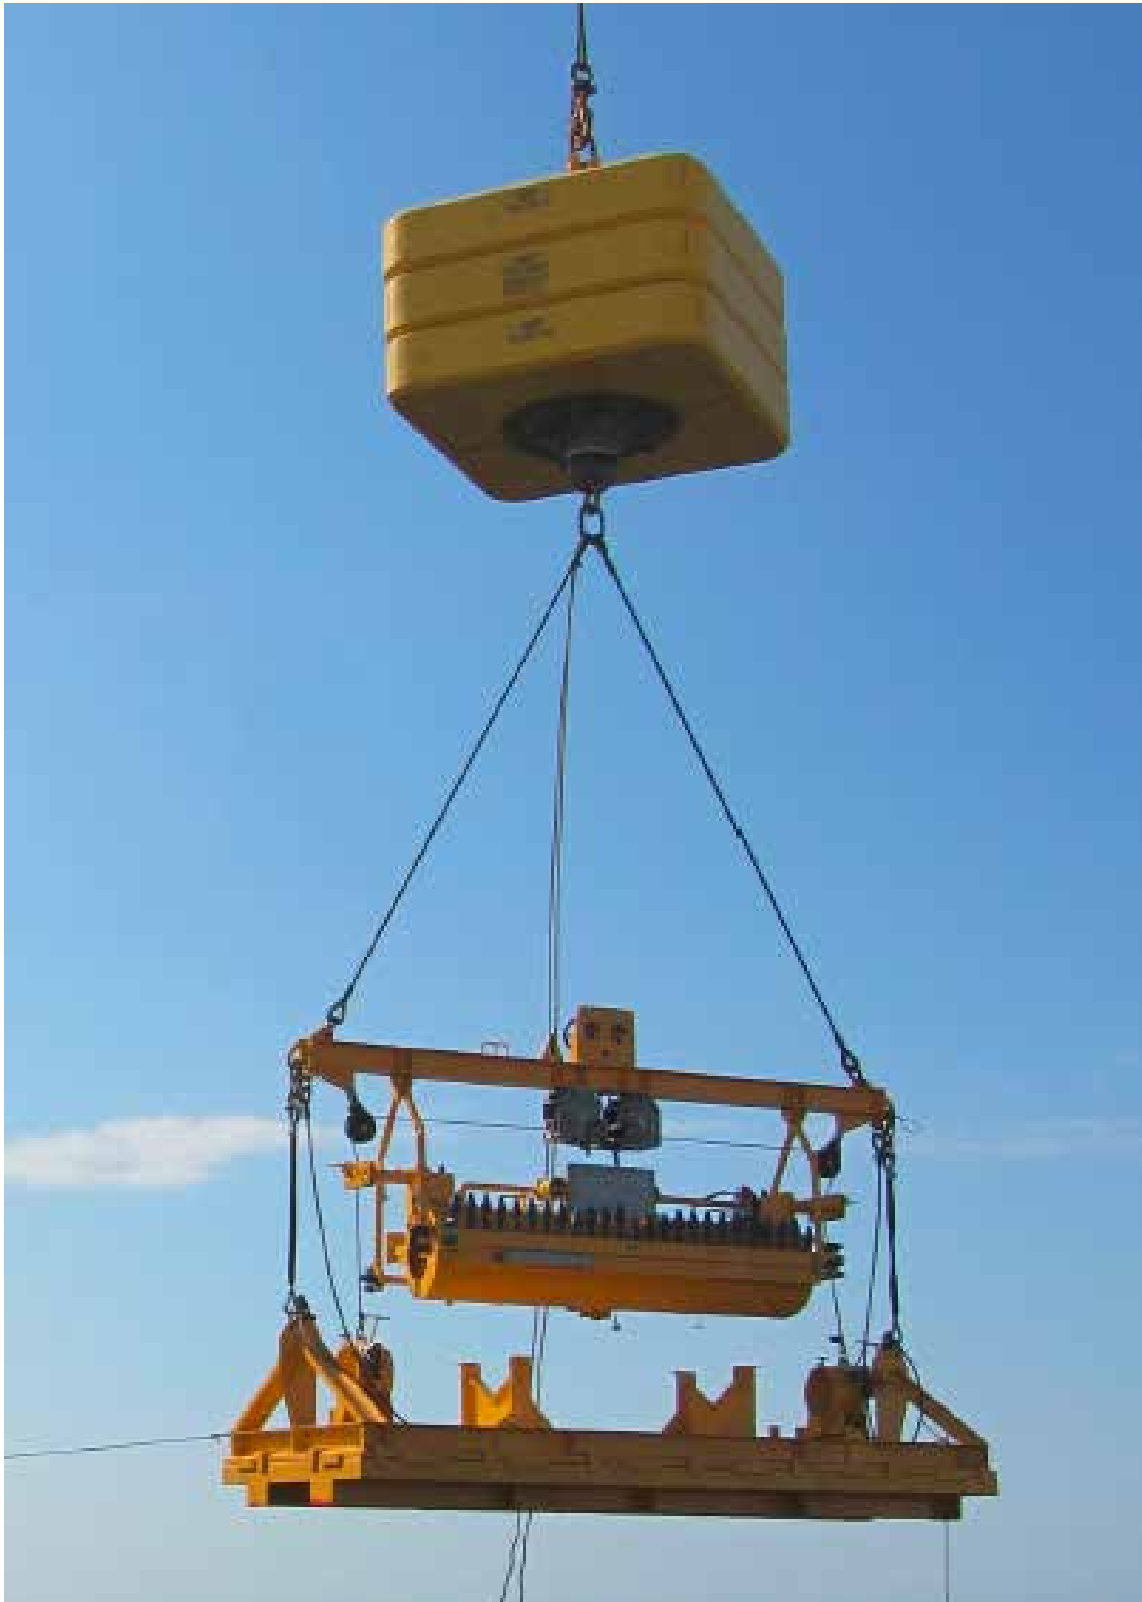
Figure 4 – Grout Sleeve – Suppressor Skid – Buoyancy Module rigged for deployment

It was also recognized that the most critical time during an offshore operation is the time when the crane or lowering line on the vessel is connected to a fixed object on the sea floor. To mitigate this risk, the grout sleeve was deployed with a buoyancy module and a suppressor weight (Figure 4). The buoyancy module was sufficient to suspend the grout sleeve above the sea floor. This method allowed the assembly to be landed on the sea floor next to the pipeline and then quickly disconnected from the vessel. Once this package was on the sea floor the ROV was in complete control of the installation. A pair of ROV-operated winches mounted on the spreader bar were then used to pull the grout sleeve down onto the pipeline (Figure 5). Later these winches were used to provide a controlled ascent for the spreader bar and buoyancy module after the grout sleeve was disconnected.

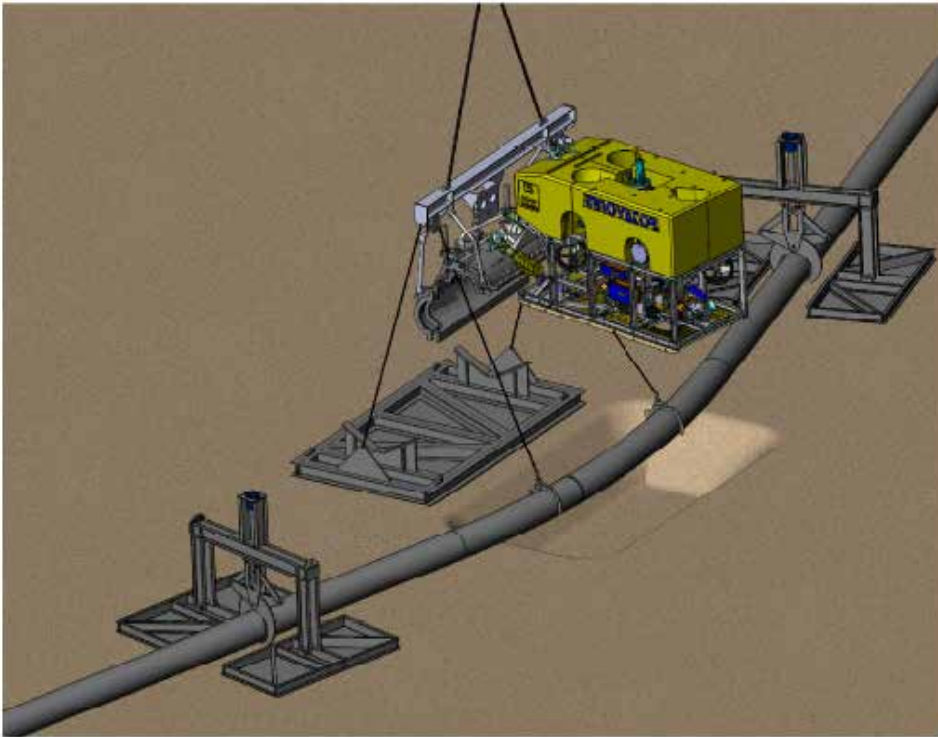
Figure 5 – ROV powers Spreader Bar Winches to pull Grout Sleeve down to pipeline

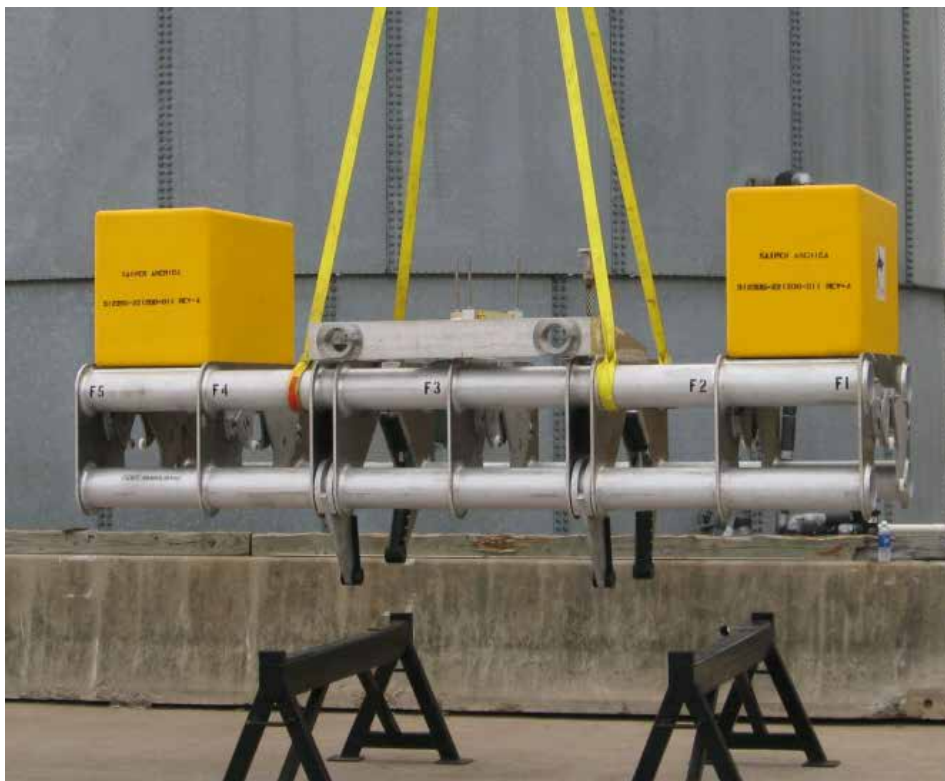
Figure 6 – Metrology Tool suspended for wet test

A special metrology tool (Figure 6) was built to measure the pipeline curvature in the area where the grout sleeve would be installed. This ROV-operated tool was deployed on a skid that was disconnected from the lowering line after it landed on the

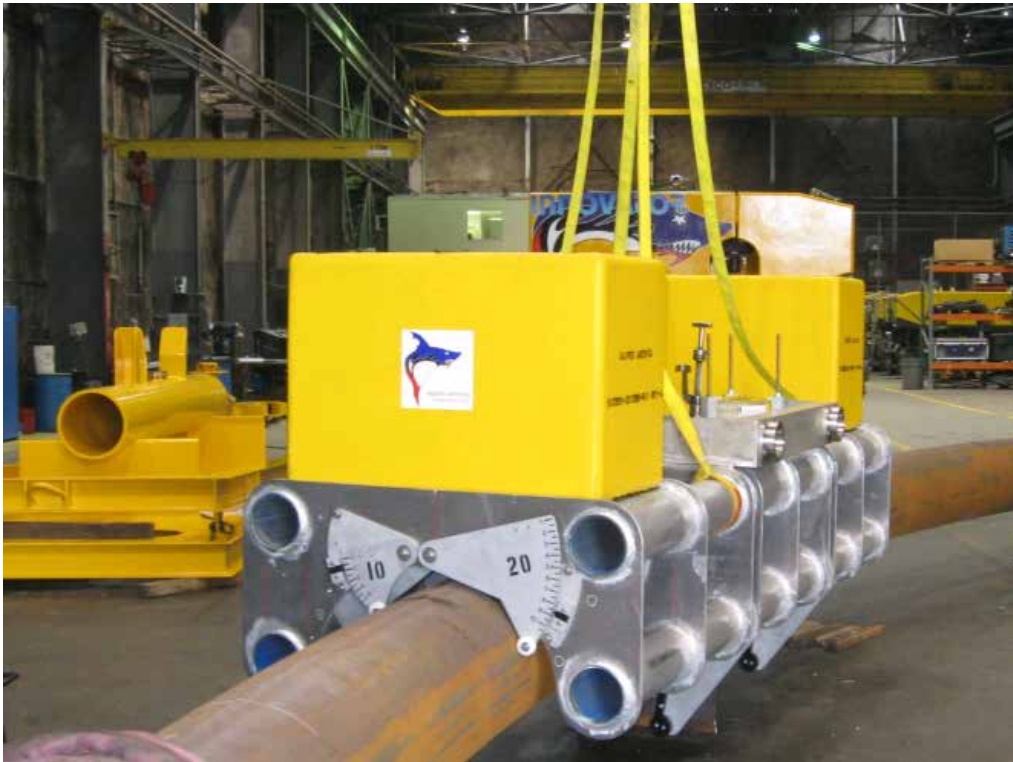
Figure 7 – Metrology Tool landed on test pipe

sea floor. The ROV then docked with the tool and positioned it on the pipeline by centering it on the dent. The ROV powered two pair of hydraulic arms on the tool to clamp the tool on the pipeline. The ROV could then disconnect from the tool and make a video record of the readings on twenty equally spaced mechanical gages (Figure 7) that rested against the pipeline at five selected positions along the length of the tool. After the tool was recovered to the workshop, short sections of pipe were fitted into the tool and positioned to duplicate the gage readings from the sea floor. These short sections were then welded together, removed from the tool, and laid into the open grout sleeve to confirm clearance around the pipe (Figure 8) and the exit angle of the pipe from the sleeve.

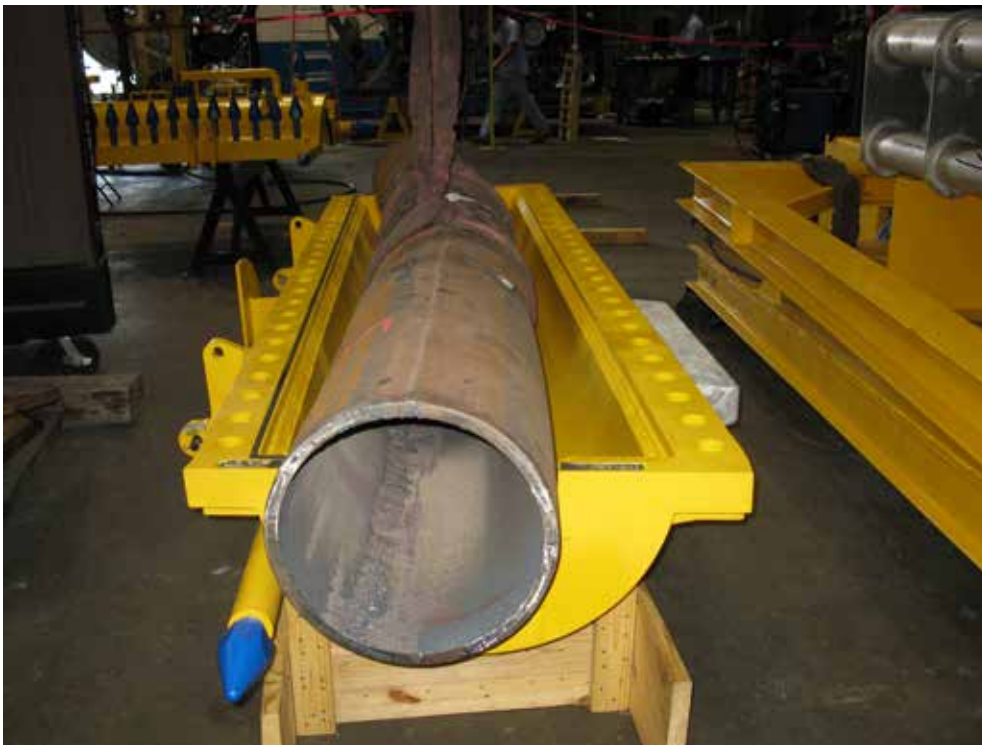
Figure 8 – Fit-up of test pipe fabricated from Metrology Tool measurement

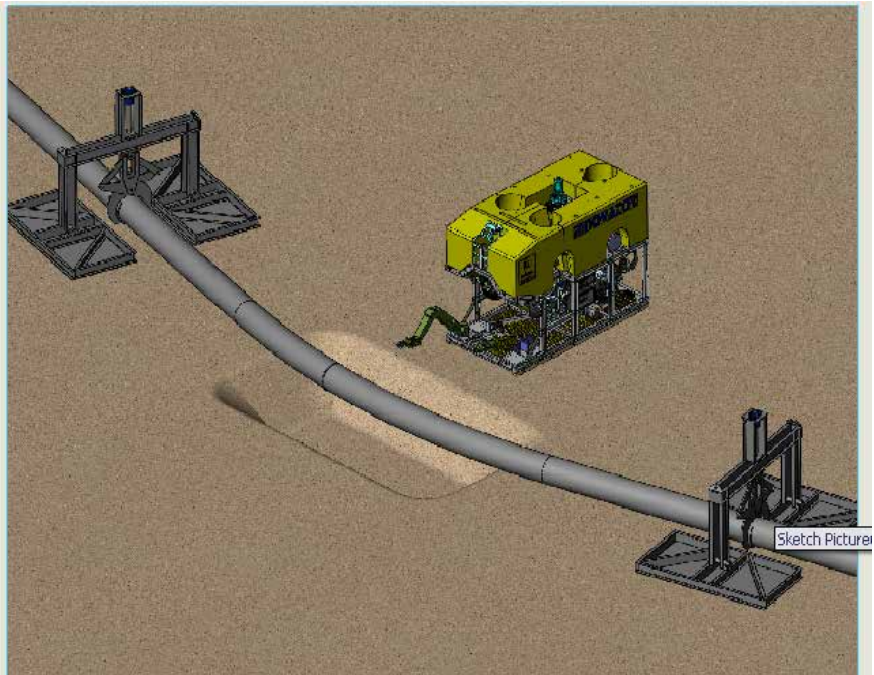
Figure 9 – Pipeline held with Pipeline Support Frames while ROV dredges access hole

Installation of the grout sleeve required that an access hole be dredged under the pipeline. This hole needed to be about 20 ft long and 4 feet deep to provide clearance for the bottom half of the sleeve to swing closed under the pipeline. It was recognized that the weight of the sleeve plus the cement grout would be around 12,000 lbs, when the buoyancy module was released. Therefore, to prevent the pipe from sagging into the hole we installed an ROV-operated pipe support frames about 30 ft. back from either side of the hole (Figure 9). Each frame consisted of two mudmats and a single, motor-operated grab. These frames did not lift the pipeline but simply added mudmat support. After the grout sleeve was installed, the ROV pulled a fabric grout bag into the hole under the sleeve. This bag was then filled with cement grout to fill the vacant space below the grout sleeve. After the grout was allowed to cure for a few hours, the ROV disconnected the spreader bar from the sleeve and it, along with the buoyancy module and suppressor weight, were recovered to the surface. The pipeline support frames were also released and recovered. The only things left on the sea floor were the grout sleeve and the grout bag supporting it (Figure 10). This remediation action cleared the pipeline for full operating pressure operation.
