## **EVALUATING ANCHOR IMPACT DAMAGE TO THE SUBSEA CANYON CHIEF PIPELINE USING ANALYSIS AND FULL-SCALE TESTING METHODS**

### **ABSTRACT**

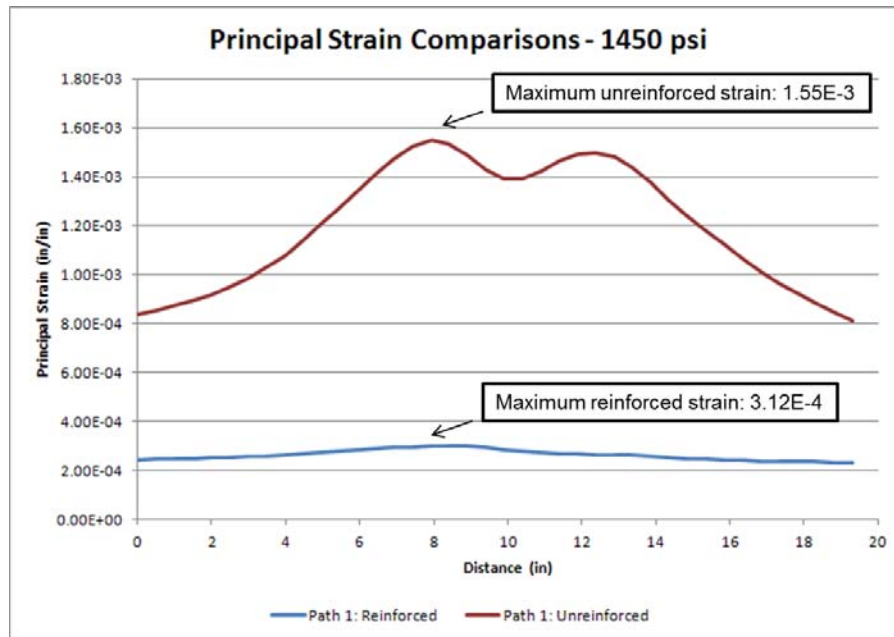
An in-line inspection conducted by Rosen detected the presence of multiple dents, including one having a depth of 7.4 percent of the outside diameter of the pipe. Additionally, this dent damage included a localized metal loss having a depth of 11 percent of the pipe's nominal wall thickness. A total of 16 dents were evaluated using finite element analysis (FEA), although the primary focus was a 7.4 percent deep dent, identified by Rosen as Dent ID 339968. Figure 3 provides a stress contour plot from the finite element analysis for the dented region at a pressure of 100% SMYS (hoop stress of 60,000 psi). As noted in Figure 3, the maximum principal stress is 221.4 ksi, corresponding to a stress concentration factor of approximately 3.7. FEA was also used to calculate stresses in the sleeve and also estimate the level of strain reduction in the dented region due to the presence of the sleeve. Figure 4 is a schematic diagram showing the layout for this particular FEA model, while Figure 5 plots strains in the dented region with and without reinforcement. As observed in this latter figure, the sleeve acted to reduce strain in the dent by a factor of approximately 5 at a pressure of 1,450 psi (25% SMYS).

Figure 5 – FEA-calculated strains in dented region with and without sleeve reinforcement

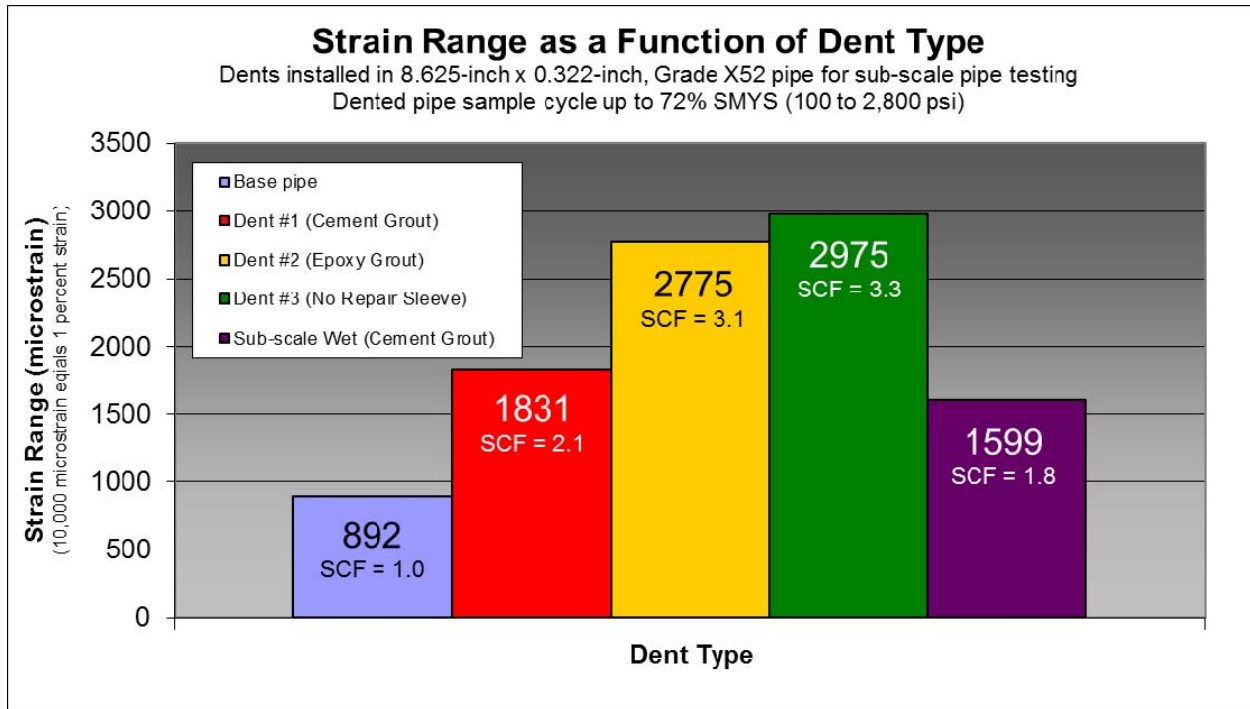
Figure 6 shows the cross-section of bolt-on sleeve for sub-scale testing. The sub-scale test, while Figure 7 is a schematic diagram showing set-up for sub-scale dry test with repair sleeves. Figure 8 shows strain range measurements and the associated stress concentration factors from the sub-scale tests.

**Figure 8 - Strain range measurements from the sub-scale tests**

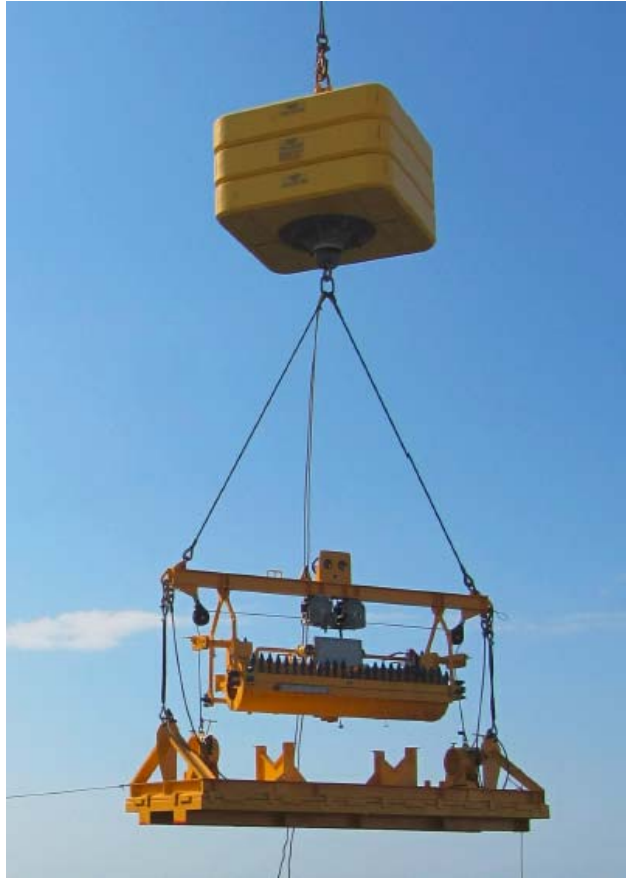
**Figure 12 – Grouted sleeve with suppressor skid and buoyancy module rigged for deployment**

It was also recognized that the most critical time during an offshore operation is the time when the crane or lowering line on the vessel is connected to a fixed object on the sea floor. To mitigate this risk, the grout sleeve was deployed with a buoyancy module and a suppressor weight (Figure 12). The buoyancy module was sufficient to suspend the grout sleeve above the sea floor. This method allowed the assembly to be landed on the sea floor next to the pipeline and then quickly disconnected from the vessel. Once this package was on the sea floor the ROV was in complete control of the installation. A pair of ROV-operated winches, mounted on the spreader bar, was then used to pull the grout sleeve down onto the pipeline. This step is illustrated in Figure 13. Later these winches were used to provide a controlled ascent for the spreader bar and buoyancy module after the grout sleeve was disconnected.

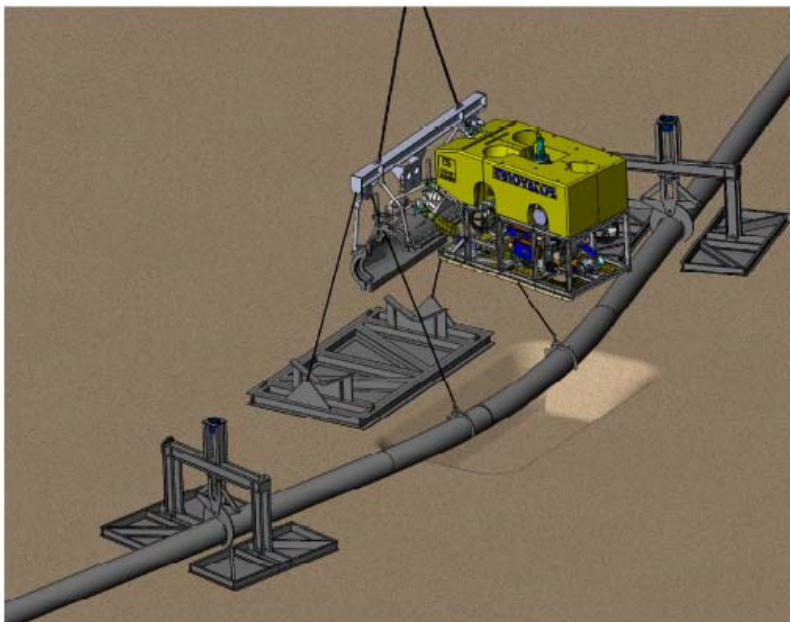
**Figure 13 - ROV powers Spreader Bar Winches to pull Grout Sleeve down to pipeline**

Installation of the grout sleeve required that an access hole be dredged under the pipeline. This hole needed to be approximately 20 feet long and 4 feet deep to provide clearance for the bottom half of the sleeve to swing closed under the pipeline (cf. Figure 13). It was recognized that the weight of the sleeve plus the cement grout would be approximately 12,000 lbs, when the buoyancy module was released. Therefore, to prevent the pipe from sagging into the hole ROV-operated pipe support frames were installed approximately 30 feet back from either side of the hole. Each frame consisted of two mudmats and a single, motor-operated grab. These frames did not lift the pipeline but simply added mudmat support. The support frames were used during installation so that the pipe functioned as a simple beam. The support frames did not lift the pipeline; rather they supported it so that it could not deflect into the mud. A simple beam calculation was made that showed that the pipeline could support itself between the pipe support frames. The weight of the sleeve was supported by the buoyancy until after the grout bag was installed in the hole. The pipeline did not see any significant loading during the repair. While the sleeve, spreader bar, and buoyancy module were connected to the pipeline, there was a net upward force of approximately 1,000 lbs on the pipeline. After the sleeve was filled with grout, there was a net downward force of approximately 1,000 pounds. After the grout bag was filled, we believe the pipeline was fully supported and there was no force acting on the pipeline.
