## **GIRTH WELD FAILURE IN A LARGE DIAMETER GAS TRANSMISSION PIPELINE**

### **ABSTRACT**

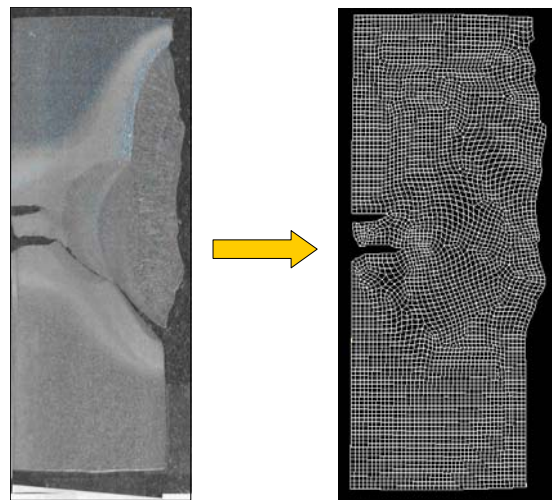
**Figure 5 – Weld profile used to create geometry for FEA model**

**Analysis Methodology** Using the geometry of the girth weld from the failure analysis investigation, measurements were made for the purpose of constructing the local finite element model. Figure 5 shows the geometry of the weld profile used to create the finite element model. A relatively fine mesh was used in the vicinity of the ID lack of penetration to capture elevated stresses.

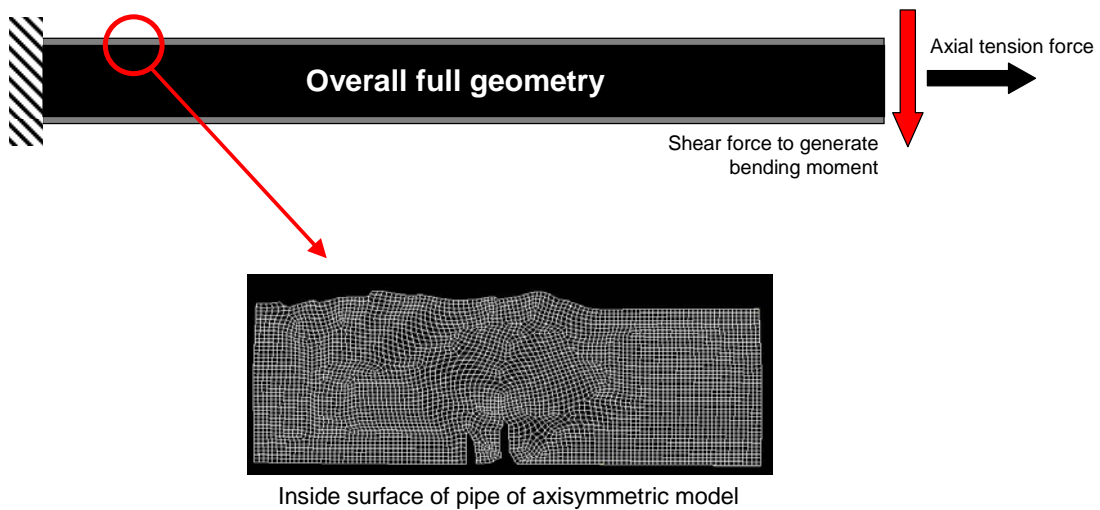
**Figure 6 – Axisymmetric model with asymmetric loading**

Referring once again to Figure 6, the end of the pipe was fixed in all degrees of freedoms as one would load a cantilever beam. Pressure was applied on all internal surfaces of the pipe including the crack. Uniform tension was applied to the open end elements of the pipe as a distributed load. A bending moment was applied via a shear load at the open end of the model. A total of 25 load cases were analyzed, and bending moments ranging from 0 to 100% of the yield moment were applied along with axial tension loads ranging from 0 to 100% of the yield tension force. For all load cases an internal pressure of 811.2 psi was used. Stresses were extracted from these 25 models and used to

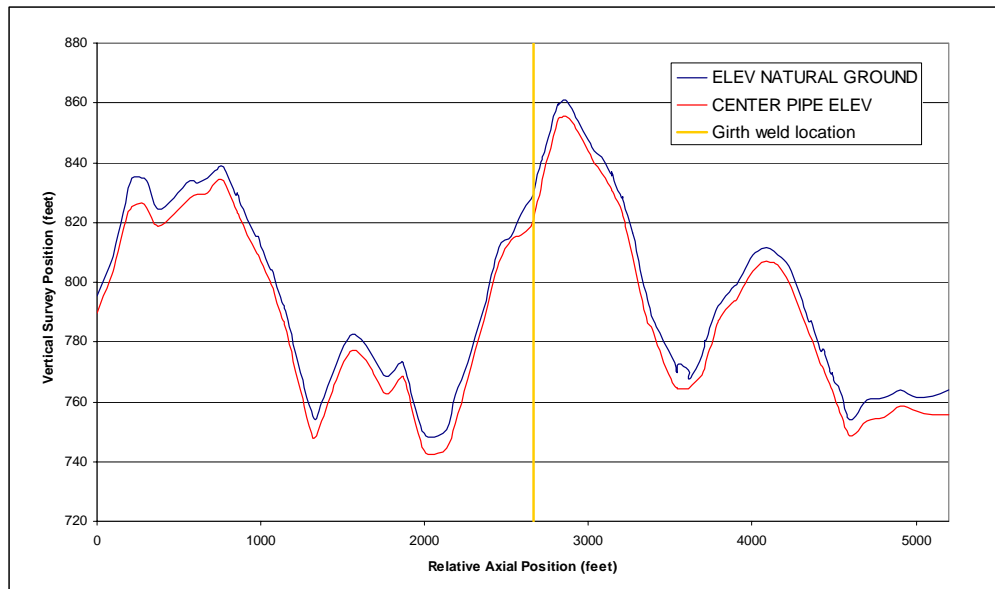
**Figure 12 – Plot showing survey data of pipeline and natural ground**

In addition to the sketch, survey data was provided that included the coordinates of the pipeline in three-dimensional space. Additionally, the survey data included the level of soil cover on the pipeline. Figure 12 is a plot showing the topography of the pipeline in two-dimensional space that includes the position of the pipeline (**RED** curve), as well as the elevation of the natural ground that provides the depth of soil cover (**BLUE** curve). Also included in this figure is the position of the girth weld relative to the topography of the pipeline.

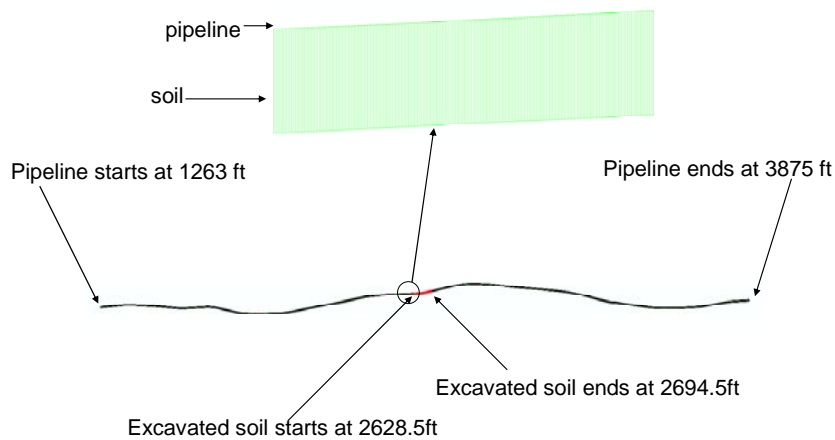
**Figure 13 – Geometry for the two-dimensional global planar model**

**Geometry for Global Model** Figure 13 shows the geometry for the global finite element model. The pipe was modeled using the ABAQUS *PIPE21* beam element that permits the integration of internal pressure loading. The soil was modeled using the ABAQUS pipe-soil interaction elements. These elements permit the inclusion of soil stiffness in all directions, including axial, transverse (which was not used in this planar model), and vertical (uplift and bearing). In order to use the soil properties provided (cf. Table 4), it was necessary to convert the spring values provided in lbs per cubic foot (pcf) to the ABAQUS soil spring interaction elements that require linear displacement spring in units of lbs per inch. The equations below are used to make the necessary conversions for the axial and vertical springs.
