Title: ASSESSING MECHANICAL DAMAGE IN OFFSHORE PIPELINES - TWO CASE STUDIES

ASSESSING MECHANICAL DAMAGE IN OFFSHORE PIPELINES – TWO CASE STUDIES

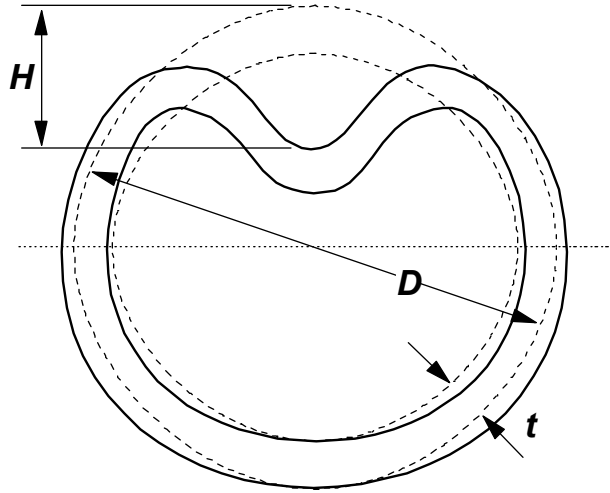
A dent in a pipeline is a permanent plastic deformation of the circular cross section of the pipe. Dent depth is defined as the maximum reduction in the diameter of the pipe compared to the original diameter (i.e. the nominal diameter less the minimum diameter), Figure 1. This definition of dent depth includes both the local indentation and any divergence from the nominal circular cross-section (e.g. out-of-roundness or ovality).

Figure 1 The dimensions of a dent

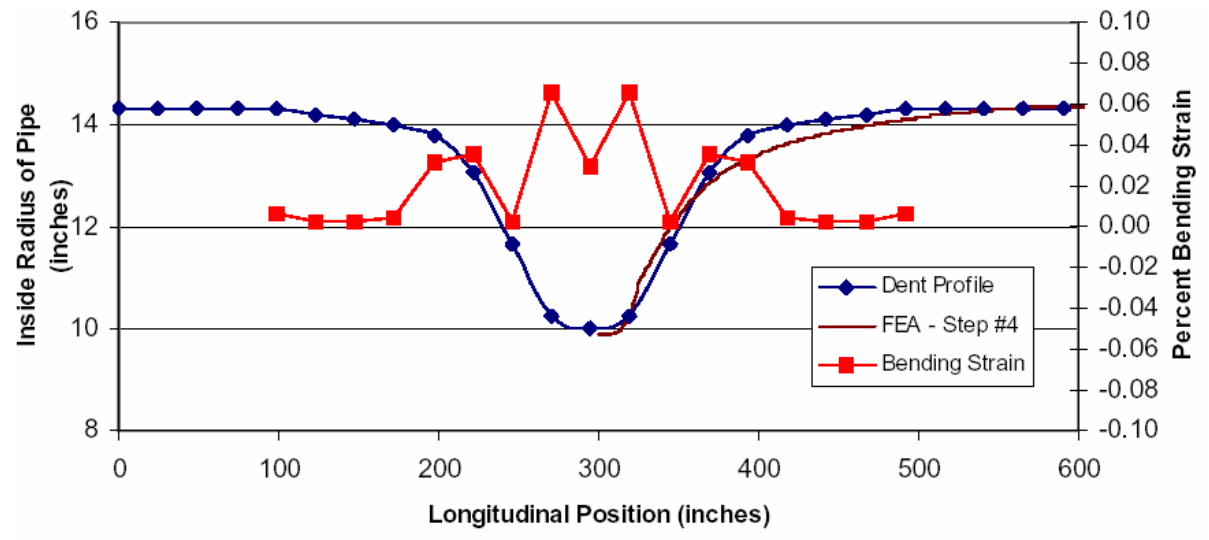
The preliminary study made use of elastic-plastic, non-linear geometry FEA using a rigid indenter (Figure 9) to produce an equivalent residual dent depth (after re-rounding) to that recorded by the calliper pig, e.g. Figure 10. From this analysis a strain level on the order of 3% was calculated. This was initially not of particular concern as recently introduced ASME guidance allows strain in dents up to 6%. In addition, calculations using the design *S-N* curve with an appropriate stress concentration factor (SCF) for the dent (accounting for the increased strain) indicated very long fatigue lives under the expected fluctuations in internal pressure, giving further confidence. The cyclic hoop stress range was approximately 174 N.mm^{-2} for a pressure range of 80 bar. Using this stress range, the fatigue life was found to be 188,980 cycles. This fatigue life corresponded to conditions that exceeded the service requirements many times over. Further supporting test data from the literature and confidential project data confirmed the conclusion that fatigue was not a limiting factor should the dent be as assumed, i.e. a plain dent, not on a weld.

Figure 10 Comparison of dent profile based on calliper data and finite element results
