# **RECENT TEST RESULTS AND FIELD EXPERIENCE WITH ARMOR PLATE PIPE WRAP IN REPAIRING CORRODED AND MECHANICALLY-DAMAGED PIPES**

**Chris Alexander**  
Stress Engineering Services, Inc

**Fred Wilson**  
Armor Plate, Inc.

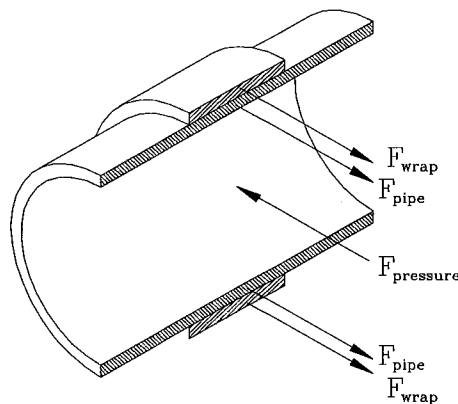
**Figure 1 Cross-sectional view of pipeline repair**

**Figure 1** shows a cross-sectional view of a pipe and a composite wrap installed on the outside of the pipe. This schematic illustrates how the pipe and wrap mechanically resist the force created by the internal pressure.

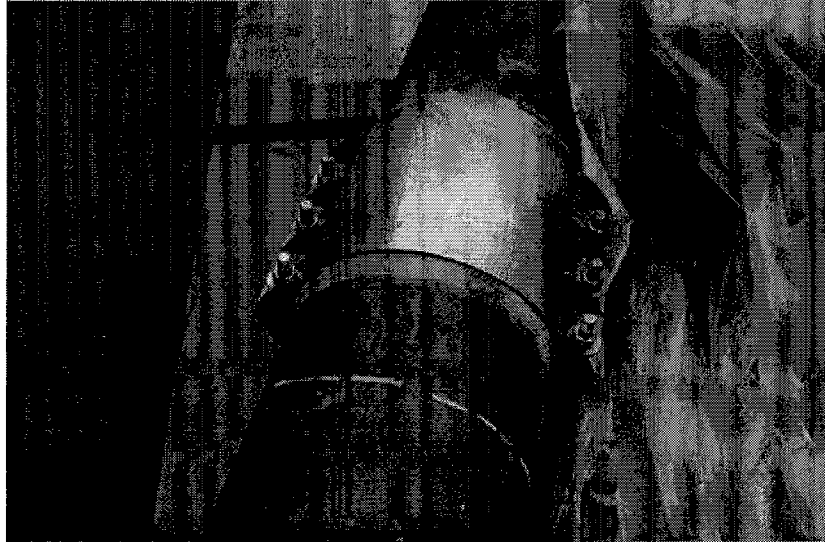
Figure 2 Stainless steel clamp used in conjunction with APPW

While the focus of this testing was on the use of Armor Plate in repairing mechanical damage, the recent development of a stainless steel clamp by Armor Plate, Inc. (used in conjunction with the composite wrap materials) was implemented into the fatigue test program. One clamp was installed on each of the pipe samples. **Figure 2** is a photograph of one of the clamps. As seen, the clamp is comprised of two halves that are bolted together. Both Sample A1 and Sample B1 involved four layers of APPW in addition to the clamps. The clamps are fabricated from 1/8-in 316 stainless steel material and are bolted together using six 3/4-in bolts. Prior to their installation, the APPW sleeves were applied and permitted to cure. The surfaces of the wrap were ground smooth and grease was applied to reduce friction during the bolt-tightening process. The bolts were tightened to 125 ft-lbs which corresponded to an approximate bolt stress of 52,000 psi.

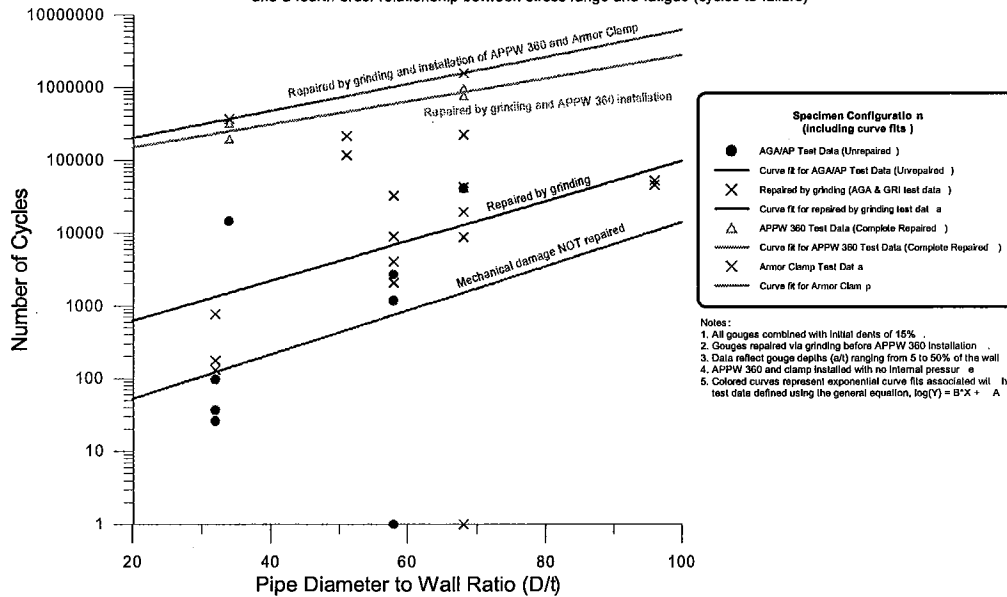
### CYCLES TO FAILURE FOR MECHANICAL DAMAGE REPAIRED USING ARMOR PLATE PIPE WRAP

Data plotted for cycles to failure as a function of pipe diameter to wall thickness ratio. Equivalent fatigue numbers are plotted assuming an equivalent pressure range of 50 percent of the maximum allowable operating pressure using Miner's Rule and a fourth-order relationship between stress range and fatigue (cycles to failure).

Figure 3 Fatigue data for dents and gouges in varying states of repair

**Figure 3** plots the cycles to failure for the samples repaired using APPW as well as the data for the two stainless steel clamps. Four sets of data are plotted.
