REPAIR OF HIGH PRESSURE PIPE FITTINGS USING COMPOSITE MATERIALS

Julian Bedoya

Chris Alexander

Tommy Precht

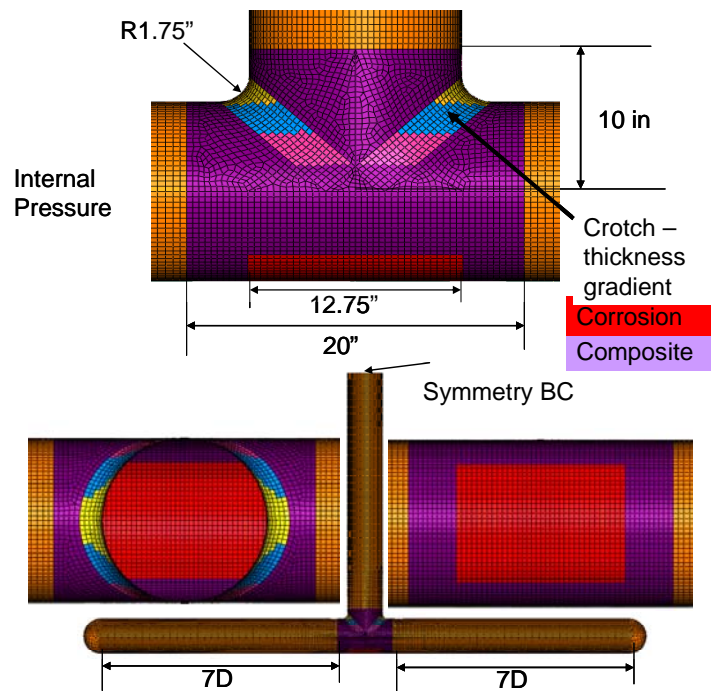
Figure 1 – Finite element mesh of Tee. Symmetry boundary conditions applied at top of branch connection.

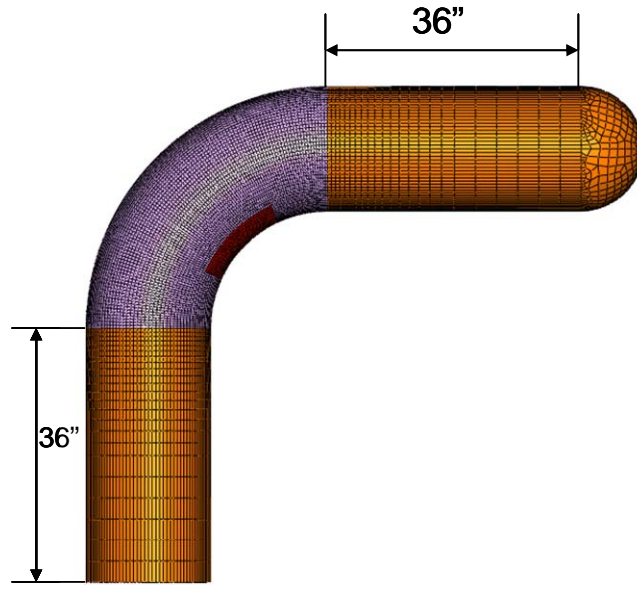
Symmetry BC

Figure 2 – Finite element mesh of Elbow. Symmetry boundary conditions (BC) applied at bottom pup.

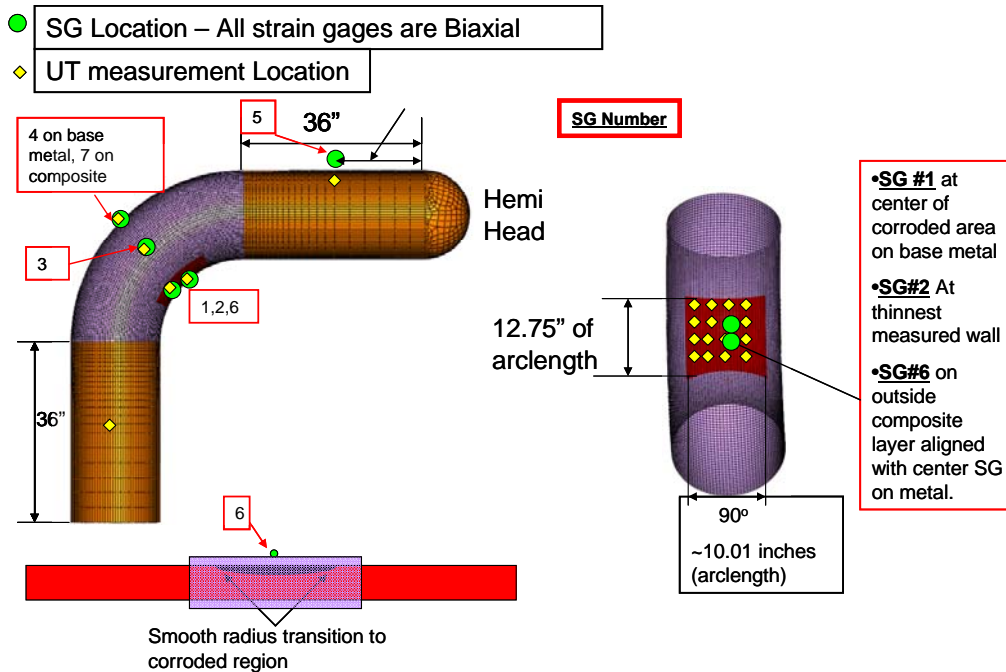
Figure 4 – Geometry, strain gage (SG), and wall thickness measurement (UT) parameters for testing work for Elbow.

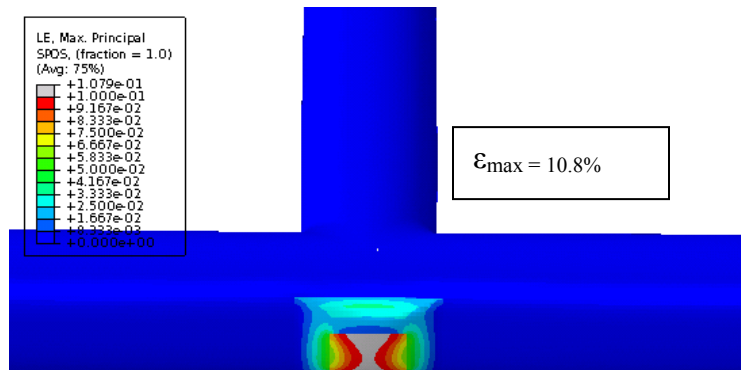
Figure 5 – Maximum principal strain (ϵ_{\max}) at 2,250 psi (~100% MAOP) in unrepaired Tee.

The critical corrosion section had a thickness of 0.150 inches, while the average wall thickness was 0.191 inches. The nominal fitting wall thickness was 0.500 inches. The thicknesses at the crotch were defined in three groups with the thickest at the top of the fitting of 0.625 inches, 0.525 inches and 0.500 inches. The thickness of the composite was modeled as 0.750 inches. Figure 6 shows the maximum principal strain in the corroded metal at 2,250 psi (MAOP is 2,200 psi), at a peak value less than 0.5%. The maximum principal strain in the critically corroded region at the predicted burst pressure per the FEA results was 1.7%, while the maximum principal strain in the base pipe was an order of magnitude higher at 17.7%. The FEA model predicted failure in the base pipe and not in the repaired fitting. The burst pressure was estimated by the FE model at 4,400 psi.

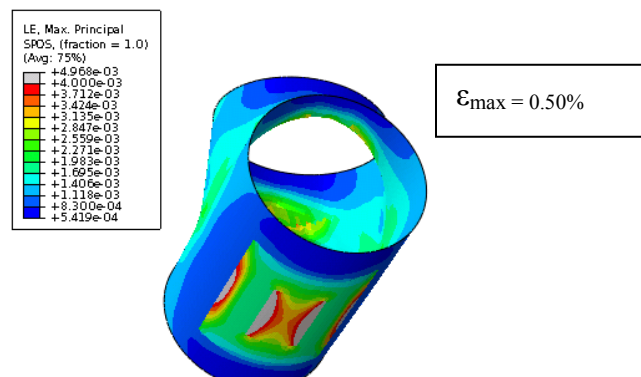
Figure 6 – Maximum principal strain (ϵ_{\max}) at 2,250 psi (~100% MAOP) in the repaired Tee.

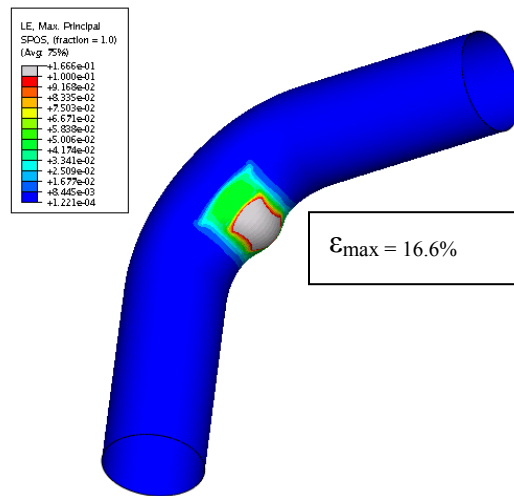
Figure 7 – Maximum principal strain (ϵ_{\max}) in the unrepaired elbow at 2,250 psi (~100% MAOP).

The critical corrosion section had a thickness of 0.155 inches, while the average wall thickness was 0.202 inches. The nominal fitting wall thickness was 0.400 inches. Figure 7 shows the maximum principal strain in the corroded metal at 2,250 psi (MAOP is 2,200 psi), at a peak value of 16.67%. The maximum principal strain in the critically corroded region at the predicted burst pressure per the FEA results (2,523 psi) was 29.1%.

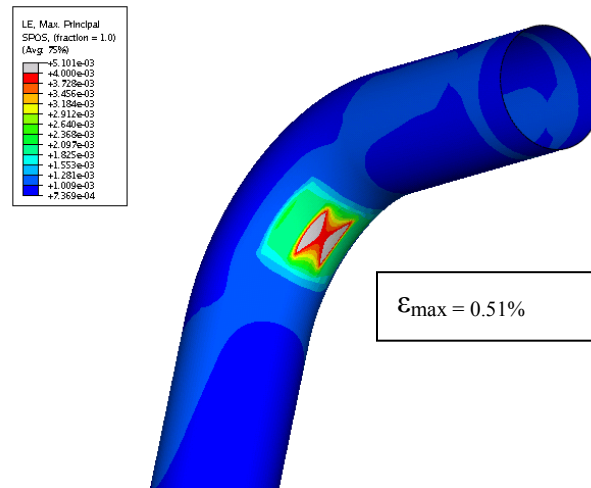
Figure 8 – Maximum principal strain (ϵ_{\max}) in the repaired elbow at 2,250 psi (~100% MAOP).

The critical corrosion section had a thickness of 0.155 inches, while the average wall thickness of the elbow fitting was 0.205 inches. The nominal fitting wall thickness was 0.400 inches. Figure 8 shows the maximum principal strain in the corroded metal at 2,250 psi (MAOP is 2,200 psi), at a peak value of 0.51%. The maximum principal strain in the critically corroded region at the predicted burst pressure per the FEA results (4,552 psi) was approximately 1.5%. The FEA model predicted failure in the base pipe. The maximum principal strain in the base pipe at the predicted burst pressure was 21.8%.

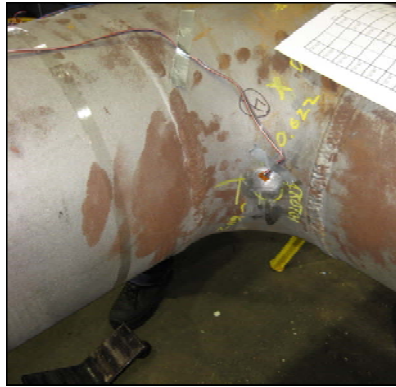
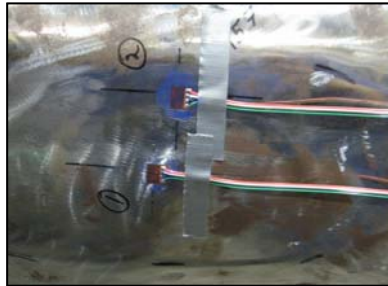
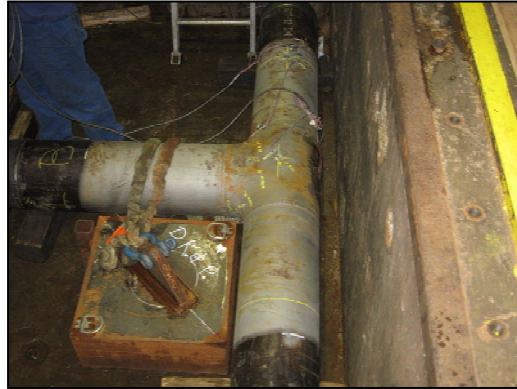
The average measured wall thickness in the defect region was 0.207" corresponding to 58.6% simulated corrosion.

Figure 9 – Photographs of unrepai red tee prior to testing.

The average measured wall thickness in the defect region was 0.207 inches, or 58.6% simulated corrosion. Figure 9 shows photographs of the unrepaired tee prior to testing. Figure 13 shows the pressure vs. microstrain (10,000 microstrain is equal to 1% strain) for the unrepaired tee, the repaired tee, and the base pipe. At approximately 18,200 microstrain (1.82% strain) the strain gage on the unrepaired tee in the defect debonded, resulting in erroneous strain readings thereafter. A green dotted line of approximately the same slope as the actual pressure vs. strain data prior to the strain gauge failure, is linearly extrapolated for the purpose of comparing the performance of

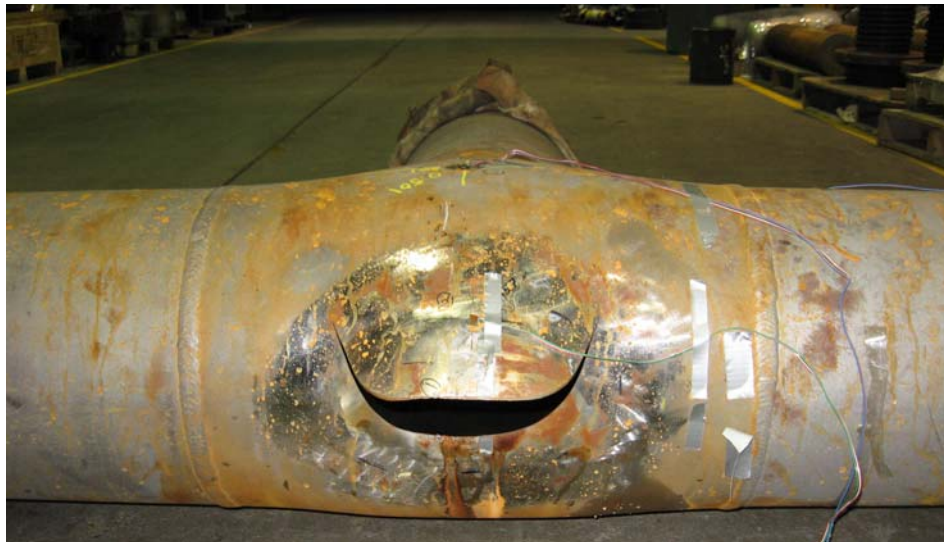
Figure 10 – Photograph of failed unrepai red Tee at 3,059 psi.

a composite repaired corroded section to an unrepaired corroded section. It is noted that generally the characteristic trend of actual pressure vs. strain data in the plastic regime is for this curve to flatten (i.e., to approach a slope of zero), and not have a constant slope. Comparing the performance of composite repaired corroded section to this linear extrapolation of the pressure vs. strain of the unrepaired section in the plastic regime results in an upper bound baseline to which the composite repair is being evaluated against. The burst of the unrepaired tee occurred in the defect region at 3,059 psi. Figure 10 shows several pictures of the failed unrepaired fitting.

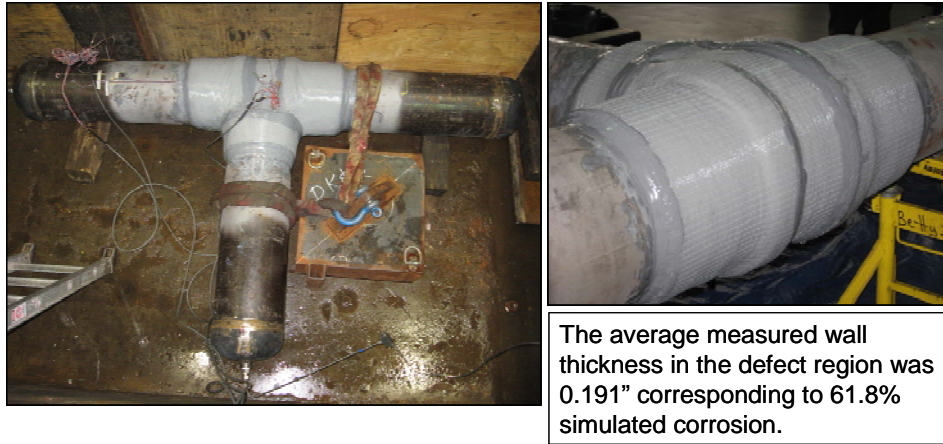
Figure 11 – Photograph of repaired Tee prior to testing.

Figure 11 shows two photographs of the repaired tee in the burst pit prior to the test. The sample was repaired with 12 layers of APPW totaling a thickness of 0.75-inches. The average measured wall thickness at the defect was 0.191-inches, corresponding to a simulated corrosion of 61.8%. Figure 13 shows the pressure vs. strain data. Until approximately 1,800 psi internal pressure, the behavior between the repaired and unrepaired tee was very similar. However, the differences in strain increase at higher pressures. The burst for the repaired tee occurred in the nominal pipe outside of the repaired region at a pressure of 4,617 psi. Figure 12 shows a photograph of the repaired tee sample having failed in the base pipe.

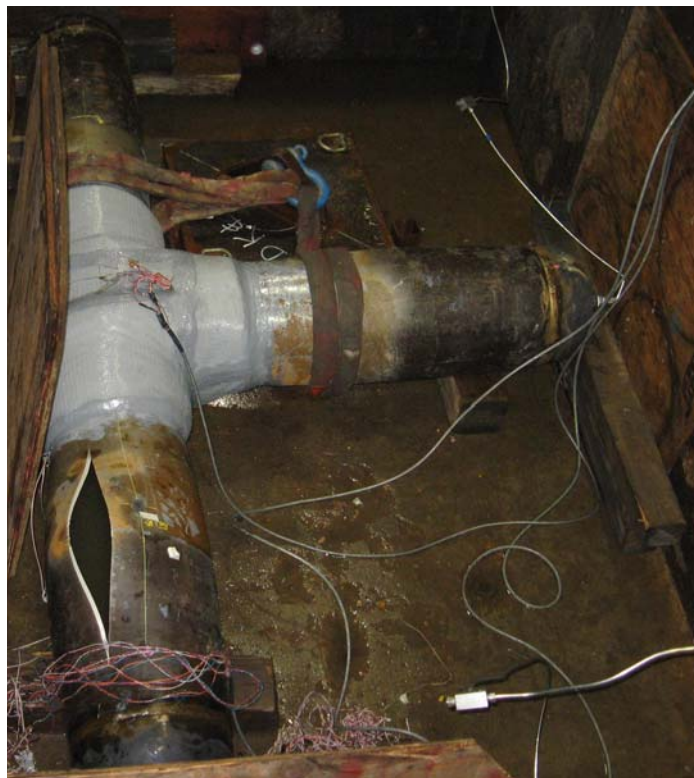
Figure 12 – Photograph of failed repaired Tee at 4,617 psi.

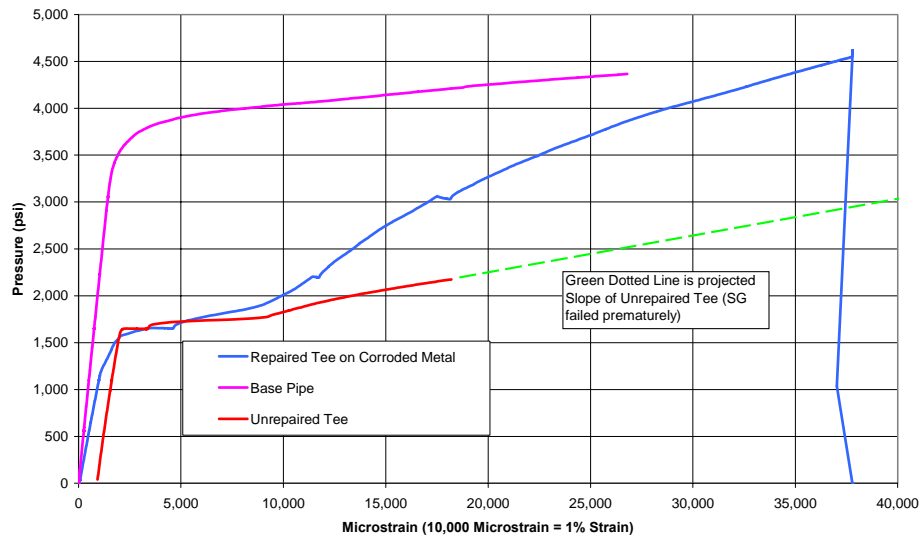
Pressure vs. Microstrain For 12.75"X12.75" X0.375" Y52 Tee with 60% Ground Corrosion

Figure 13 – Pressure vs. microstrain plots for repaired Tee, Base pipe and Unrepaired Tee. 10,000 microstrain = 1% strain.

Figures 13 and 18 show pressure vs. strain for all the fittings tested as well as the base pipe. As can be seen, the behavior of the steel (repair) in the repaired and unrepaired samples is very similar until a given pressure – 1,800 psi for the tees and 1,500 psi for the elbows – when the composite system begins to incur load. It should be understood that in principle all composite repair systems function the same way. The success of one system over the next depends highly on the combined stiffness of the steel-composite system, and the resulting ultimate tensile strength of the system.

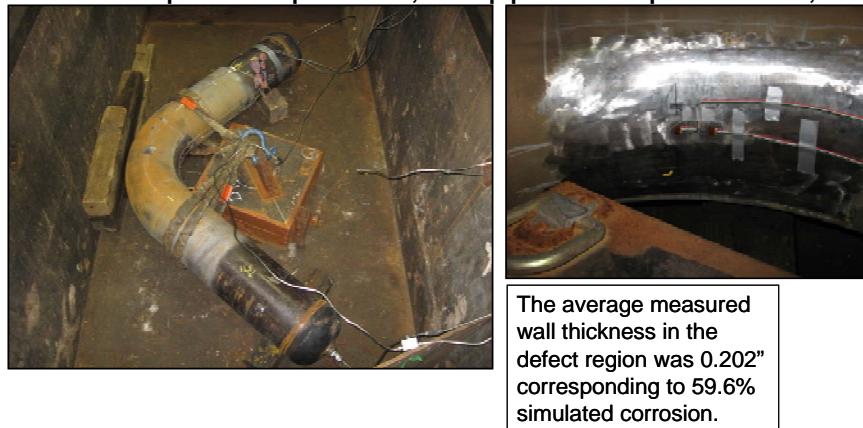
Figure 14 – Photographs of unrepaired elbow prior to testing.

Figure 14 shows photographs of the unrepaired elbow in the burst pit prior to the test. The average measured thickness of the defect was 0.202-inches, or 59.6% simulated corrosion. The unrepaired elbow burst at a pressure of 2,610 psi in the defect. The maximum measured strain was close to 20,000 microstrain, or 2%; however, this value occurred before the actual burst, most likely due to the strain gauge becoming debonded. The pressure vs. strain data for the unrepaired and repaired elbows, and the base pipe are shown in Figure 18. Linear extrapolation of the slope of the measured pressure vs. strain just before becoming debonded is shown, providing a bounding estimate for the plastic strains between yielding and the actual burst. The maximum strain measured in the nominal pipe was 1,020 microstrain, or 0.102%. Figure 15 shows a photograph of the failure of this sample.

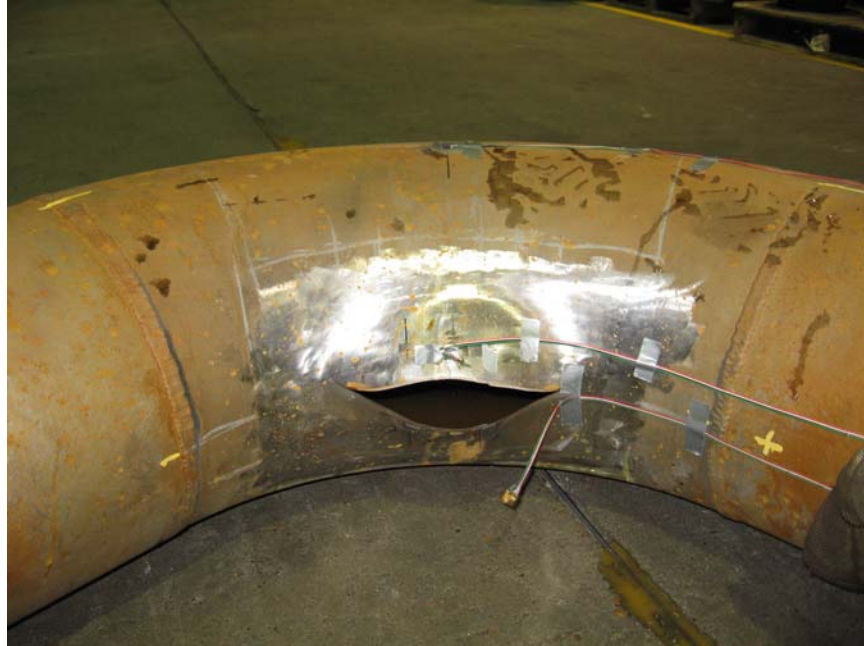
Figure 15 – Photograph of failed unrepaired elbow at 2,610 psi.

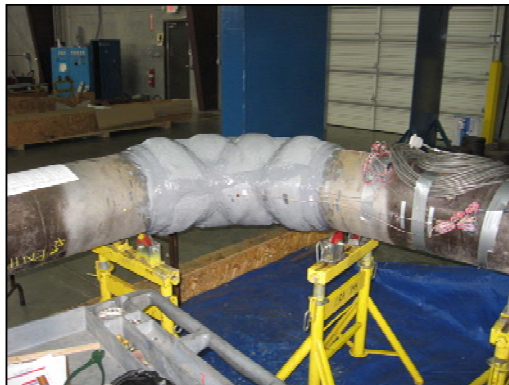
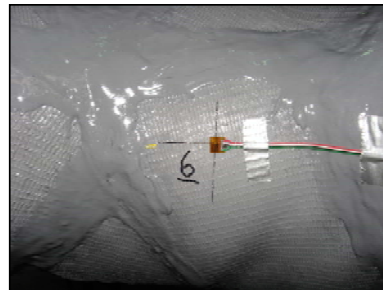
The average measured wall thickness in the defect region was 0.205" corresponding to 59% simulated corrosion.

Figure 16 – Photograph of APPW repaired elbow prior to testing.

The average measured wall thickness in the defect region was 0.205-inches, or 59% simulated corrosion. Figure 16 shows two photographs of the sample prior to testing. The burst pressure of the sample occurred at 4,625 psi in the nominal pipe on the pup without strain gage data. Figure 18 shows the pressure vs. strain relationship. It can be seen that until approximately 1,500 psi of internal pressure the behavior of the repaired and unrepaired elbow were similar. At 1,500 psi of internal pressure, a sudden decrease in strain can be seen in the repair section of the sample. This is due to the composite repair becoming engaged and affecting the measured strains in the base metal. The maximum measured strain in the nominal pipe was approximately 27,000 microstrain (2.7% strain); however, this value was reached in advance of the actual burst, most likely due to the strain gauge losing the bond with the metal. The strains in the nominal pipe continued to rise until burst, but due to the strain gauge becoming debonded, this rise in strain beyond 2.7% was not captured. Conversely, the maximum strain recorded in the defect was over 36,000 microstrain (3.6% strain). Figure 18 also shows the internal pressure increasing with a constant strain in the defect. This was due to the strain gauge reaching a saturation voltage (100 mV), and not actual material behavior. At some point, the strain in the nominal pipe continued to rise to a higher value while the strains in the defect rose,

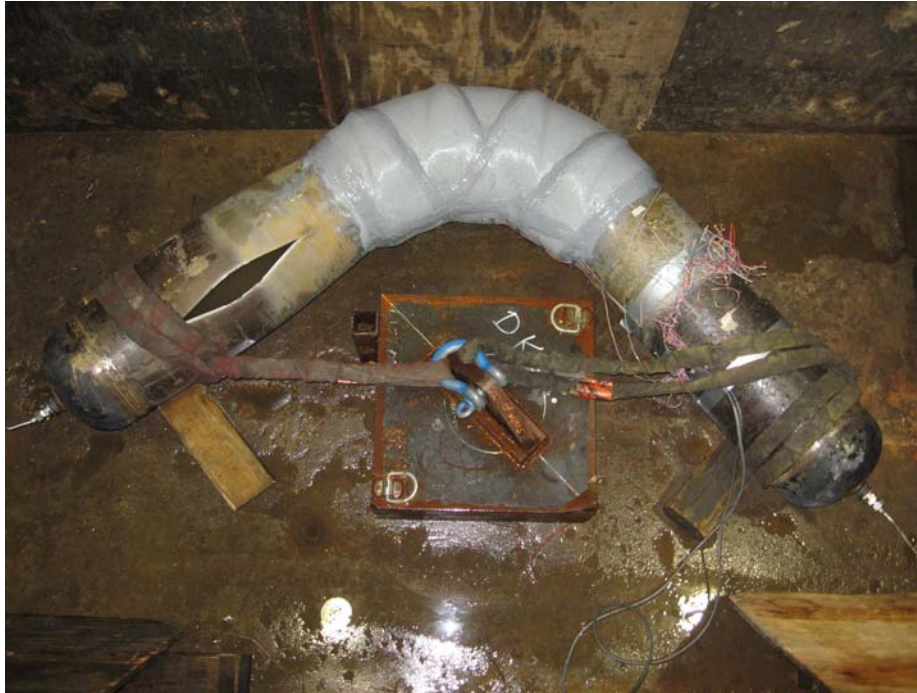
Figure 17 – Photograph of failed APPW repaired elbow at 4,625 psi.

but at a slower pace. Table 2 shows a summary of maximum principal strain shown in Figures 13 and 18. Figure 17 shows a photograph of the burst repaired elbow. Figure 19 shows both repaired fittings with failures outside the repair area and in the nominal pipe. Figure 20 shows a bar chart of the burst pressures for the four samples tested.

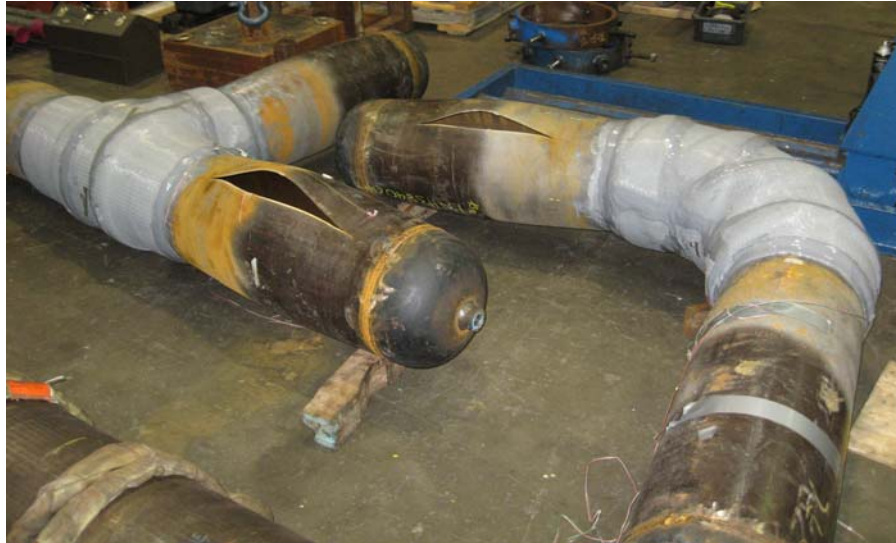
Figure 19 – Photographs of failed APPW repaired fittings in the base pipe.

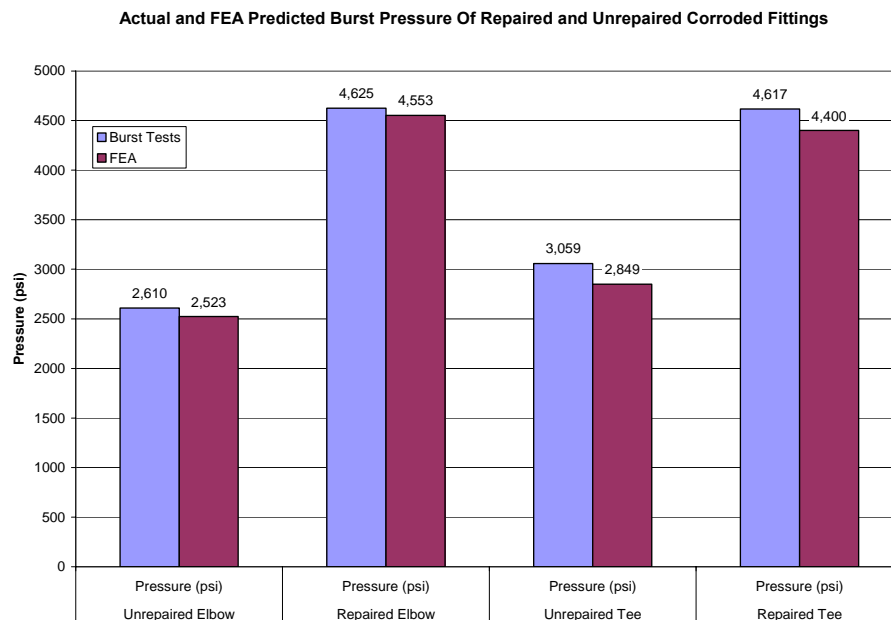
Figure 20 – Actual and predicted burst pressure summary for repaired and unrepaired 12-inch NPS Y52 fittings.
