DEVELOPING GUIDELINES FOR EVALUATING DAMAGE TO SUBSEA PIPELINES

C. Alexander*, R. Ayers
Stress Engineering Services, Inc., Houston, Texas USA

B. Exley
Williams Gas Pipeline, Houston, Texas USA

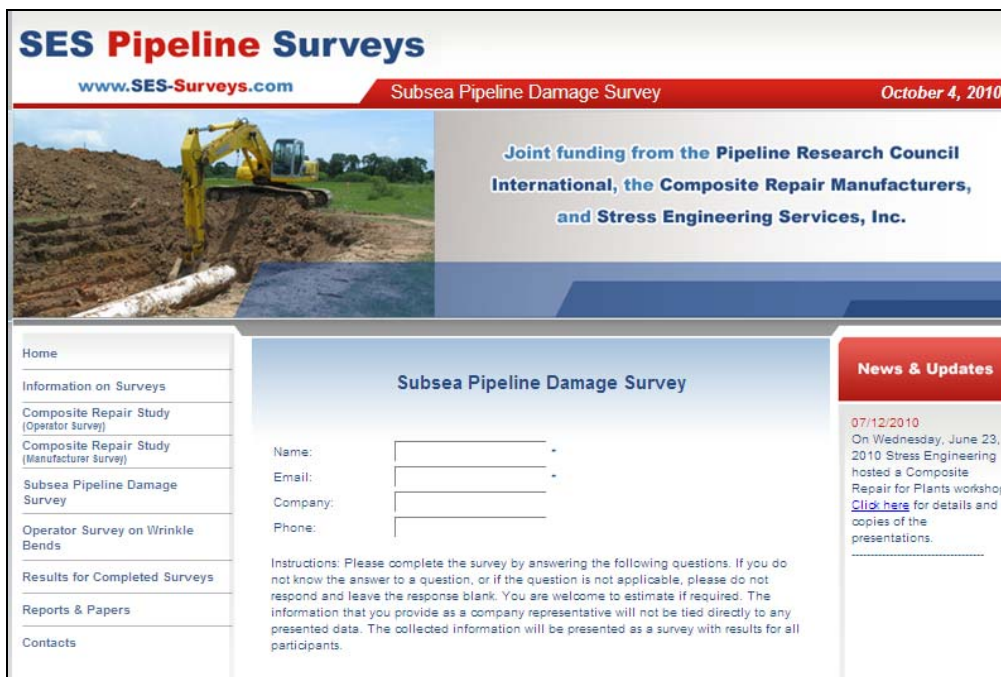
Figure 1. Screen shot from www.ses-surveys.com

To collect information from pipeline operators regarding their experiences and practices regarding wrinkle bends, a survey was conducted. Stress Engineering constructed a web-based tool for collecting survey information that was posted at www.ses-surveys.com. Results from the collected data can be seen on this website. A screen shot of the website is shown in Figure 1.

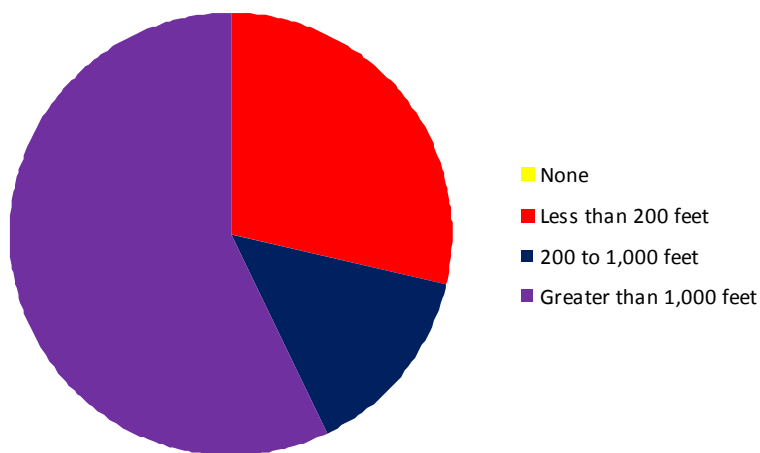
Which of the following water depths do the majority of your subsea pipeline systems operate?

- None
- Less than 200 feet [2 votes]
- 200 to 1,000 feet [1 vote]
- Greater than 1,000 feet [4 votes]

Figure 2. Survey response to question concerning pipeline water depths

Survey results were based on a total of 26 questions. Provided in Figure 2 through 5 are pie graphs showing responses to four of these questions. The survey was used to gather information on the problems and solutions associated with operating damaged subsea pipelines.

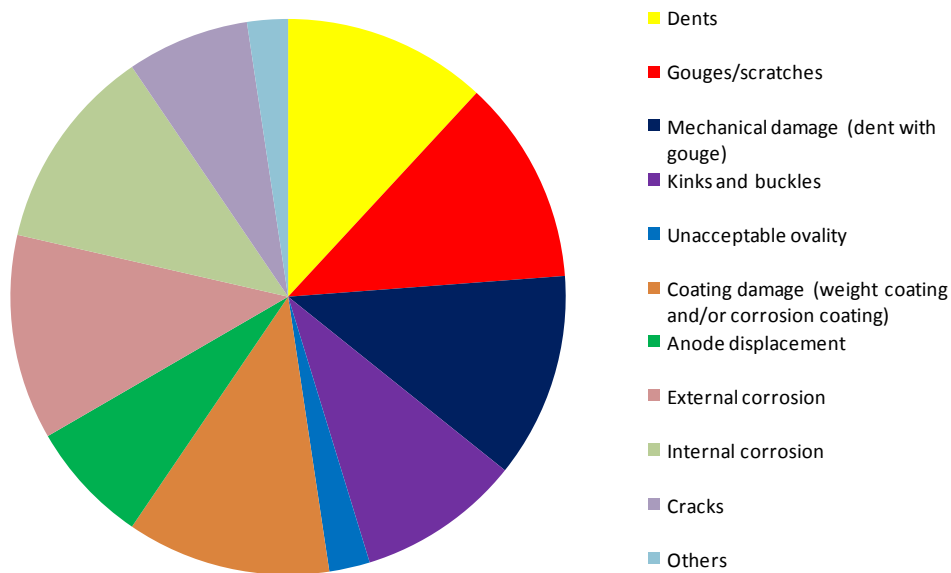
What types of damages (i.e. categories) have occurred in your pipeline system?

Figure 3. Survey response to question concerning damage categories

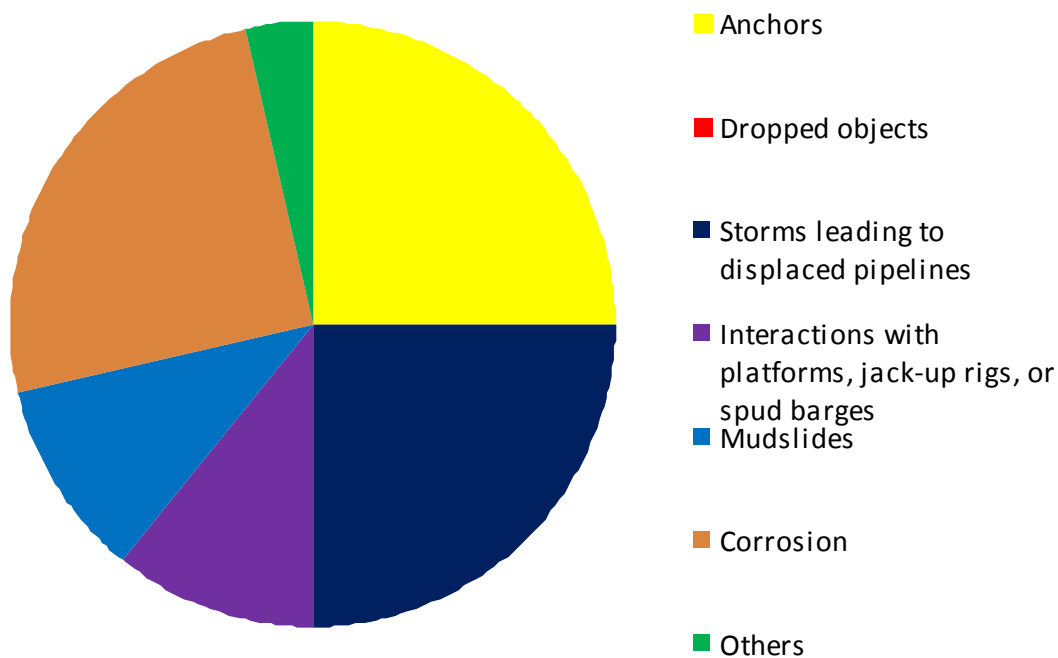
What sources of damage have been observed in your system?

Figure 4. Survey response to question concerning sources of damage

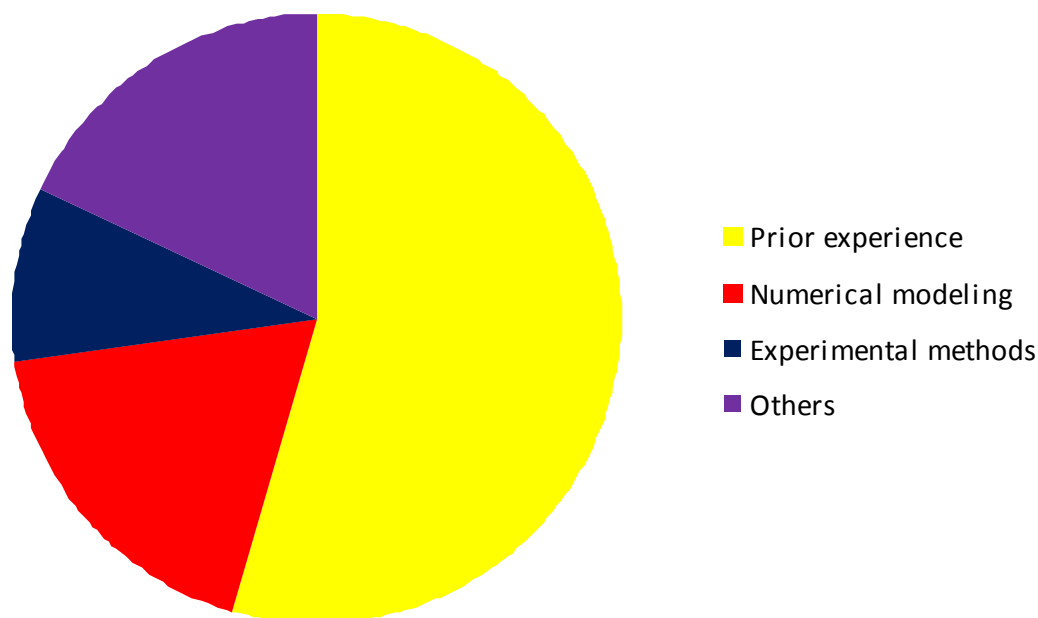
Insurance-related question: How do you quantify the severity of damage associated with a particular damage scenario?

Figure 5. Survey response to question concerning quantifying damage severity

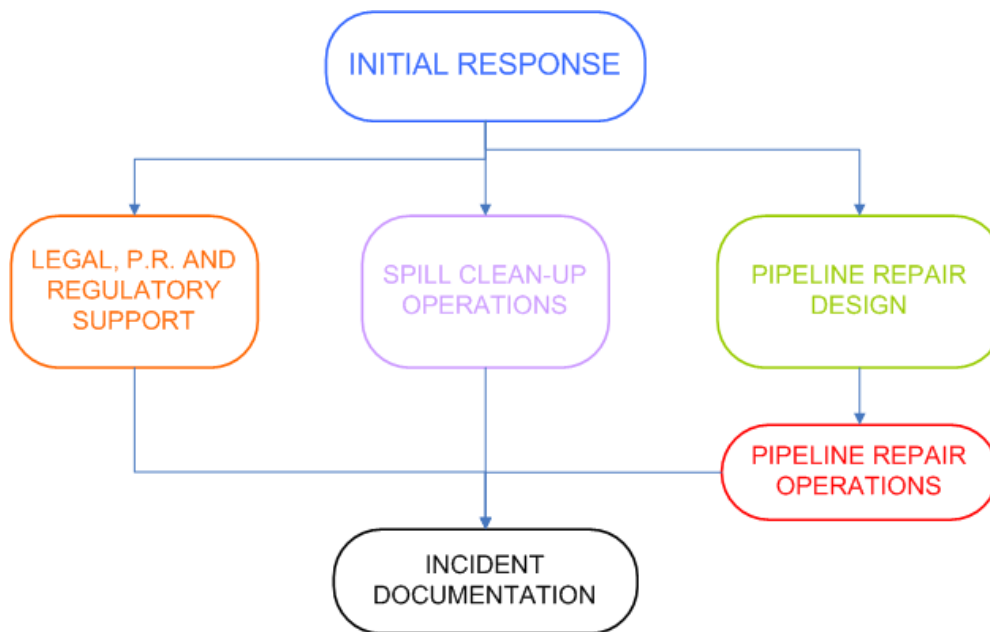
Figure 6. Six Key Elements of Response Plan

These major elements of the Guidelines were developed from a much more detailed Response Plan (decision tree) which is too detailed to be useful in this paper. The tree is a graphical representation of the thirty steps identified as critical to the response effort. The flowchart is color-coded to match the respective response steps in the detailed Guidelines.

There are six key elements that are identified as the basis of Response Plan, as shown in the following chart (Figure 6).

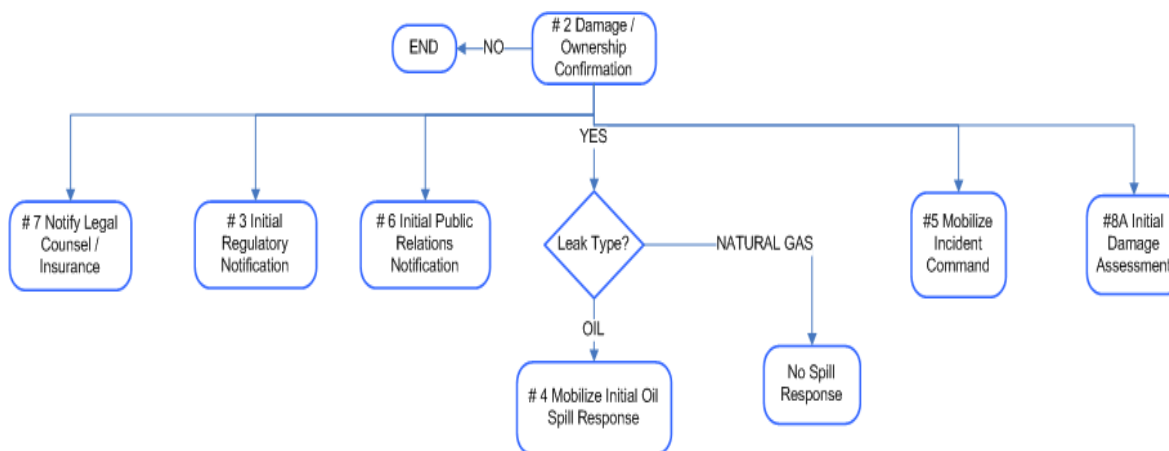
Figure 7. Initial Response Steps

In the Detailed Offshore Pipeline Damage Incident Response Guidelines (decision tree), the **Initial Response** steps appear as shown in the flowchart provided below (Figure 7).
