A Validation Study of Computed Tomography Inspection Technology Using Full-scale Test Articles with Crack-like Features

Pipeline Pigging and Integrity Management Conference

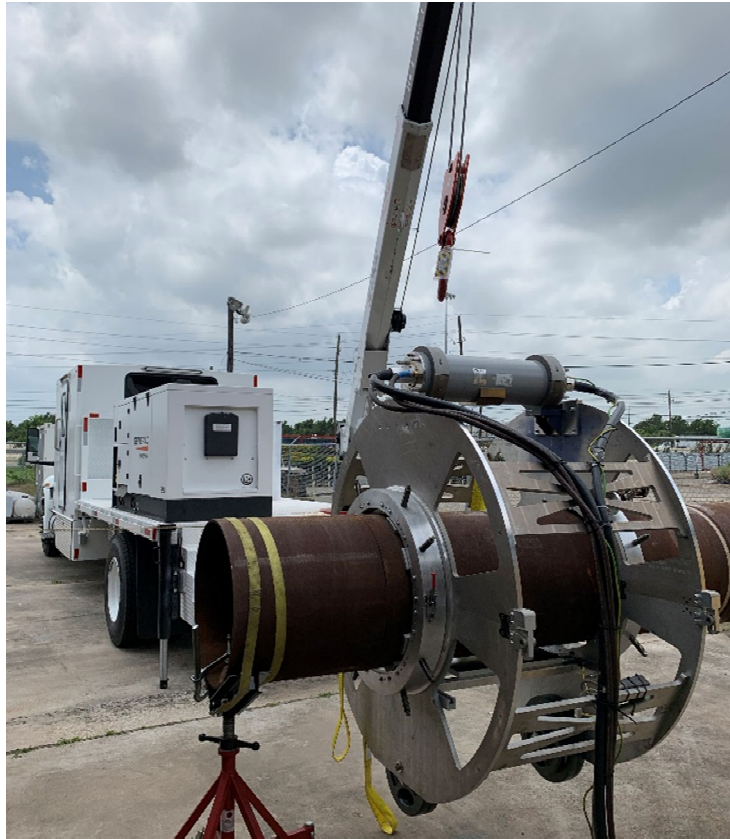
Figure 1: View of Inspection associates CT tool and crane truck

The use of Computed Tomography (CT) can be used for the inspection of crack-like features in high pressure transmission pipelines to provide higher resolution data than conventional NDE technologies. One challenge associated with the inspection of crack-like features is their geometry, including their relative sharpness and narrow profile. These characteristics make it difficult to detect and size using conventional non-destructive examination tools. Computed tomography has the potential to measure these small crack-like features. ADV was contracted by Inspection Associates, Inc. to generate a variety of crack-like features in full-scale pipe samples using EDM-starter notches. The test program was designed to permit Inspection Associates to analyze the crack geometries using their in the ditch CT tool, and then compare the inspection results to a micrographic analysis of each crack geometry. A photograph of Inspection Associates' CT tool is provided in Figure 1.

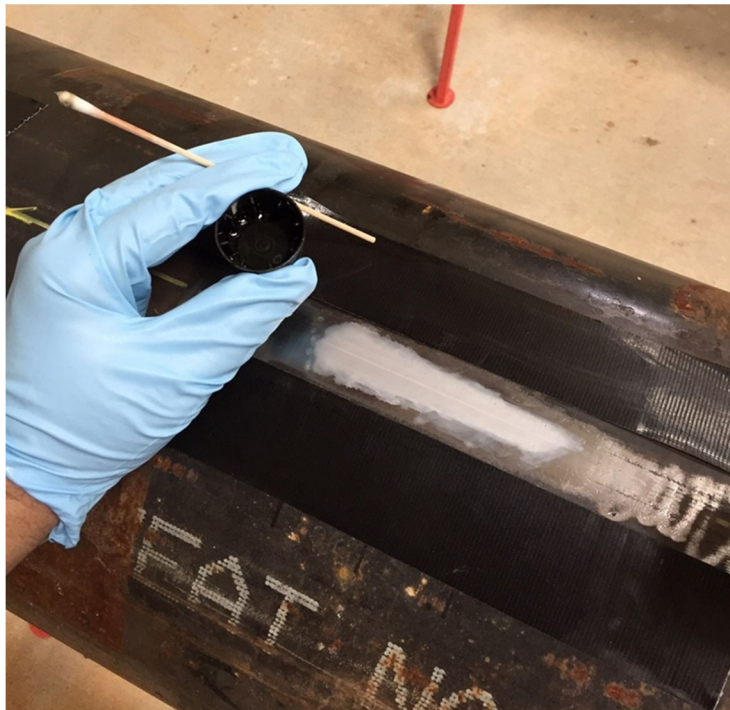
Figure 2: Macro-etching to locate the ERW bondline

The test program used three (3) 6-ft long pipe sections comprised of 12.75-inch x 0.375-inch, Grade X42 HF-ERW pipe material. A wide range of crack-like features were generated for this test program. The first sample contained six (6) pipe body defects, the second sample contained four (4) defects in the outer diameter ERW bondline, while the third contained four (4) defects on the inner diameter ERW bondline. An overview of the overall test matrix is provided below in Table 1. Samples 2 and 3 contained EDM notches in the ERW bondline. A macro-etching process was used to locate the ERW bondlines, as shown in see Figure 2.

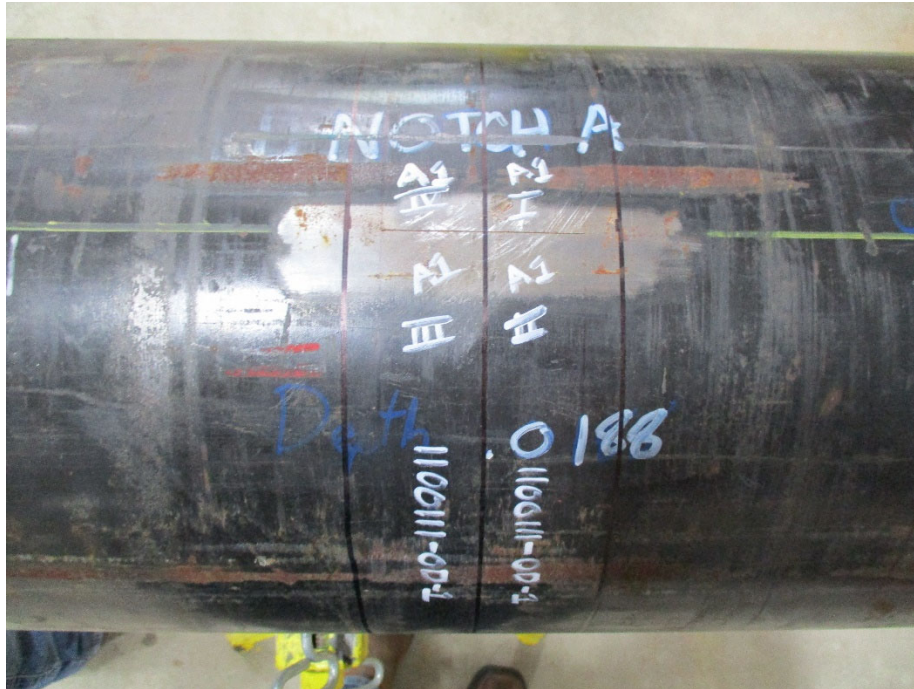
Figure 3: Example of how notches were labeled and sectioned

Following pressure cycling, Inspection Associates scanned the features using their CT tool. Then, the samples were sectioned and independently-examined by ADV Integrity along the longitudinal and transverse profiles. Each notch was split into four quadrants as shown in Figure 3. Quadrants III and IV were prepared as transverse metallurgical specimens and Quadrants I and II were cryogenically fractured for a longitudinal view. The transverse mounts were cold mounted in metallurgical epoxy, polished to a 0.05 µm surface, and then finished with a 2% nital etch. Both the transverse and longitudinal specimens were measured using photomicroscopy. A summary of the depth measurements from the CT scans and microscope measurements are listed in Table 3 in the Results section of this report.
