EFFECTS OF SMOOTH AND ROCK DENTS ON LIQUID PETROLEUM PIPELINES

Christopher R. Alexander
Stress Engineering Services, Inc.
Houston, Texas

John F. Kiefner
Kiefner & Associates, Inc.
Worthington, Ohio

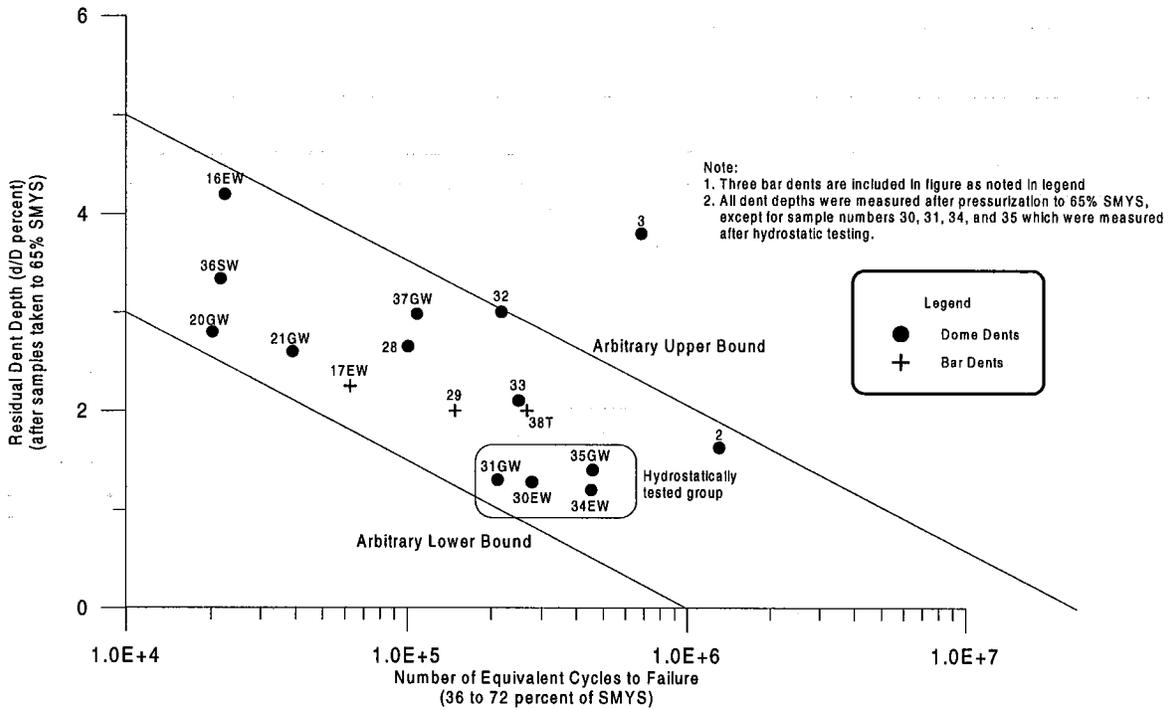
Figure 1 Fatigue Lives of Unconstrained Dome-Shaped Dents

The fatigue lives of all fourteen unconstrained dome-shaped dents are plotted in **Figure 1**. Data for the ten non-pretested specimens are plotted based on their depths after pressurization to 65 percent SMYS, and those for the four hydrostatically pretested specimens are plotted based on their depths after being hydrostatically tested. Arbitrary upper and lower bounds to these data were drawn on **Figure 1** to establish the rough relationship between dent depth after rerounding at 65 percent SMYS and fatigue life. Clearly, the shallower the dent after rerounding, the longer the life. The effects of ERW seams, SAW seams, and girth welds appear to be overridden by the effect of dent depth. Experiments UD6A-2 and UD12A-3 lie outside the upper bound. This may be because they were inadvertently overpressured at some stage of the pressure cycle testing.

Fatigue Lives of Unconstrained Dome-Shaped Dents

- For unconstrained smooth dents the deeper the dent at the start of cycling, the shorter its fatigue life in terms of pressure cycles required to create a leak.

- Hydrostatic testing had a beneficial effect on the fatigue lives of the unconstrained smooth dents most likely because of the additional rerounding associated with testing to pressure levels in the range of 90 to 102 percent of SMYS.

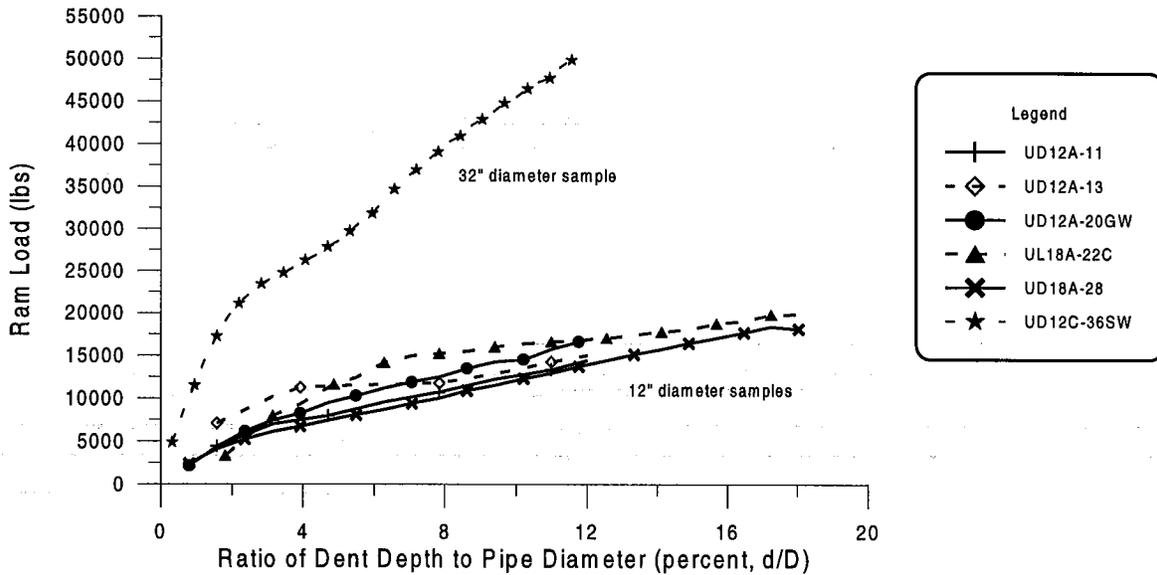
Figure 2 Relationship Between Ram Load and Dent Depth for Selected Pipe Samples

The relationships between ram loads and dent depths for 15 of the 20 dome-shaped dents are shown in **Figure 2**. The shapes of these curves seem similar over a wide range of conditions. The highest loads were associated with the 32 inch OD by 0.312-inch wall thickness pipe even though this pipe had the highest D/t value (103). This suggests that wall thickness bending may be an important factor in the resistance to indentation.

RAM LOAD AS A FUNCTION OF DENT DEPTH FOR INDENTATION WITH NO INTERNAL PRESSURE

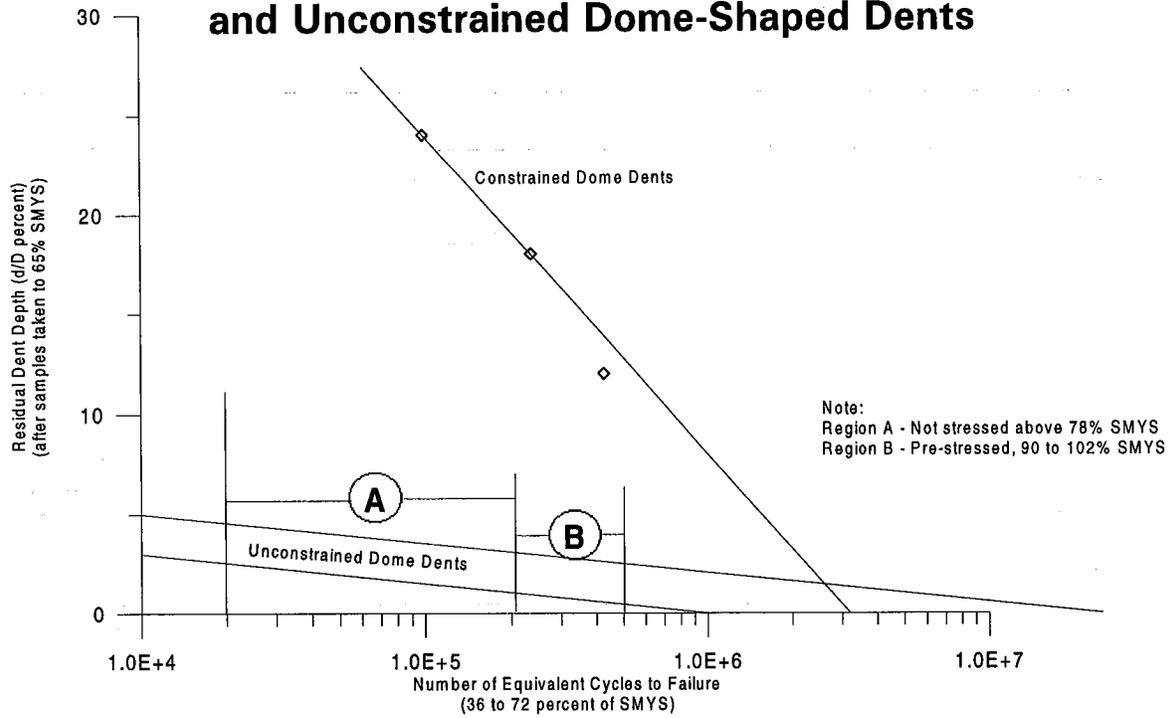
Figure 3 Comparison of Fatigue Lives for Unconstrained and Constrained Dome-Shaped Dents

Comparison of Fatigue Lives for Constrained and Unconstrained Dome-Shaped Dents

The results of these tests are provided in **Table 6**. The dent in Experiment CD12A-15 survived 426,585 cycles without showing any signs of cracking in the dent. The test was terminated because the constraint failed, allowing rerounding probably to the maximum cyclic pressure

level (i.e., to 78 percent of SMYS). The other two dents developed leaks unique to the constrained dent configuration. Each one developed a transversely-oriented crack which initiated at the ID surface and propagated to the OD surface. In both experiments the crack was located symmetrically across the longitudinal axis of the dent (transverse), but within and near the edge of the contact area between the constraining end cap and the pipe. In contrast, the unconstrained dents developed longitudinally-oriented cracks which propagated from the OD surface to the ID surface.
