INTENTIONAL DESTRUCTIVE TESTING: A MEANS FOR ESTABLISHING MECHANICAL INTEGRITY

ABSTRACT

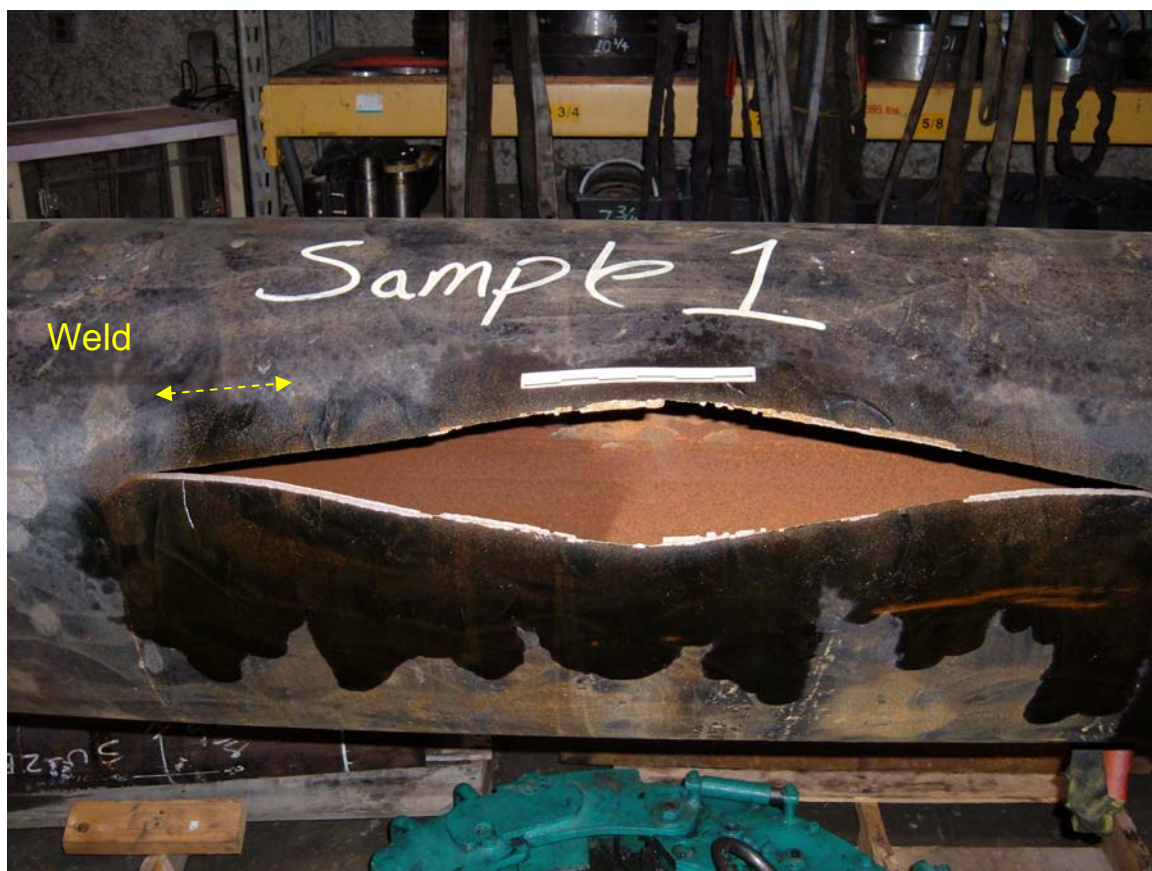
Figure 5 - Hydrostatic test rupture in Sample #1
The location of the longitudinal seam weld is also shown.

Of the three burst tests that were performed, the minimum burst pressure that occurred was 2,129 psi, which corresponds to 148 percent of the yield pressure and translates to a hoop stress of 68,128 psi. Figure 5 is a photograph showing the hydrostatic test rupture in Sample #1; note the location of the longitudinal seam weld that occurred outside the failure. Table 1 lists the test pressure results for all three burst samples.

Post-failure metallurgical evaluation showed that no failures occurred in the weld seam and that none of the seam weld features contributed to the pressure failures. Additionally, there was no evidence that corrosion or fatigue contributed to the rupture origins or that failures occurred due to deficiencies in material properties.

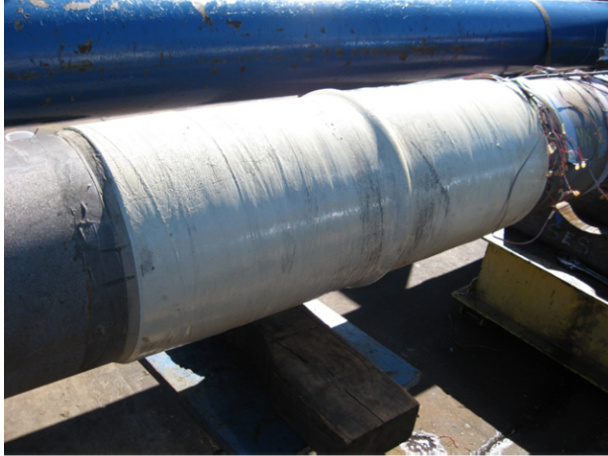
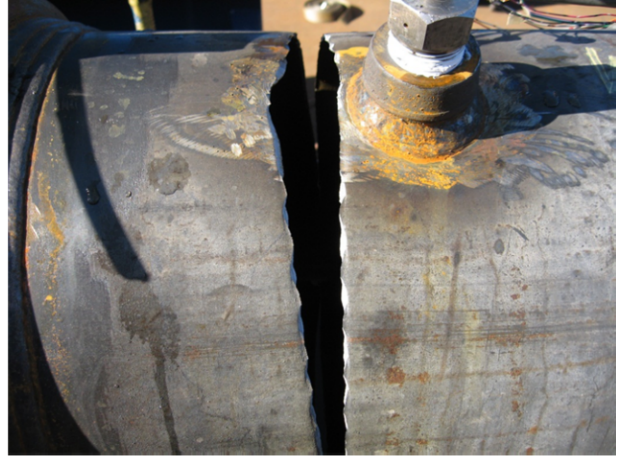
Sample prior to testing in tension

Failure in tension sample

Figure 8 – Photograph of tension failure in Product C test sample

When considering the performance of the composite reinforcing systems, there were some differences in the results for the tension-to-failure samples. The unreinforced tension sample failed at a tension load of 293 kips. Considering the reinforced tension samples with full bonding areas, the reinforced samples had tension-to-failure loads ranging from 433 to 481 kips. The repair using Product C was able to achieve a maximum tension load of 522 kips with failure occurring in the base pipe near a welded bosset outside the repair, as shown in Figure 8. Shown in Figure 9 are photographs showing the bend test results for reinforced test sample; note the wrinkle that formed outside of composite reinforcement. A plot of tensile load versus deflection for all five of the tested systems is shown in Figure 10. The results presented in this plot only include loads applied by the load frame; whereas the tension values presented above include the presence of pressure end loads.

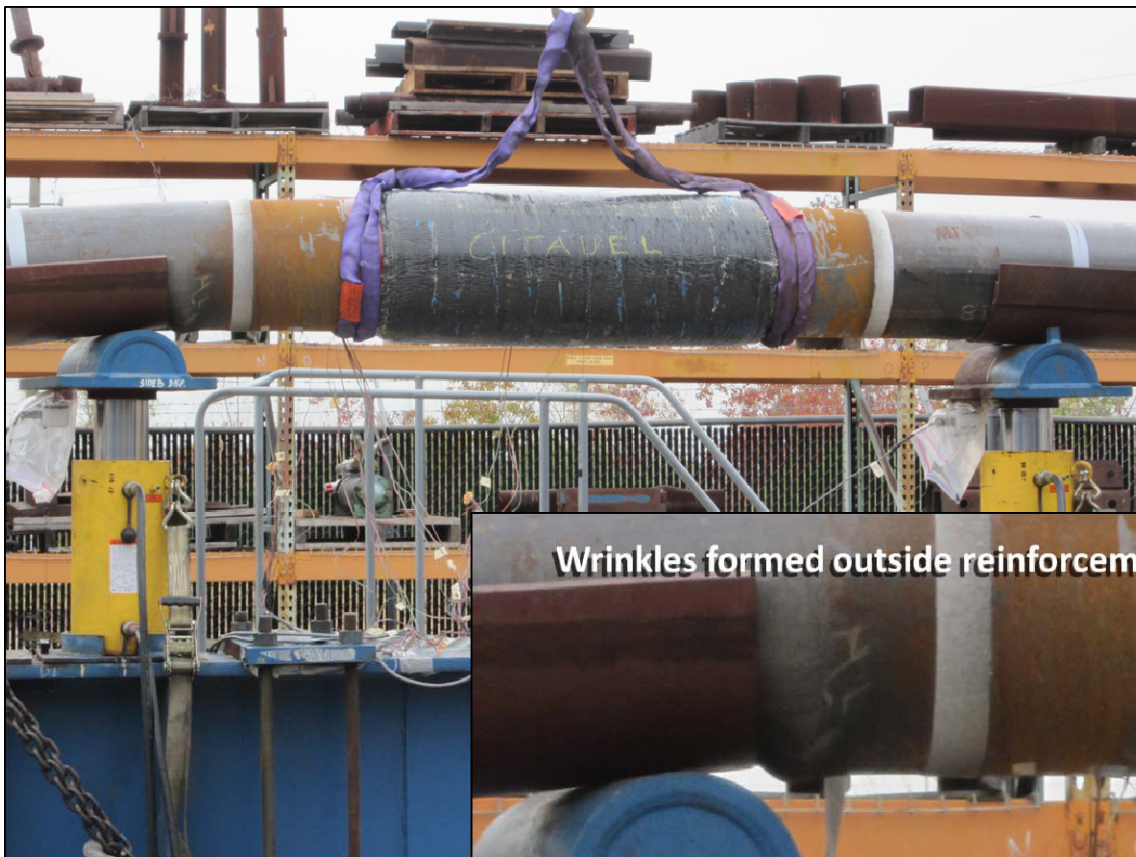
Wrinkles formed outside reinforcement

Figure 9 – Bend test results for reinforced test sample
(note wrinkle that formed outside of composite reinforcement)

During bend testing, all five of the composite reinforced systems performed well in the sense that the initial level of distortion in the pipe occurred outside of the reinforcement. These results demonstrate that the stiffness of the reinforced sections are not only greater than the base pipe, but of sufficient magnitude to ensure that wrinkles form outside a composite-reinforced section when subjected to bending loads. Figure 7 includes photographs of the unreinforced bend sample, including a cross-section of the weld after failure. The sample shown in this figure was subjected to increasing bending loads until a failure occurred.

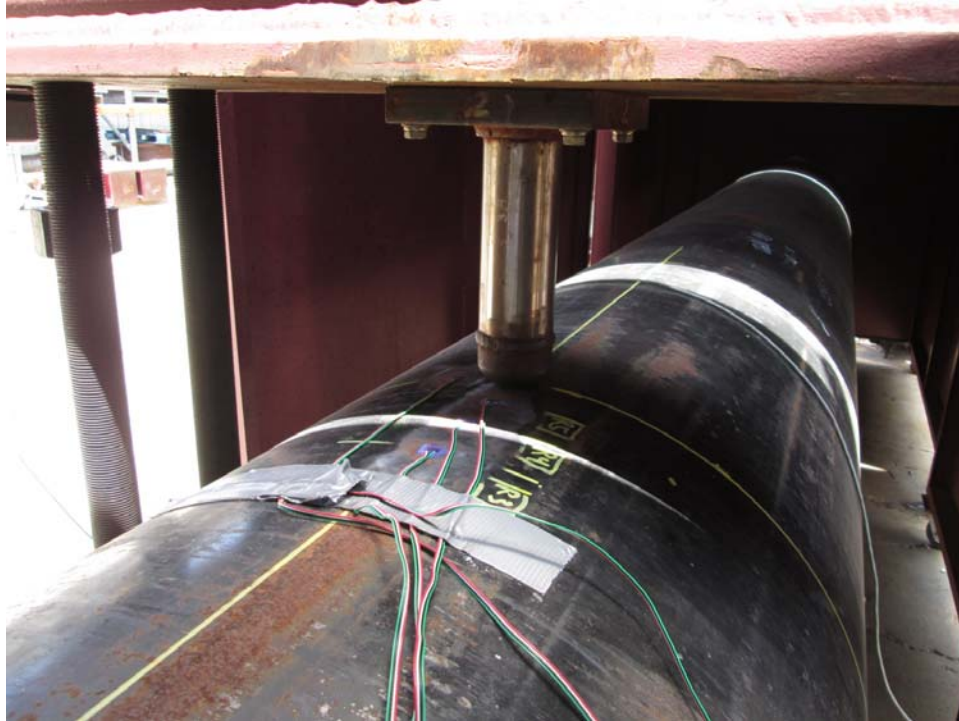
Figure 11 – Installation of dent in 24-inch diameter pipe

In this particular test a 15% deep initial dent (dent depth divided by outside pipe diameter) was installed in a 24-inch x 0.25-inch pipe as shown in Figure 11. Strain gages were installed in the dented region of the pipe and the sample was cycled to failure at a pressure range between 10 and 80% SMYS of the pipe. The sample failed after the application of 39,800 cycles, with a longitudinally-oriented crack being developed in the dented region as shown in Figure 12.

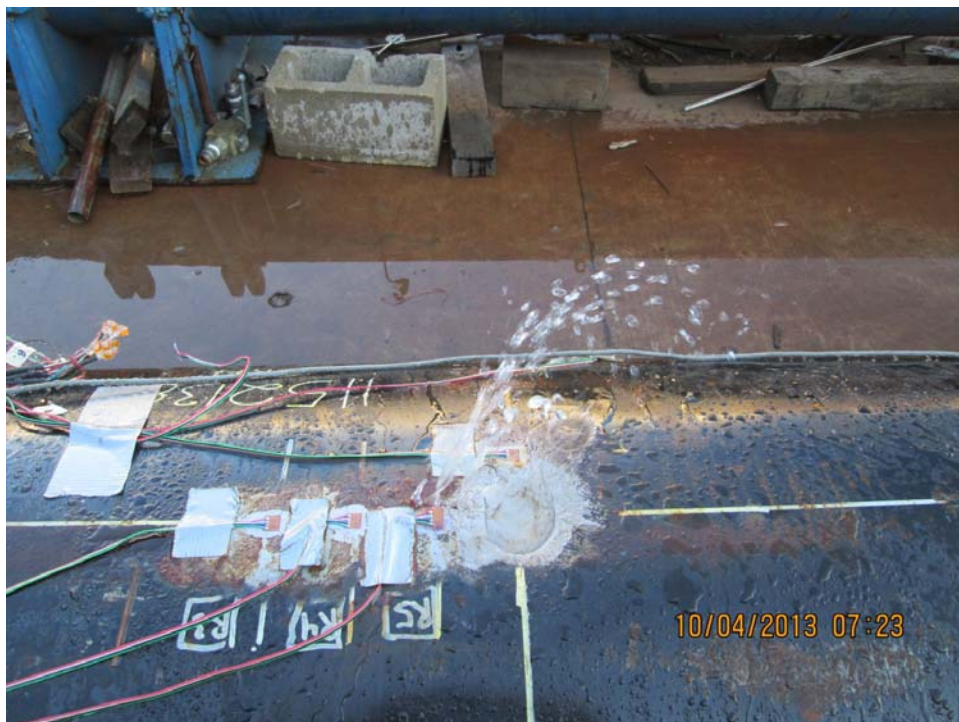
Figure 12 – Pressure cycle fatigue failure in dented 24-inch diameter pipe
