Composite Repair Performance at Elevated Temperatures

Pipe Wrap, LLC
Houston, Texas U.S.A.

Stress Engineering
Services, Inc.
Houston, Texas U.S.A.

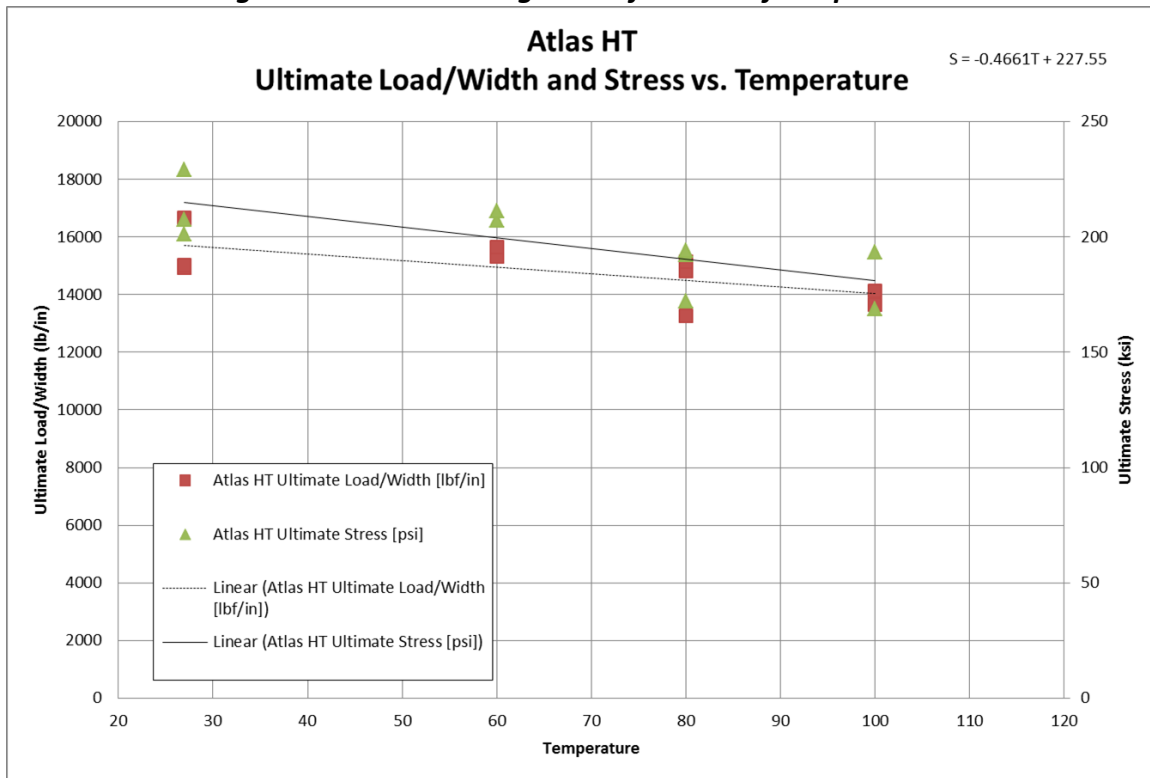
Figure 4 – Tensile strength as a function of temperature

Provided in Table 3 is a summary of short-term tensile strengths as a function of temperature. As observed in the list, the maximum tensile strength occurred at room temperature (27°C) at 229 ksi (1,579 MPa). The minimum tensile strength occurred at 100°C at 169 ksi (1,165 MPa), not considering the failure in the grip. Figure 4 is a plot of the tabulated data showing tensile strength as a function of temperature. Also included in this figure is an equation correlating strength as a function of temperature. Curves fits of this type are useful for design purposes as they can be used to account for reductions in material strength with increasing temperature.

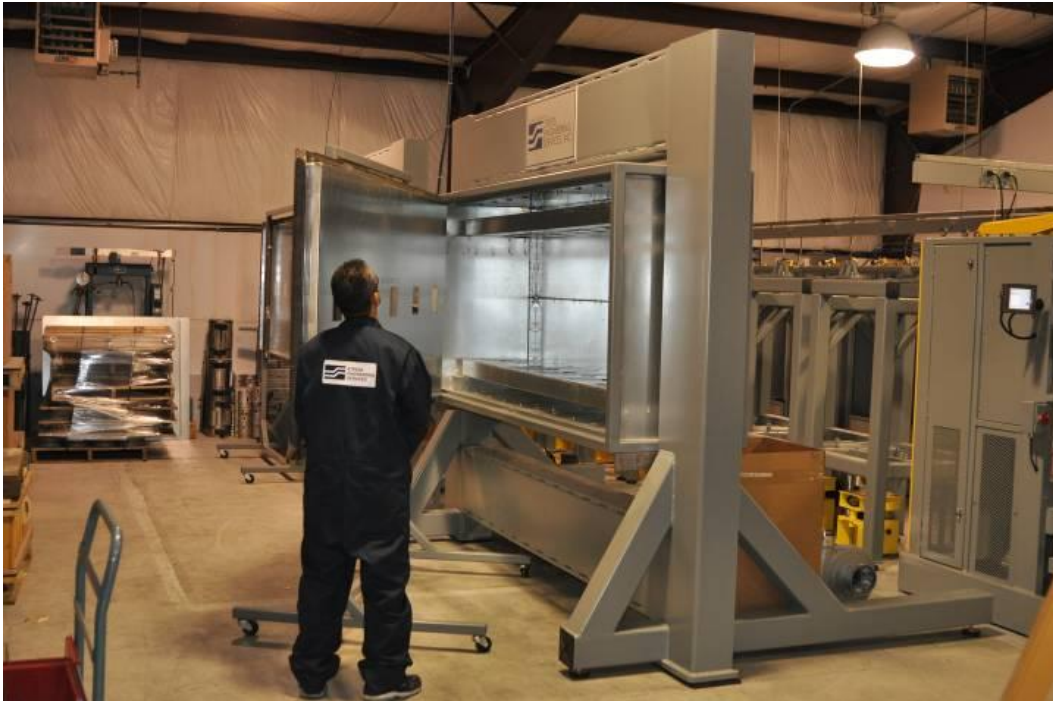
Figure 5 – Photograph showing the creep test facility

Figures 5 and 6 are photographs of the Stress Engineering Services Inc. creep test facility. Figure 7 is a schematic showing the layout of the test facility. The set-up has two 10-station creep machines, permitting 20 samples to be tested at one time. Each station has a capacity of 3,000 lbs. The heating unit has a temperature range up to 250°F (121°C), achieving a uniform oven temperature within 2°F. The system has an automatic break-detection feature where temperatures and rupture time are recorded by a computer.

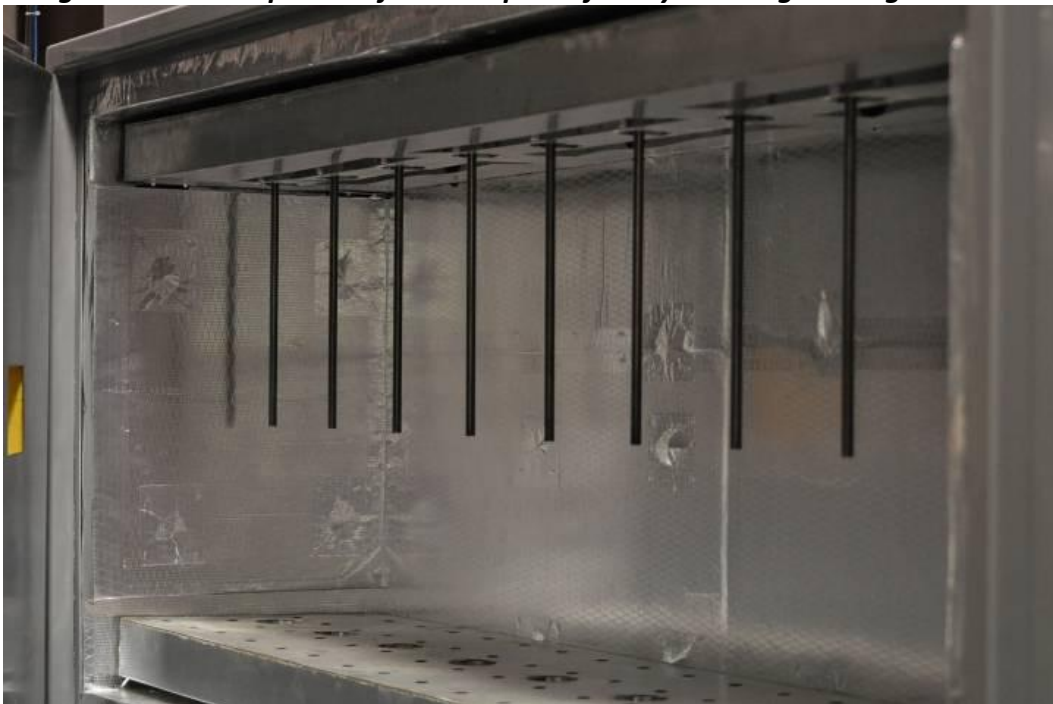
Figure 6 – Close-up view of the creep test facility showing loading chamber

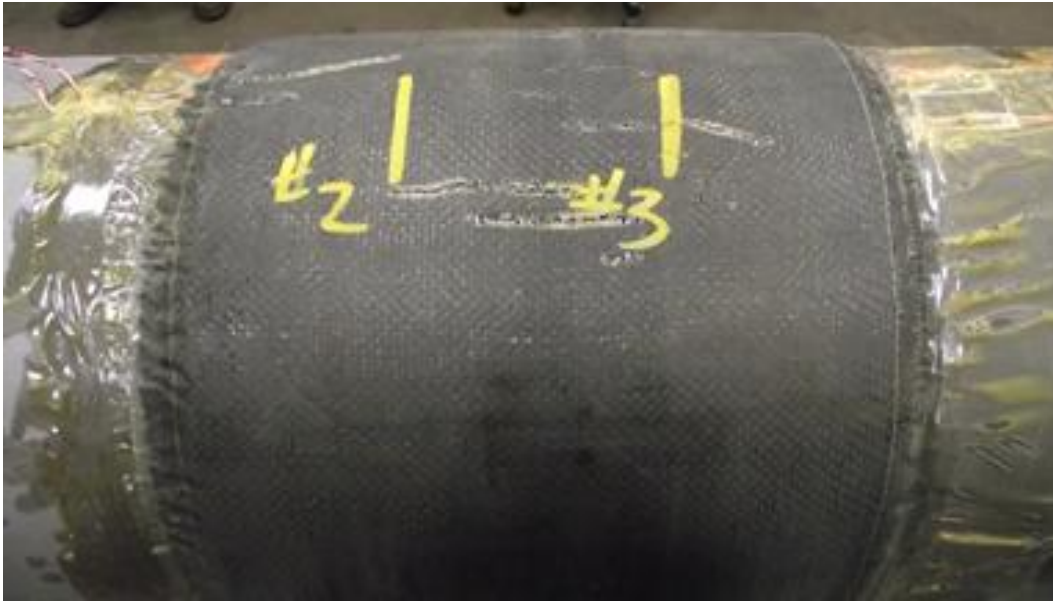
Figure 10 – Photograph of composite repair after installation

Strain gage were installed on the test sample, along with thermocouples, prior to installation of the Atlas CFE composite material. Figure 9 shows a close-up of the strain gages installed in the machined region of the test sample. Also included in this figure (upper right hand side) is a photograph of the wall thickness measurements made after machining. After installation of the composite material, thickness of the repair was measured to be approximately 0.43 inches. Figure 10 is a photograph of the composite repair after installation.

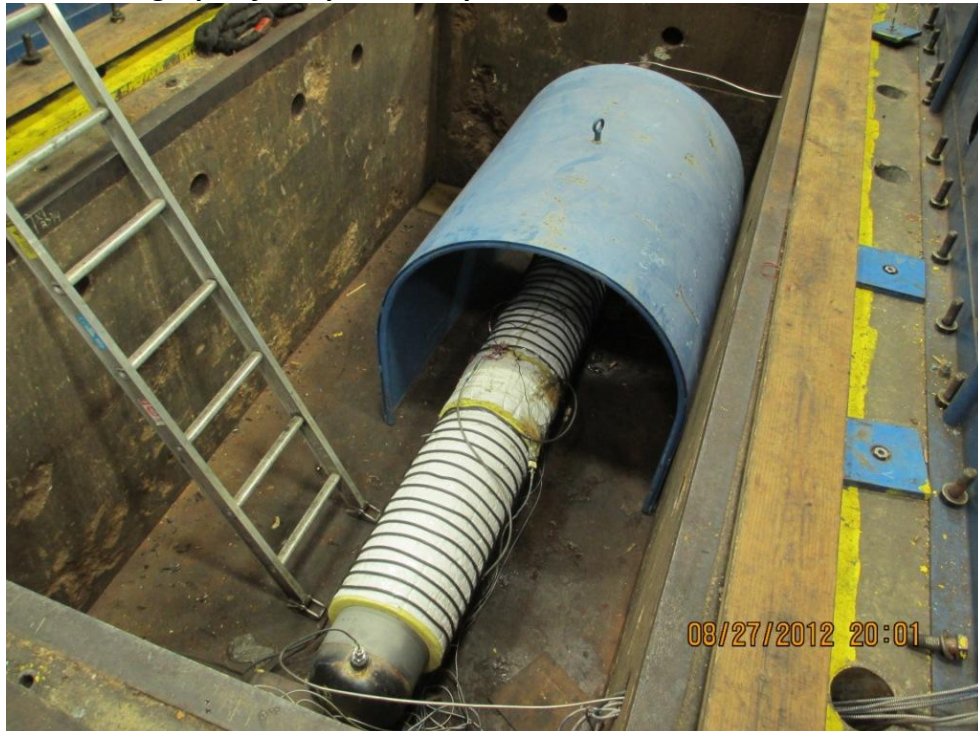
Figure 11 – Photograph of sample in test pit with insulation and induction heating coils

Prior to the application of internal pressure, the test sample was filled with heat transfer oil. This medium was selected as the target test temperature was 120°C (248°F), a temperature that precluded the use of water due to the potential formation of steam in the sample. Figure 11 is a photograph of the sample in the test pit with insulation and induction heating coils. During pressure testing, internal pressure, strain and temperature were monitored at a rate of 1 scan per second.

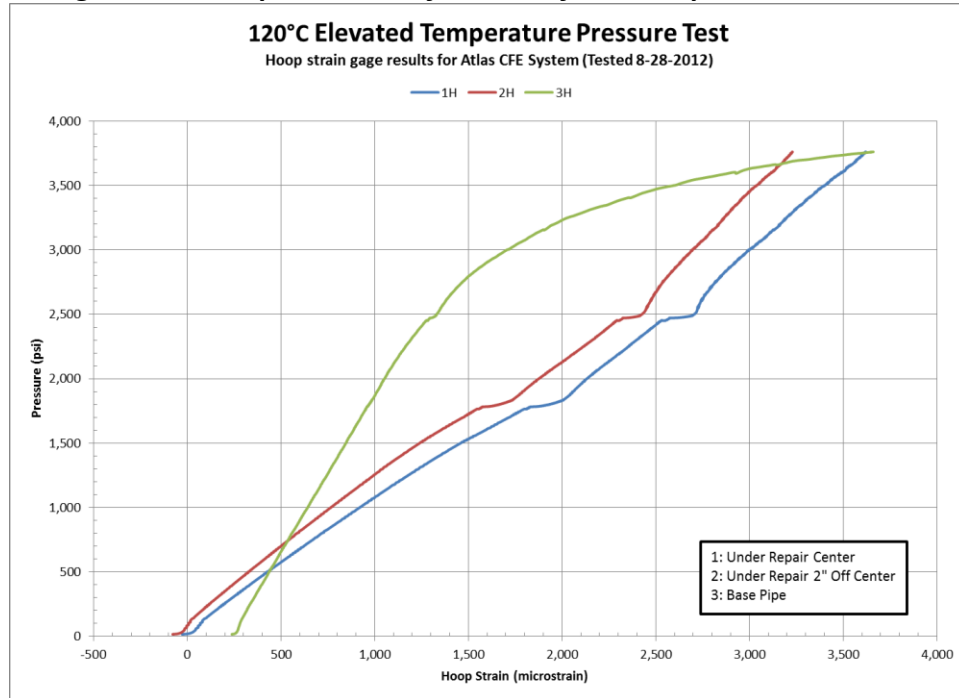
Figure 12 – Hoop strain as a function of internal pressure at 120°C

Figure 12 shows a plot of hoop strain as a function of internal pressure at 120°C. Pressure holds of 5 minutes were made at 1,778 psi (72% SMYS, where SMYS is the Specified Minimum Yield Strength of the pipe material) and 2,470 psi (100% SMYS). Gage #1 was located in the middle of the simulated corrosion region and measured hoop strains of 1,832 $\mu\epsilon$ (microstrain) and 2,572 $\mu\epsilon$ at the 72% and 100% SMYS pressure levels, respectively (note: 10,000 $\mu\epsilon$ corresponds to 1% strain). Also included in Figure 8 are hoop strains measured on the base pipe.

Typically, internal pressure in reinforced pipe samples is increased to failure; however, due to safety concerns a maximum pressure of 3,765 psi was applied. Prior tests on similar pipe material resulted in burst pressures of approximately 4,100 psi. As observed in Figure 12, by the point the maximum pressure of 3,765 psi was reached strain in the main body of the pipe sample were exceeding strain levels beneath the repair in the simulated corrosion region.
